# The reservoir as an asset

Proceedings of the ninth conference of the British  
Dam Society held at the University of York on  
11–14 September 1996

The existing overflow at Dove Stone reservoir had insufficient capacity to pass the design flood. The recommended solution was to provide an auxiliary spillway with a 55m long weir. Significant cost savings were achieved by using tipping fusegates to reduce the weir length to 9.8m. Model testing was necessary to prove the design and to optimize the final arrangement to produce additional savings.

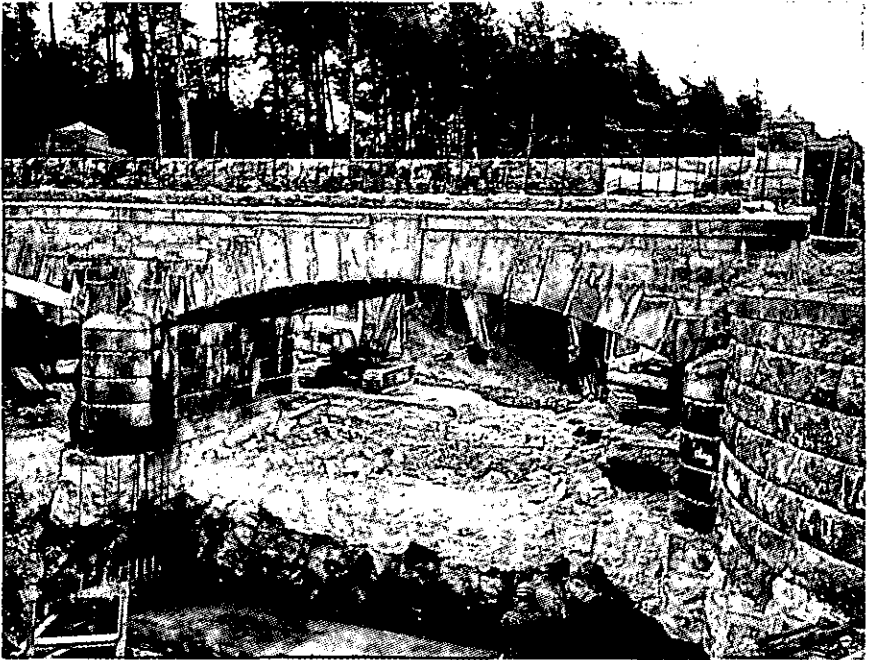
FIG 2. SPILLWAY BRIDGE EXCAVATION

The original bridge and spillway channel were found to be of substantial construction, more so than had been indicated in the structural investigation. Foundations were brickwork or mass concrete on rock with no soft materials encountered (Fig. 2). This enabled temporary works to be scaled down bringing significant time and cost savings. The clay core was identified beneath a shallow trough within the spillway channel bed and running under blanked off arches to each side wall (Fig. 3). These arches had foundations

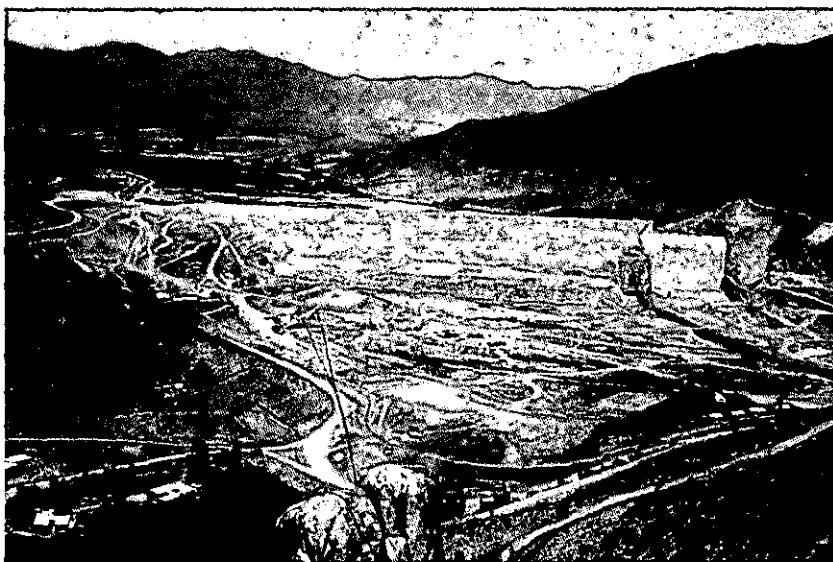
Fig. 4. Photograph of the whole downstream face of Paloma dam and spillway.

Laboratory of the University of Chile, with particular emphasis on the shape of the ogee under the gates, to ensure best flow during all stages of discharge. Fig.3 gives a cross section of the dam, with the spillway and chute superimposed, to show its position in relation to the adjoining embankment, and Fig.4 is a photograph of the whole downstream face of the dam and spillway.

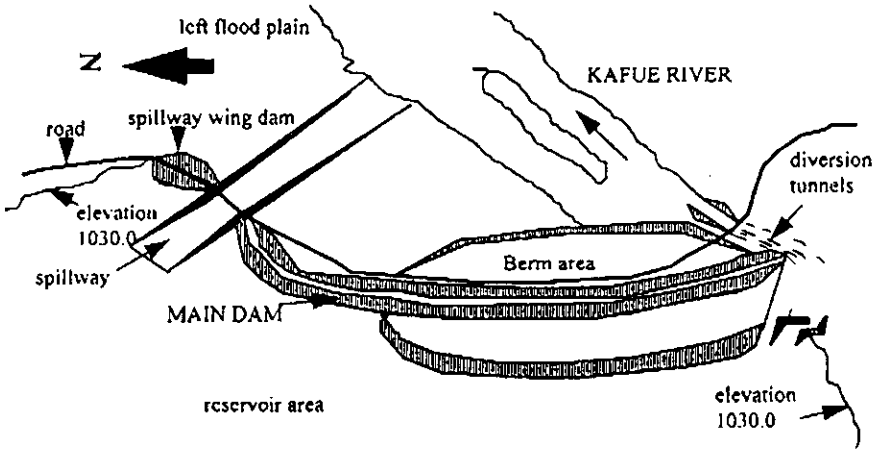
Fig.2. Sketch plan of the dam showing part of the investigated area.

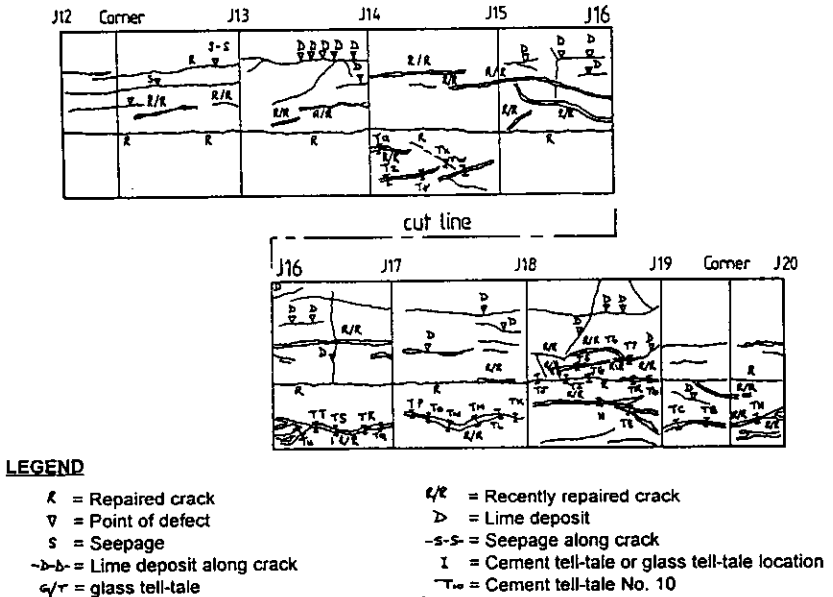
To Shek Fresh Water (F/W) Service Reservoir, completed in 1982, is of concrete gravity construction in two compartments, with a Salt Water (S/W) Reservoir constructed against the east perimeter wall. In 1983, cracks were observed in the perimeter walls during routine inspection by WSD. The Salt Water Reservoir was kept empty, and an Independent Inspection was made by Mr W P McLeish in 1990, following an initial inspection in 1985. There was extensive wide cracking predominantly in a near horizontal direction, on all walls, as shown in Fig. 5 for the common wall with the S/W Reservoir.
