GEOFFREY BINNIE  
LECTURE 1998

BRITISH DAM SOCIETY

The Prospect for Reservoirs  
in the 21st Century

DISCUSSION

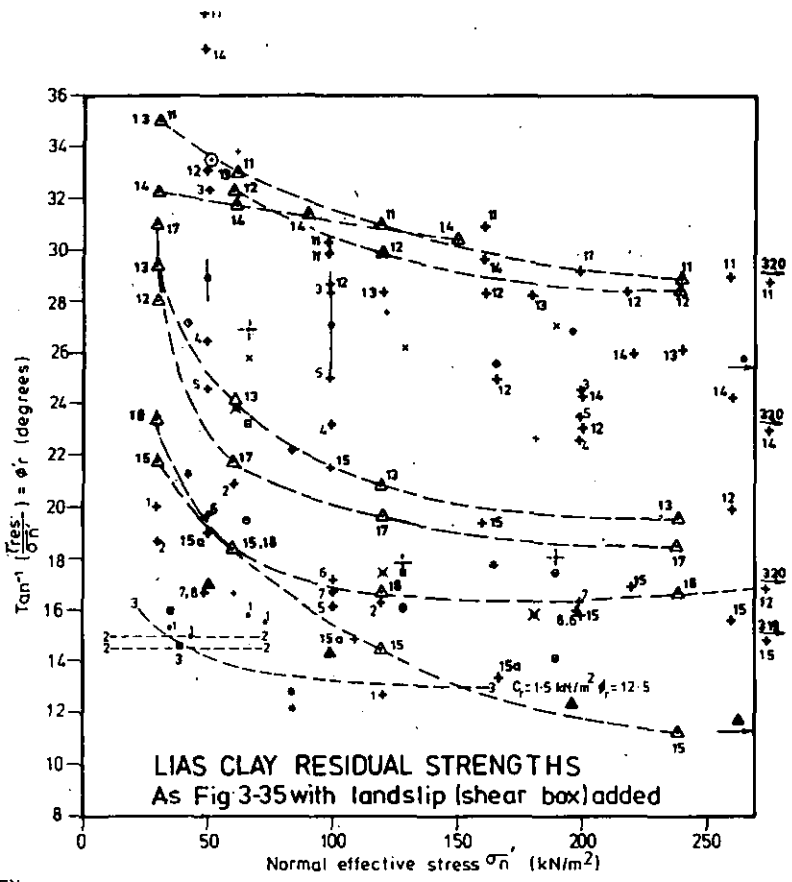
- KEY**
- Published data
- 1 Chandler et al (1973)-Ref 31
  - 2 Hutchinson et al (1974)-Ref 32
  - 3 Chandler et al (1976)-Ref 12
  - Denotes back-analysed value
  - Measured in lab tests
  - Envelope from lab tests

- 1983 AND PREVIOUS INVESTIGATIONS**
- x LGR 6/7
  - LGR 6/16
  - o LGR 17/17
  - LGR 17/19
  - † LGR 37/8
  - x LGR 37/12
  - ◇ FEA 3/8
  - FEA 17/16
  - BB 17/11
  - ▲ BB 17/5
  - BB 17/11
- Reversal shear box tests
- Ring shear tests

Results for landslip Lias samples from shear box tests (+11 to +16 as on Figure 3-33)

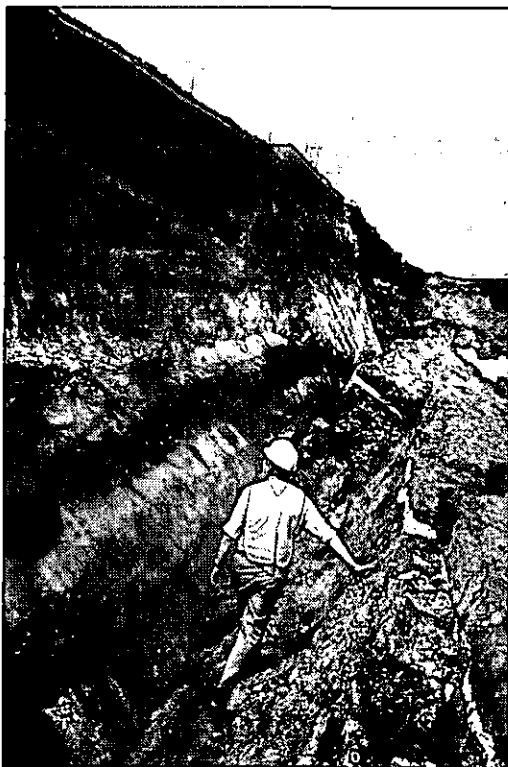
Figure 3. Failure of Carsington dam.

the reconstruction of Carsington dam, which had suffered a major upstream slip in June 1984 when the embankment was almost at full height, was £17.8 million (Banyard et al, 1992). Figure 3 shows the slope failure at Carsington.

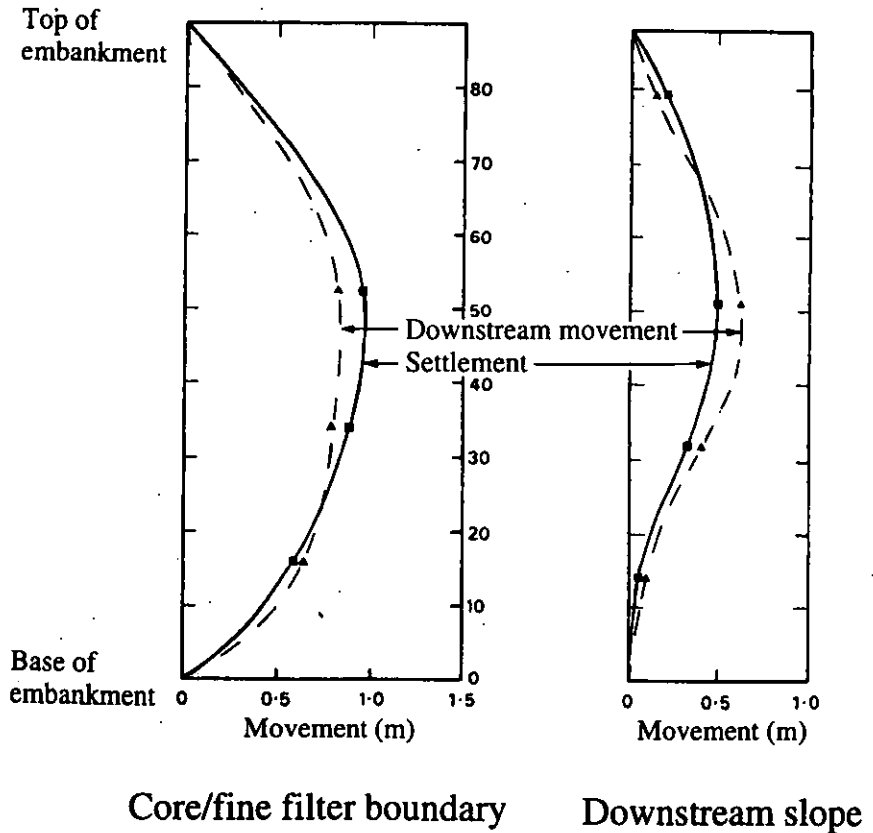
Figure 5. Construction movements at Llyn Brianne dam (after Penman and Charles, 1973a).

BRE made extensive measurements of the deformations that occurred during the construction of Llyn Brianne dam in the period between 1969 and 1971 (Penman and Charles, 1973a). The location of instrumentation is shown in Figure 4. The central clay core was placed wet of Proctor optimum moisture content at a relatively low undrained shear strength. The rockfill shoulders were heavily compacted and had a high angle of shearing resistance. The effective stresses in the core were very low during embankment construction and pressure from the wet clay core produced a major lateral thrust on the rockfill shoulders. The downstream rockfill was subjected to a greater lateral thrust during construction than it would subsequently suffer from the reservoir water and the effect of reservoir impounding on the downstream rockfill was therefore small. No additional downstream movement occurred at the clay core/ downstream rockfill interface during impounding. Figure 5 shows that large lateral movements occurred during embankment construction. During the final stages of embankment construction lateral movements as large as 20mm per metre height of fill placed were measured. Clearly these large constructional movements were not a sign of incipient failure as the factor of safety against slope instability was quite satisfactory.

The movements were not a problem, merely a sign of the healthy behaviour of a wet plastic clay core.

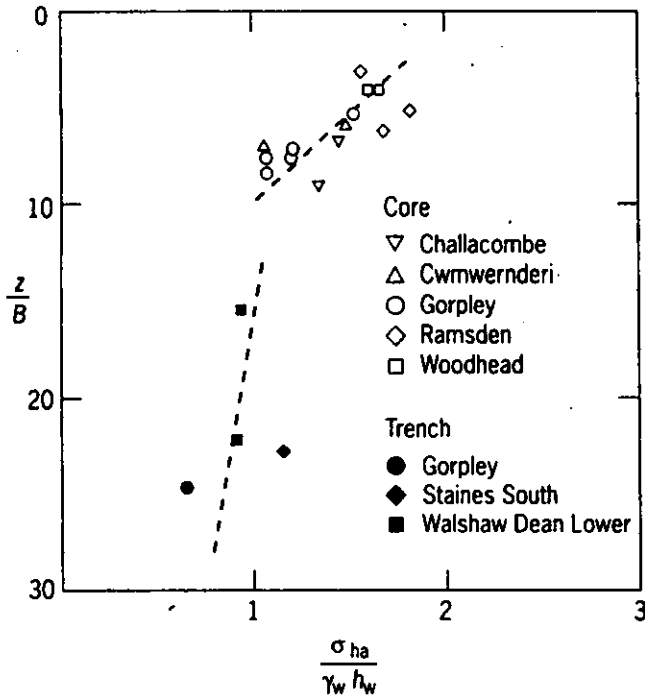
Figure 11. Stresses measured in puddle clay cores and cut-off trenches (after Tedd and Charles, 1991).

Hydraulic fracture of the core by the reservoir water pressure may initiate internal erosion. Lofquist (1992) suggested that two conditions were necessary for hydraulic fracture to occur; the first relates to the stress conditions, the second to the presence of an initiating zone, such as an existing crack or more permeable layer, which is in hydraulic connection with the reservoir. Hydraulic fracture may occur where a thin clay core is supported by stiffer granular shoulders and internal stress transfer is caused by differential settlement. Significant stress transfer can also occur along the axis of the dam in steep sided valleys. Measurements by Charles and Watts (1987) showed that the stress conditions found in narrow clay filled cutoff trenches rendered some old British dams particularly vulnerable to hydraulic fracture. The ratio  $\sigma_{ha}/\gamma_w h_w$  can be used as an indicator of susceptibility to hydraulic fracture, where  $\sigma_{ha}$  is the horizontal total stress acting in the direction along the axis of the dam and  $\gamma_w h_w$  is the full reservoir pressure at the depth of measurement. Where  $\sigma_{ha}/\gamma_w h_w > 1$ , hydraulic fracture is unlikely. Figure 11 shows  $\sigma_{ha}/\gamma_w h_w$  plotted against  $z/B$  where  $z$  is the depth below the crest at which the stress was measured and  $2B$  is the width of the core at that depth.

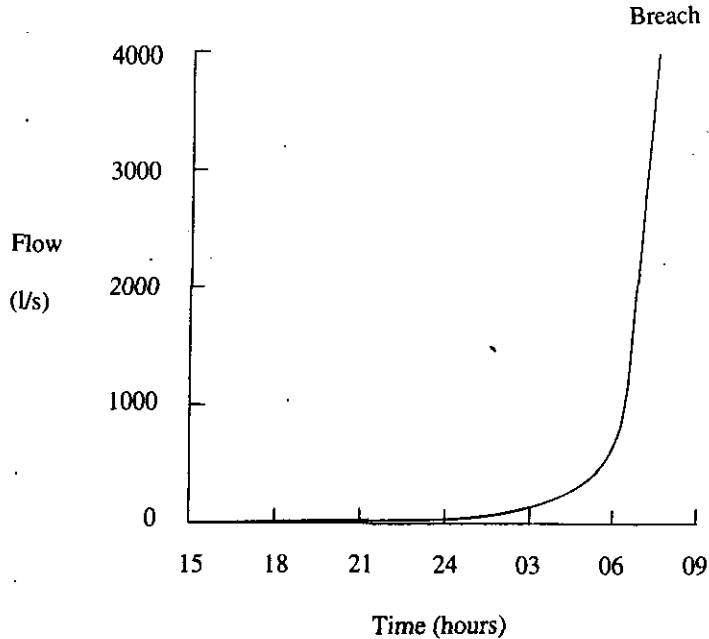
Figure 12. Flow rate at Warmwithens dam as failure developed.

Leakage and associated internal erosion have developed in very different ways at different dams. Figure 12 shows the development of the leakage flow at the 10m high Warmwithens clay fill dam in the period immediately prior to failure on 24th November 1970 as deduced from the data presented by Wickham (1992). The flow increased in a few hours from a few l/s to over 1000 l/s.

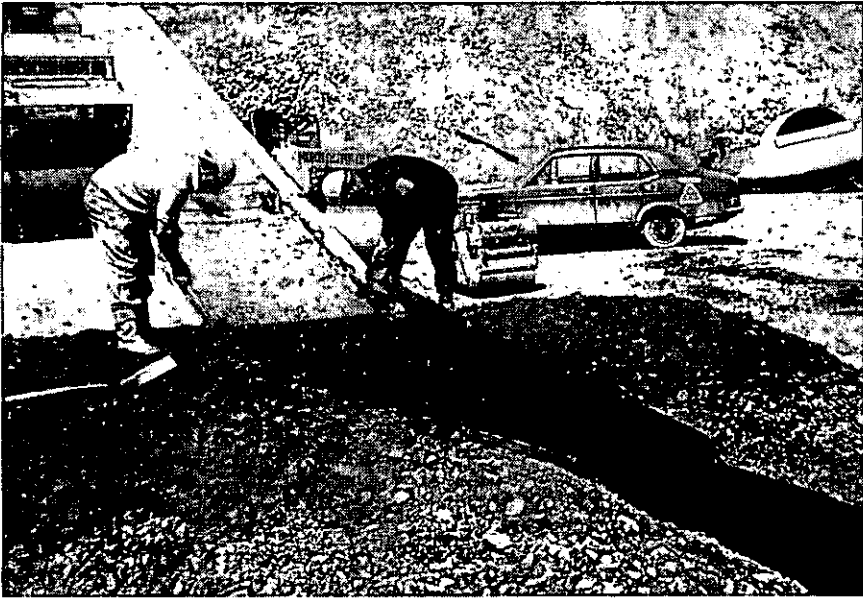
*Figure 15. Base of bituminous core on roof of inspection gallery at Queen's Valley dam, Jersey.*

An example where stress conditions are favourable is provided by Queen's Valley dam on Jersey. The dam was completed in 1991. The central vertical bituminous core is founded on the roof of the inspection gallery, as seen in Figure 15, and, as bituminous cores are very thin, the interface of core and concrete is clearly a critical location. However, providing that there is not excessive hang-up of the core on the stiff rockfill shoulders, there will always be vertical compressive stress at the interface. Therefore, there should be no possibility of hydraulic separation along the interface due to the pressure of the reservoir water.

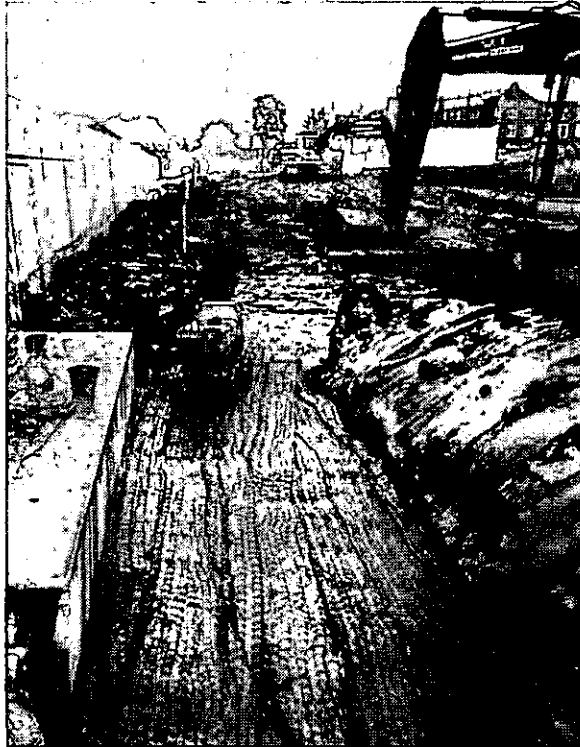
*Figure 16. Trial compaction of clay fill against concrete structure in modification of Audenshaw reservoir.*

Any structure which passes through an embankment dam from upstream to downstream presents a potential hazard to dam safety and internal erosion failures have often been associated with the presence of this type of structure. Dolcetta (1997) explained that Italian regulations prohibit such structures in embankment dams. The current modification of Audenshaw reservoir in Manchester has unavoidably involved the construction of two culverts passing through the new clay fill embankment. The stress conditions in the fill at the side of a culvert are much less favourable than for the fill on the roof of the culvert. Great care has been taken in ensuring appropriate fill placement against the culvert walls as shown in Figure 16.
