British Dam Society

# **The prospect for reservoirs in the 21st century**

Proceedings of the tenth conference of the BDS held at the  
University of Wales, Bangor on 9–12 September 1998

Edited by Paul Tedd

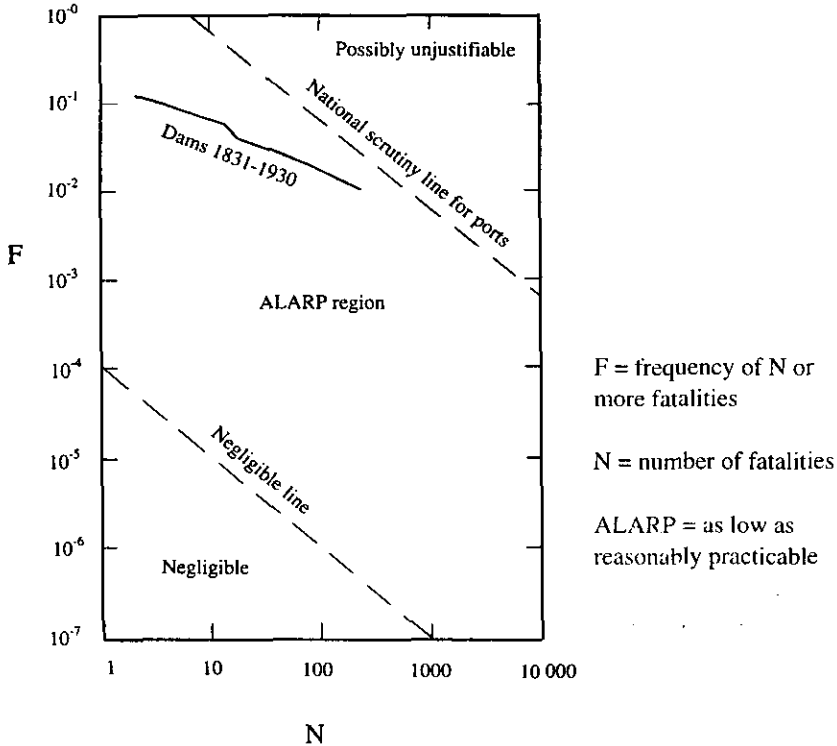
Figure 1. Comparison of British dam failures during the period 1831-1930 with risk tolerability for ports as given by Health and Safety Commission Advisory Committee on Dangerous Substances (1991).

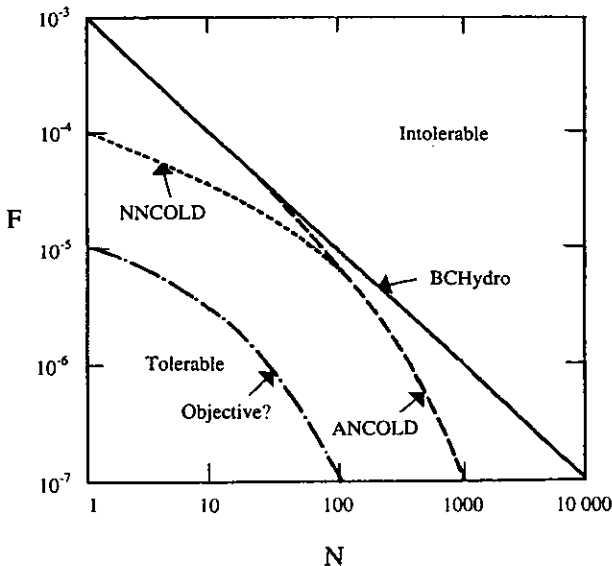
F = annual probability of N or more fatalities due to failure of a specified dam

N = number of fatalities

Figure 3. Proposals for acceptable societal risk from failure of a dam (after Hoeg, 1996).

Societal risk is usually expressed in terms of a relationship between the number of fatalities (N) and the probability of occurrence (F). F-N curves derived from Hoeg (1996) are shown in Figure 3; these suggest that the objective should be an annual probability of failure causing loss of life of not greater than  $1 \times 10^{-5}$ . McDonald (1997) has reported that there is a view in Australia that the curve representing societal risk criteria should be truncated

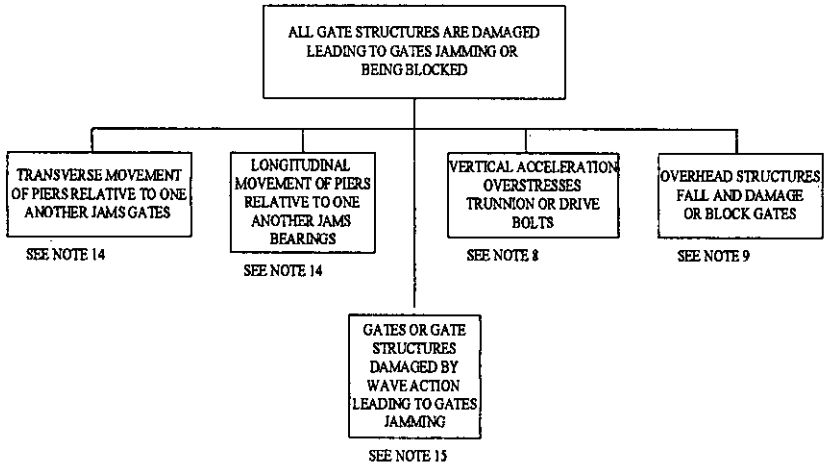
Fig. 6. Page 4 of the Fault Tree

Fault trees will need to be developed for each of the decision points identified in the event trees outlined above. It is important that the top event of the fault tree is well specified to avoid confusion in the tree development. For the present purpose a single tree, shown in Figs. 3-6, will be developed for the event "Failure of the spillway gates to initiate as designed within one hour"; for conciseness on the fault trees more abbreviated titles may be used but the fuller specification needs to be borne in mind.

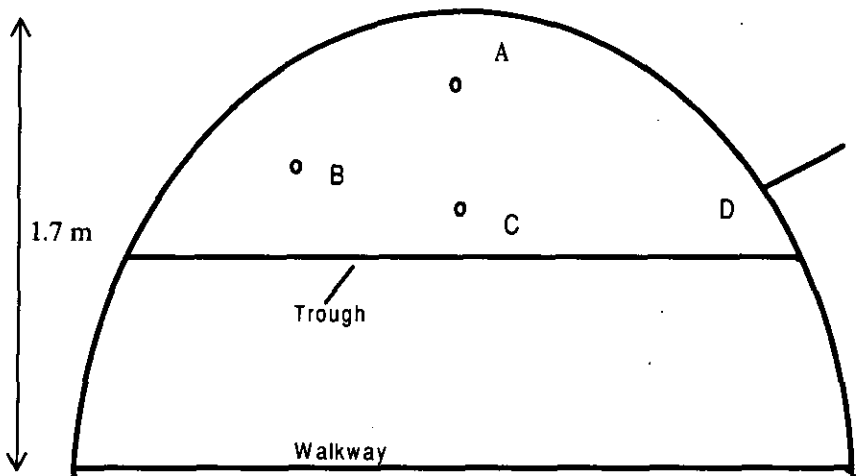
Note: hole D is 2.2 m from the headwall

Fig. 2. Settlement tanks for collecting eroded material and location of exploratory boreholes A, B, C and D in the headwall and side wall of the culvert

In December 1996, approximately 30 litres of very soft orange brown clay was removed from the wooden trough beneath the leaks, see Fig. 2. This amount only represents part of the total amount eroded since the trough was installed approximately 18 years earlier. Although it is not known if the trough has ever been emptied before, it is clear that not all the eroded material was being collected in the trough.

To quantify the current rate of erosion, two settlement tanks were arranged in series (cascade) to collect the leakage and eroded material, see Fig. 2. Measurement over a 5 month period gave an erosion rate of approximately 1 litre of in-situ clay per year. This was determined by measuring the dry weight of the collected sediment and then assuming a moisture content of 25% and a bulk density of 2000 kg/m<sup>3</sup> to calculate the in-situ volume eroded. The index properties of the clay from borehole No. 4 at 6m depth, and the eroded material are compared in Table 1 and Fig. 3. The liquid and plastic limits, and plasticity index of the eroded material were significantly higher than those of the in-situ clay such that the material plots beyond the extremely high plasticity range of a normal plasticity chart. This is presumably due to the high clay fraction in the eroded material.

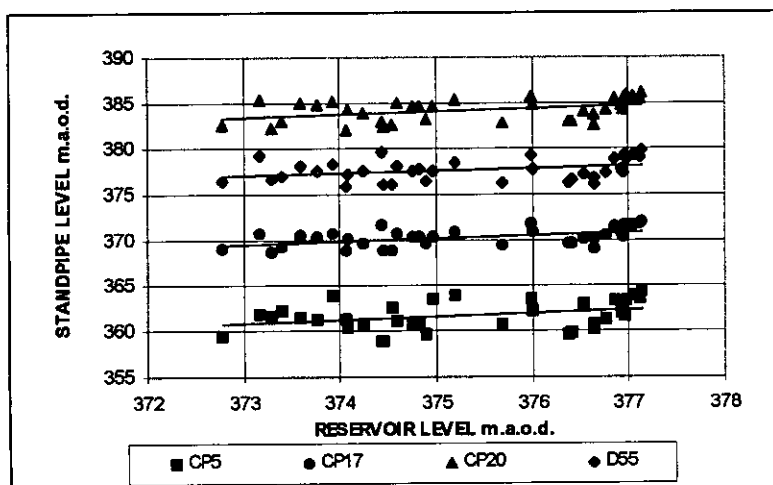
Fig. 4. Casagrande Standpipe Levels for 1994-97

Figure 4 shows some typical results with the piezometric levels rising with reservoir level as shown by the trend lines. Other standpipes gave plots with excessive scatter ( $\pm 3$  m) and some level or negative gradients. It was decided to suspend readings where the results were not meaningful and where other standpipes could reflect pressures at the location.

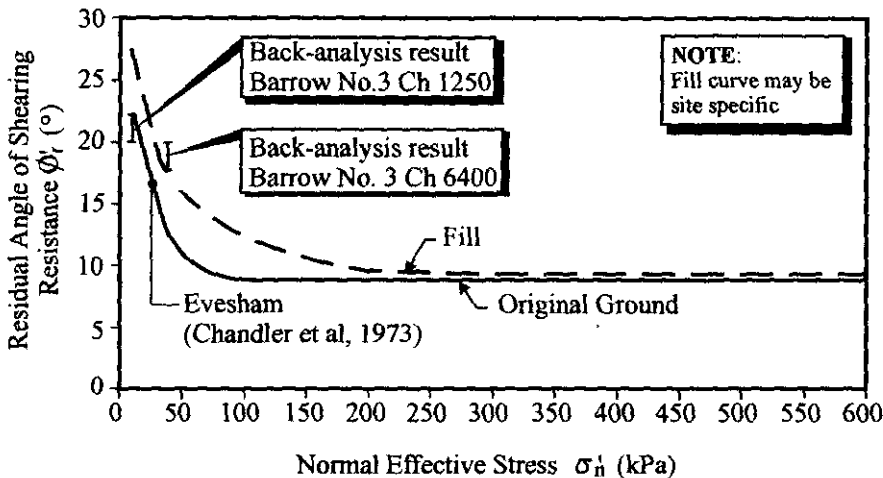
Plots of  $\theta'_r$  against normal effective stress ( $\sigma'_n$ ) based on the combined results from laboratory tests and back analysis are shown on Fig. 6. The results from Evesham (Chandler *et al*, 1973) can be seen to show good agreement with the curve representing original ground. Above a normal effective stress of approximately 200 kPa a constant value of  $\theta'_r = 9^\circ$  appears appropriate for all samples, but at lower stresses the strength rises significantly and appears to vary with the source of material, that is whether from fill or original ground. It is suggested that the 'original ground' curve is probably generally representative of the Lower Lias Clay. The 'fill' curve may be site specific.

Fig. 6. Suggested variation of residual angle of shearing resistance with normal effective stress in the Lower Lias Clay for analytical purposes.

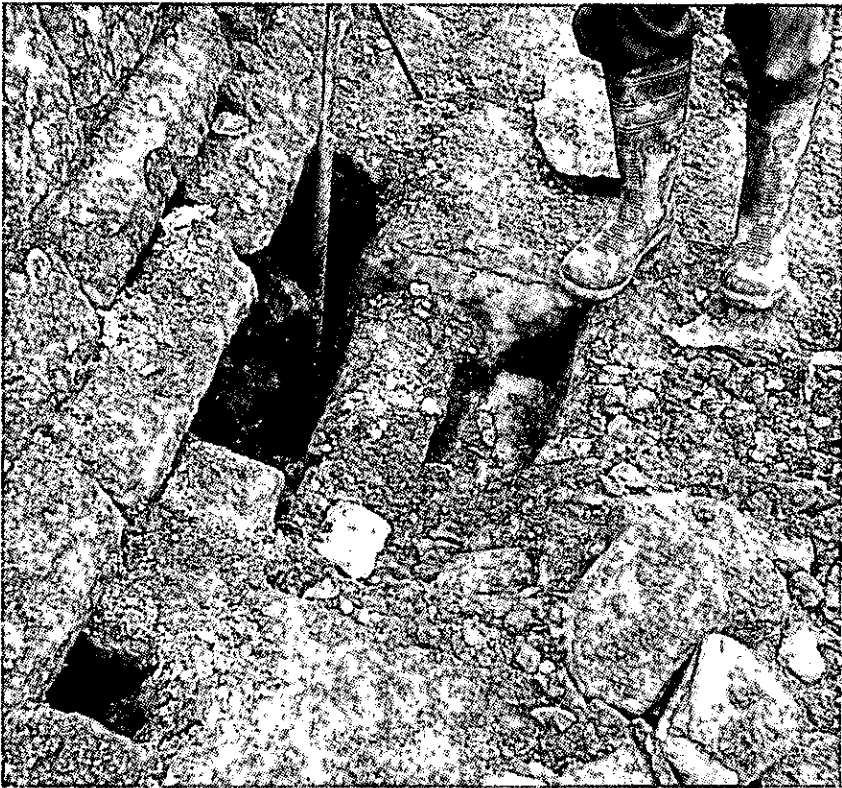
Fig. 3. Hole on the upstream slope of Walshaw Dean Upper dam, 1997

The hole was located 28 m from the eastern end of the dam. Although the embankment at this location is only 11 m high, the 3 m wide cut-off trench extends to 25 m below original ground level, see Figs 4 and 5. The history

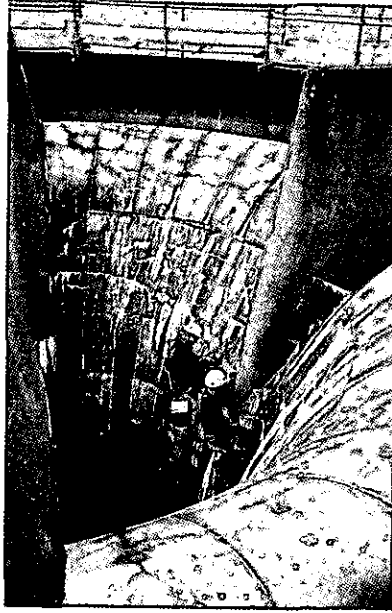
- covermeter survey was carried out to check the size and depth of cover to the reinforcement.
- ultrasonic pulse velocity testing was used to examine the general integrity of the concrete and to estimate the depth of the cracks in the anti-vortex piers.

UPV testing on the flow splitter piers

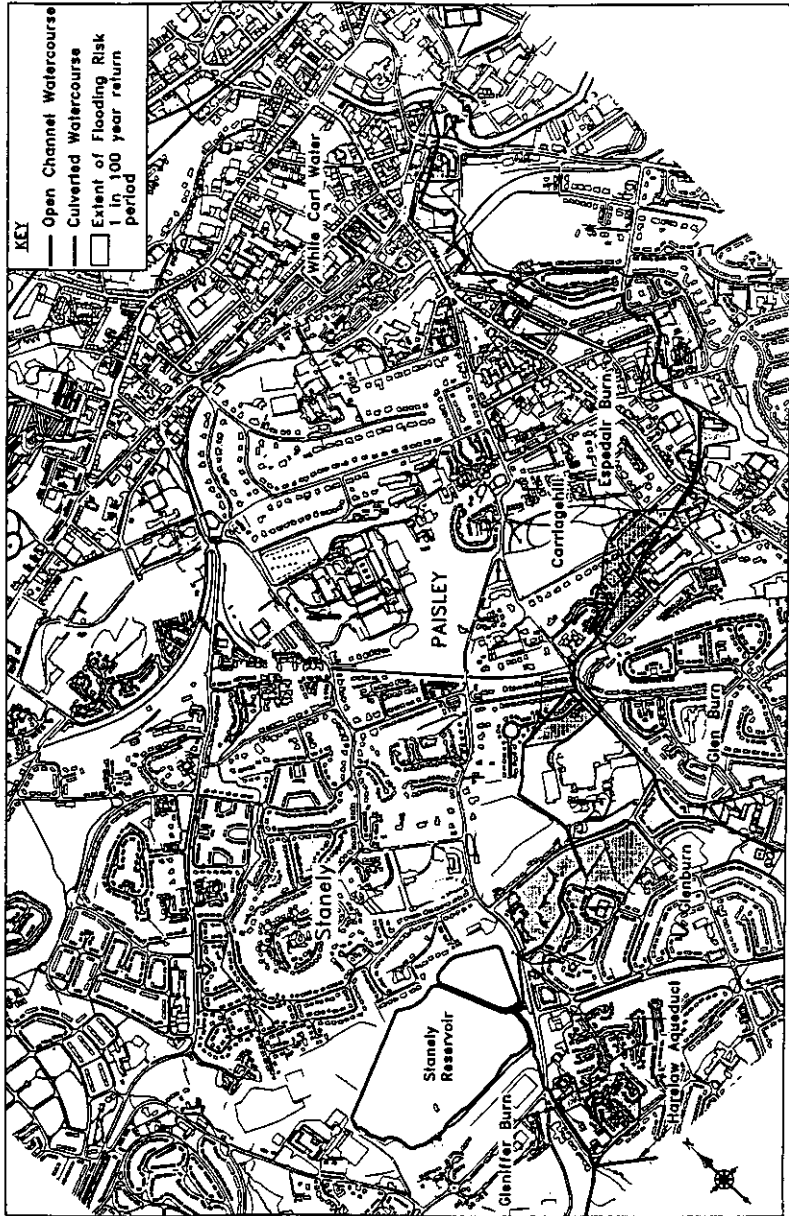
Figure 2 - Stanely Reservoir

One such example is currently being considered by Renfrewshire Council to provide attenuation of storm flows from the Gleniffer Burn and to provide protection to the properties located immediately downstream. The location of the reservoir is shown in Figure 2.

Inflow to the reservoir was originally by a diversion channel from the Gleniffer Burn controlled by a series of sluice gates. These gates have since been removed and all flow now bypasses the reservoir flowing along a section of the crest in an open channel. Outflow from the reservoir to the Gleniffer Burn is via three 3.5 m spillweirs.

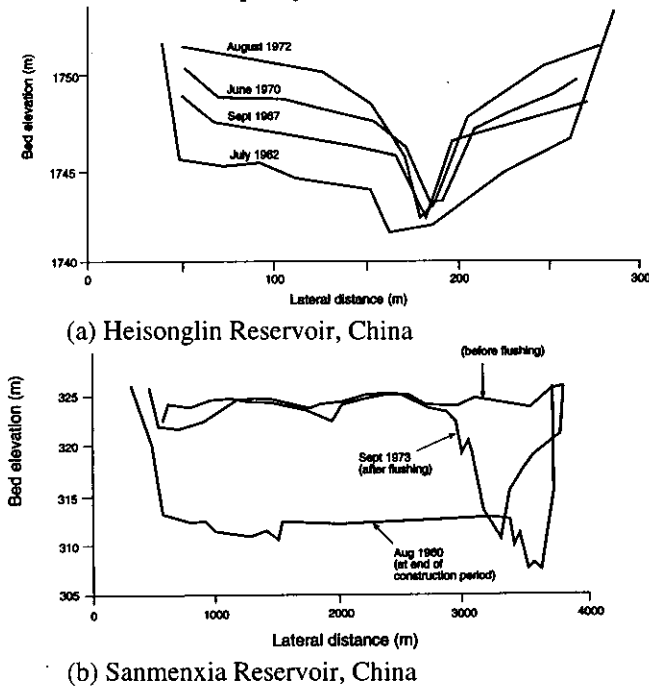
Fig 3 Cross sections in flushed reservoirs

Flushing will cause a channel to be scoured down into the reservoir deposits. In most cases this channel will be narrower than the reservoir and so substantial deposits will remain in the reservoir. In the long term these deposits will rise to an elevation close to the maximum water level, leaving the volume created by the incised flushing channel as the only storage volume remaining in the reservoir. This storage volume is defined as the sustainable reservoir capacity. Fig 3 illustrates the process, it shows cross sections at two reservoirs where flushing has maintained a relatively small sustainable reservoir capacity.

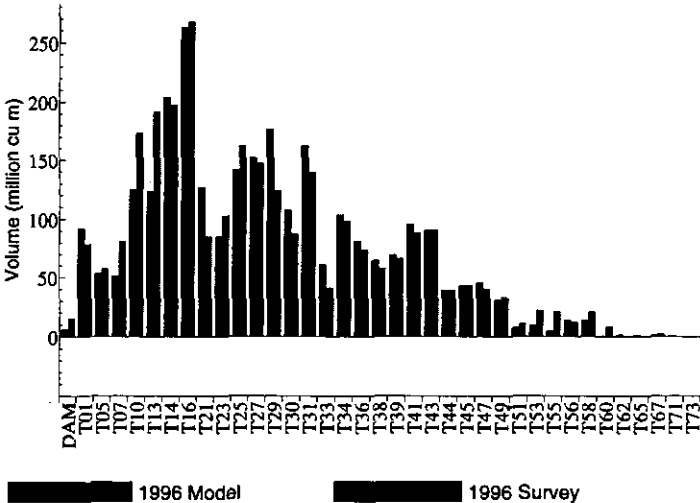
Fig 5 Calibration of numerical model at Tarbela Reservoir

A 1D numerical model of the reservoir was established and calibrated using the RESSASS software. Fig 5 shows the results of calibration. Application of the model indicated that the minimum impoundment elevation would need to be progressively raised each year to prevent deposits from threatening the intakes. Thus the live storage available in the reservoir would reduce from 9,000Mm<sup>3</sup> in 1996 to 3,000Mm<sup>3</sup> after 30 years. Economic analysis confirmed that structures to enable the intakes to withdraw flow at higher elevations, and so remove the danger of blockage after an earthquake, would have high net benefits.

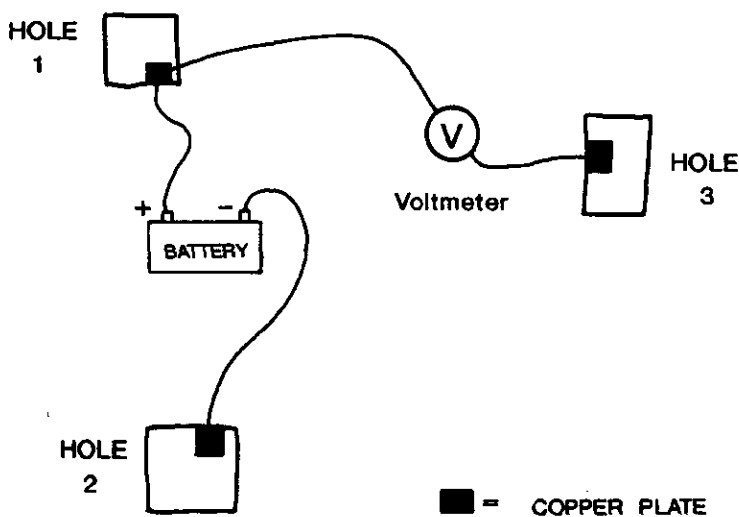
Figure 2 Electrical test circuit

The electrical testing involved filling all holes in the area with water and leaving it to permeate between the layers of debonded DAC. The test circuit as shown in Fig 2 was set up. Copper plates 1 and 2 connected to the terminals of a battery are inserted into two adjacent holes. A third plate connected via a voltmeter is installed in another hole. If a voltage is

recorded, this indicates hole 3 is connected to hole 1. This test enabled the extent of debonding to be established in a number of areas.
