British Dam Society

Dams 2000

Proceedings of the biennial conference of the BDS held
at the University of Bath on 14–17 June 2000

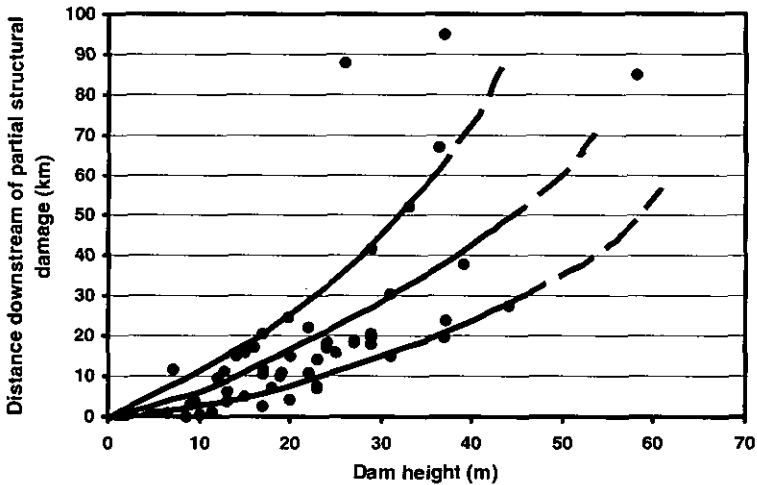
Fig. 1. Dam height plotted against distance downstream of partial structural damage

The results of this investigation revealed that the best correlation that can be established was between dam height and length of partial structural damage

downstream of the dam. Figure 1 shows an estimated best fit line through a wide scatter of points of dam height related to distance downstream of partial structural damage, but also two envelope lines providing a band within which the likely resulting length of partial structural damage could lie. For example, if a dam of height 30m should fail, the length of partial destruction is likely to be between 10km and 45km. However, the scatter of points and the outliers on the graph show that other factors need to be considered when assessing the potential extent of damage, including the volume of the reservoir and the valley shape and gradient.

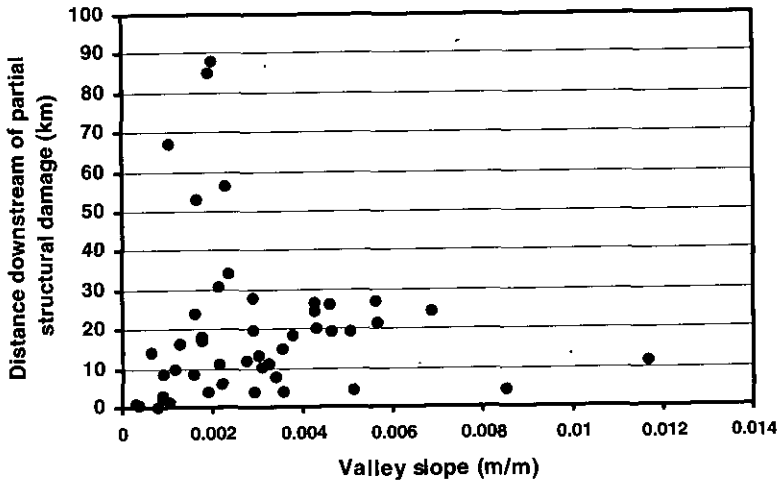
Fig. 3. Valley slope plotted against distance downstream of partial structural damage

An analysis of valley slope with extent of damage downstream again showed little correlation. Figure 3 shows valley slope plotted against length of partial structural damage. If outliers in the data set are ignored, a tenuous relationship of increasing length of damage with increasing valley slope can be established.

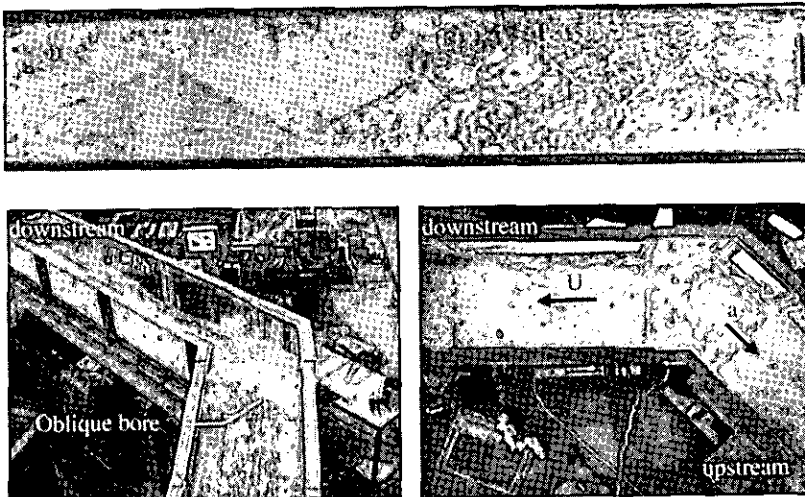
Fig. 1 Shock waves generated from 'dambreak' flow around a 45° bend.

- Dam-break wave along a rectangular flume with 90° bend to the left.
- Dam-break wave along a rectangular flume with a symmetrical channel constriction.
- Dam-break wave along a rectangular flume expanding onto a wider channel (asymmetrical).
- Dam-break wave along a rectangular flume with 45° bend to the left.
- Dam-break wave along a rectangular flume with a triangular (weir type) obstruction to flow.

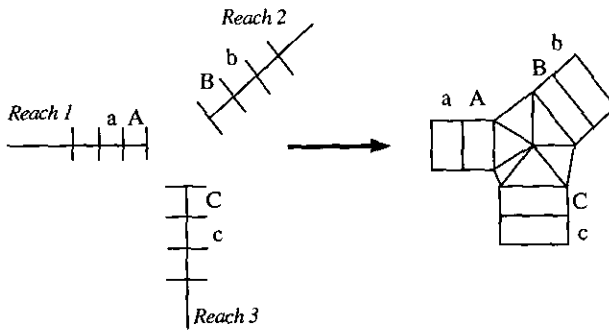
Fig. 5 2D patches within a 1D model to improve model accuracy whilst limiting processing requirements

A promising development that may offer a significant increase in model accuracy from a 1D model but without the heavy data processing requirements of a 2D model, is the use of a 'patched' model. This is where areas of 2D flow may be modelled using a 2D approach 'patched' within a 1D model (Fig 5). This technique requires further development and validation, but seems to offer significant potential.

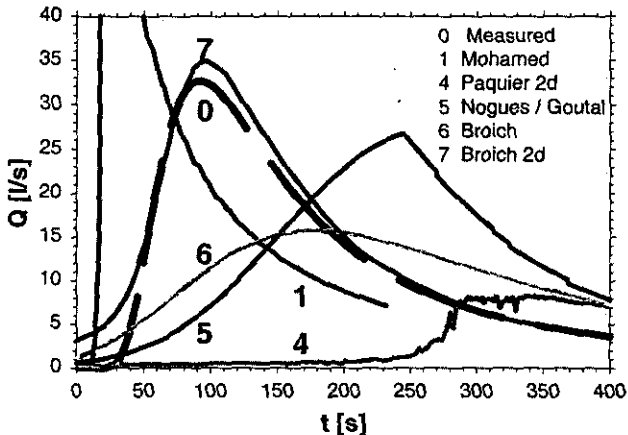
Fig. 6 Typical scatter of model results trying to predict breach formation

Existing models are very limited in their ability to reliably predict discharge and the time of formation of breaches. Figure 6 below shows a typical scatter of modelling results found for the CADAM test cases. Models comprised a range of university and commercial codes, including the NWS BREACH code.

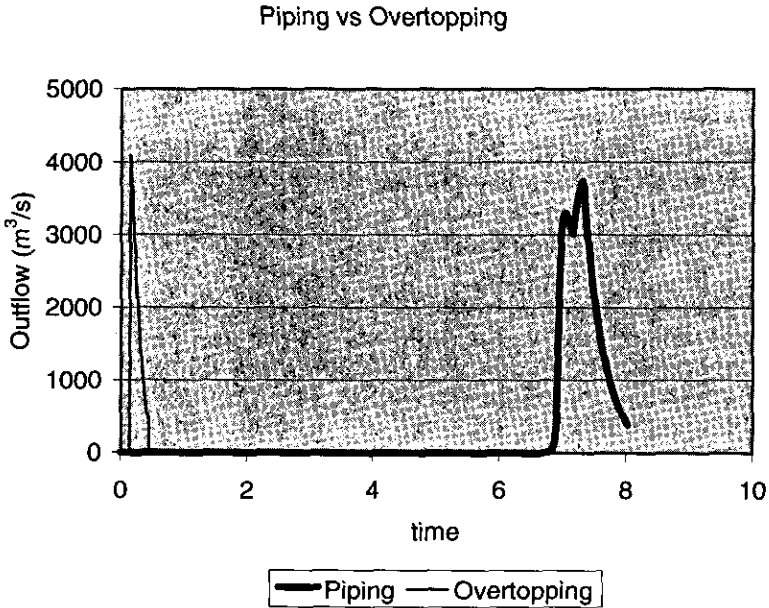
Fig. 7 Different outflow hydrographs produced by breach for an overtopping failure and a piping failure located 3cm below the crest.

Similarly, problems were also found with the BREACH software package. Under some conditions, predicted flood hydrographs were found to vary significantly with only minor modifications to input parameters. This erratic behaviour was discovered when considering the differences between piping and overtopping failure, by tending the piping location towards the crest of the dam. Erratic performance was also confirmed by a number of other CADAM members.

Figure 7 shows a plot of flood hydrographs generated by BREACH for an overtopping failure and a piping failure located just 3cm below the crest. Logic dictates that these hydrographs should be very similar however the results show a significant difference in both the volume of the hydrograph as well as the timing.

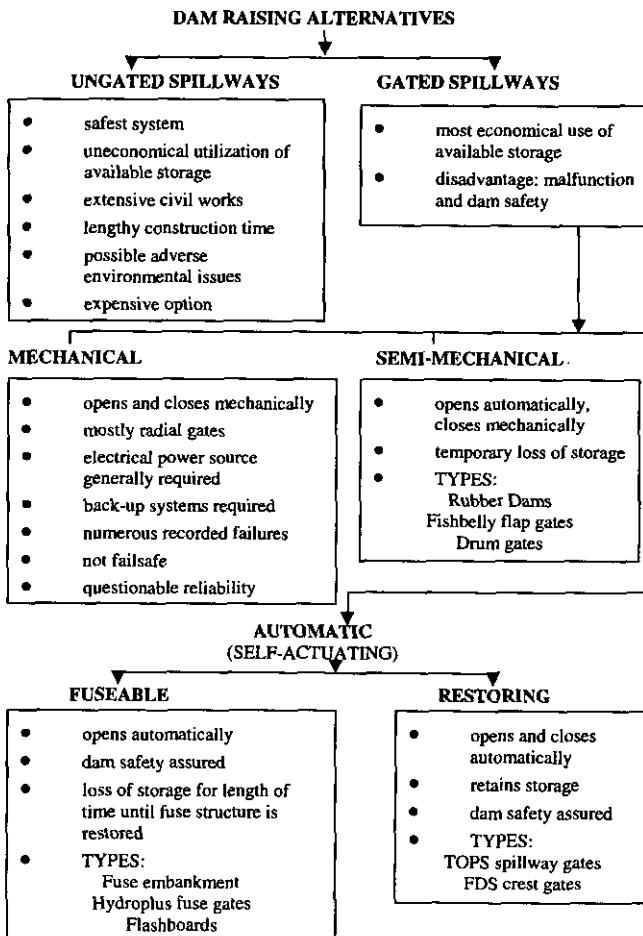
Fig. 1. Spillway gate alternatives

The gated spillways fall generally into four broad categories i.e. fully mechanical, semi-mechanical, fuseable, fully automatic and self-actuating. Each type of gate has its advantages but yet most also have one or more major disadvantages. This is illustrated in the following matrix of features.

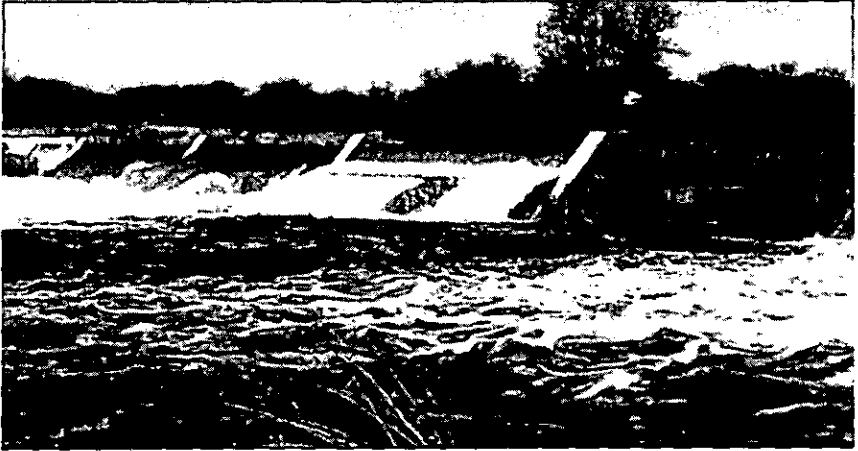
The FDS Crest gates are installed at more than 10 sites around Southern Africa and have been working successfully for approximately ten years on average. Some of the earlier gates have been subjected to major floods and were observed to operate as designed during and after the floods.

Crest gates at Tswasa weir, Groot Marico River, South Africa.

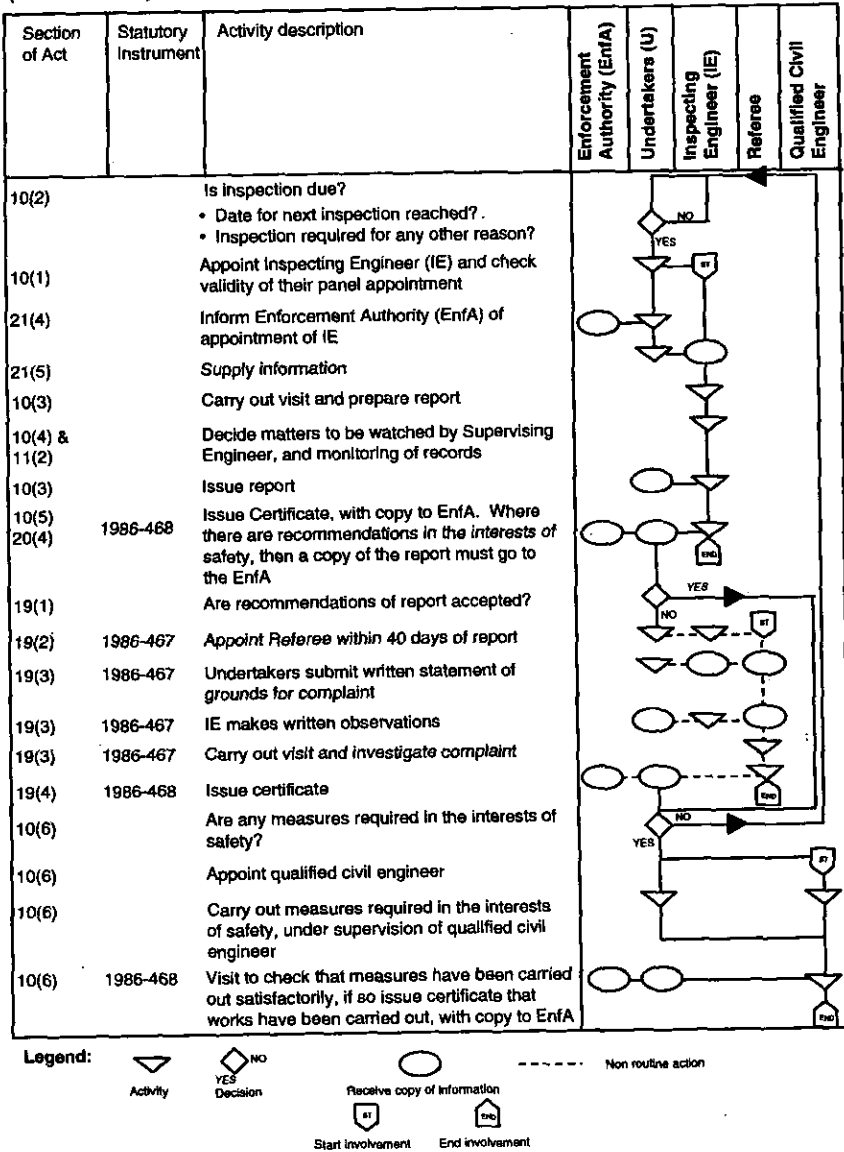
CHART 2 - PROCEDURE FOR PERIODIC INSPECTION AND SUPERVISION OF MEASURES IN THE INTERESTS OF SAFETY
 (Schematic only; refer to Reservoirs Act for details)

Fig 1. Example of one of six flow charts in the Guide

It is intended that these charts should be used both as a checklist to refresh the user's memory of the relevant sections of the Act, and also to provide information when dealing with an activity that is less routine (for example enforcement of the Act). It is envisaged that a copy of the charts could be pinned onto the office wall for quick reference. It would also prove particularly useful in discussions with owners of small reservoirs, who are often less familiar with the application of the Act.

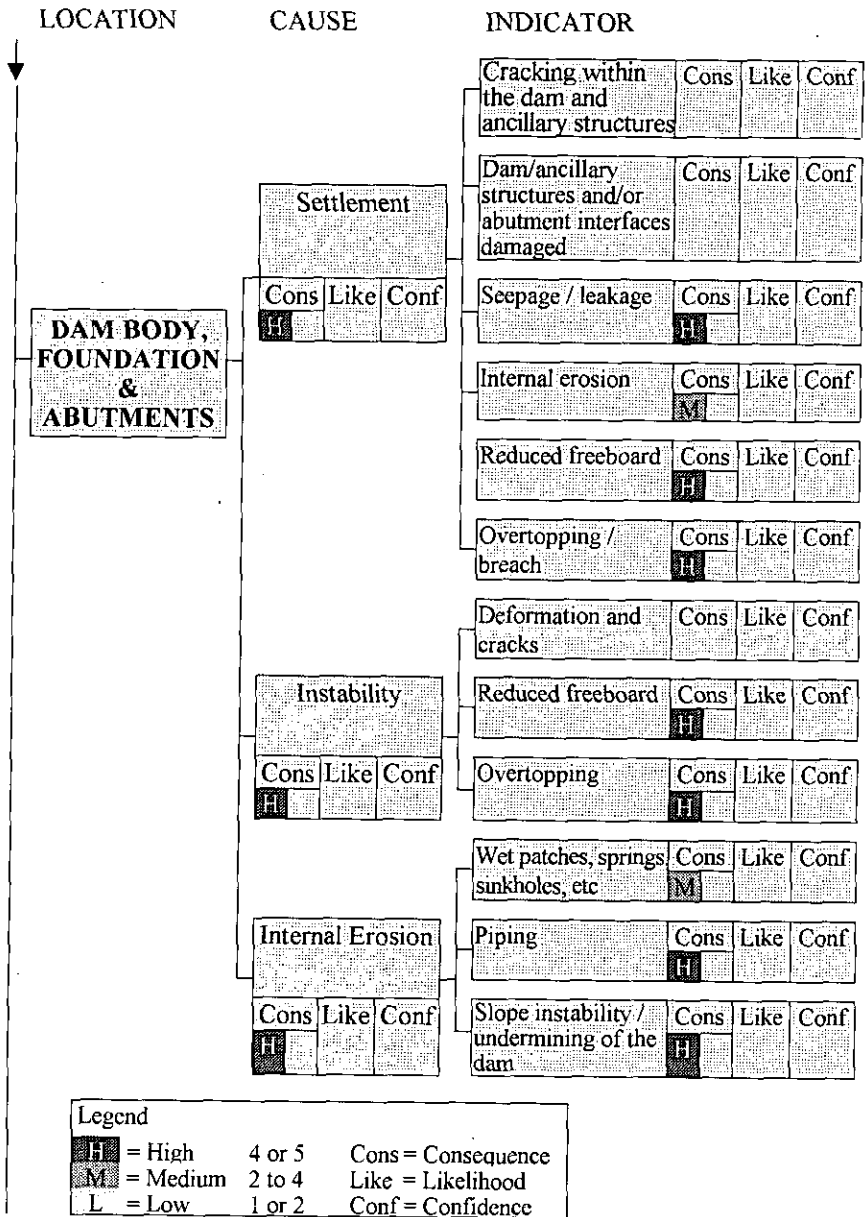
Fig 1: Extract from a typical LCI diagram (embankment dams less than 15m high constructed between 1840 and 1960)

Likelihood: what is the likelihood of failure of this particular element? (1 low, 5 high).

Confidence: what is the confidence in the reliability of the predictions for consequence and likelihood factors? (5 low, 1 high).

The 'Criticality' score for each element is calculated from:

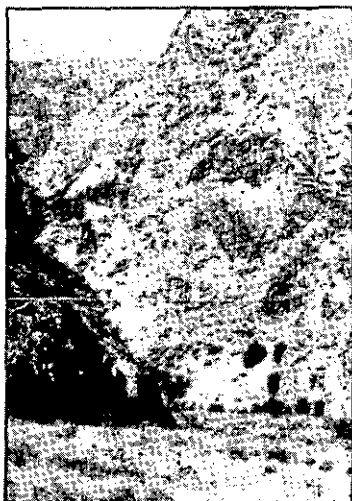
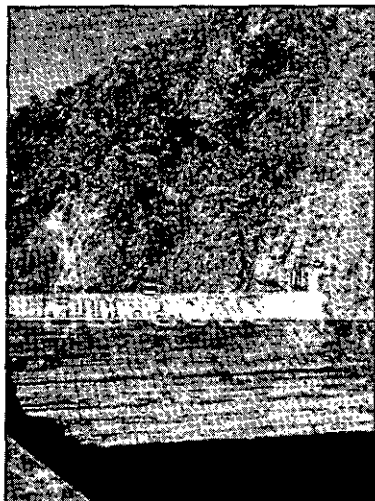
Figure 2. Papan Dam

View Downstream

Upstream Face

Papan dam is situated in the south of the country about 20 km south of the town of Osh in a deep, narrow and extremely steep sided limestone gorge. There is a population of over 500,000 persons downstream. The dam is an embankment about 100 m high and 90 m long at crest level and impounds a reservoir of 260 Mm³. It is constructed of widely graded alluvial sands and gravels taken from the reservoir area, with a cement/clay grouted core. Most of the fill was transported into the site through access tunnels.

When the reservoir level exceeds about 10 m below full storage level a series of well defined damp patches appear on the downstream slope, and drainage from the low level grouting adit increases abruptly from a few l/sec to over 100 l/sec.

There are very few functioning piezometers in the dam, but those which are still in operation indicate that the phreatic surface in the downstream shoulder is well above the design level, and rising. Back-analysis of the seepage pattern suggests that the grouting of the core zone has been largely ineffective. Although calculated hydraulic gradients in the embankment are not particularly high the grading of the gravel is such that it is probably not self-filtering, and the possibility that long term internal erosion (suffosion) is occurring under the influence of continuous seepage cannot be ruled out; this has important stability implications.

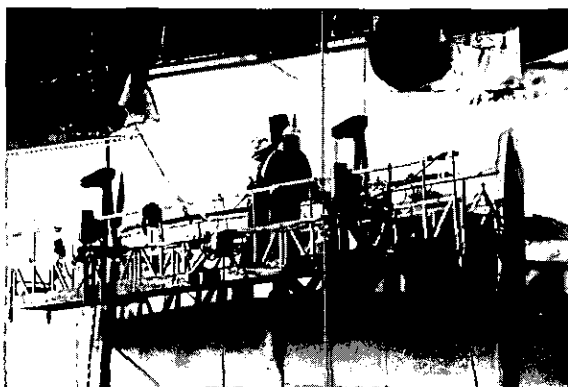
Fig. 11. The upper perimeter seal was installed just below the bottom of the concrete piers supporting the bridge deck

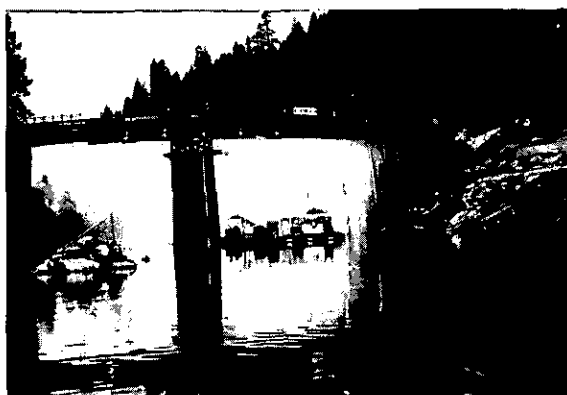
Fig. 12. Installation of water level monitoring system at panel 6. The installation of the waterproofing system was completed in less than 3 months. Total documented seepage is at present < 0.063 l/s

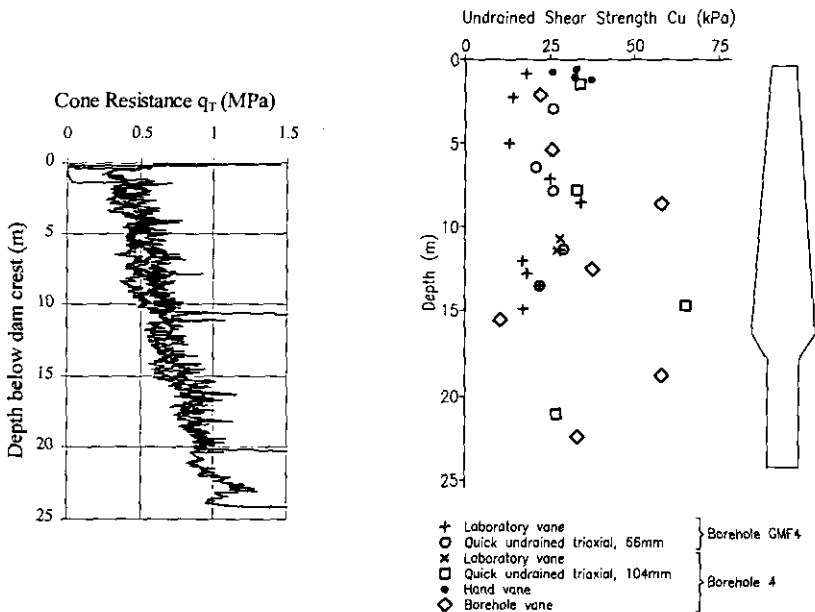
Fig. 5 CPT probings in core

Sampling of the puddle clay core was undertaken at two positions on the crest using the Goudsche Machinefabriek (GMF) system. The objective was to obtain 'consecutive' high quality samples through the core for detailed description and examination in the laboratory. The GMF sampler is a proprietary device designed to recover high quality samples in soft to firm cohesive soils. The samples are 66mm diameter by 750mm long. The sampling device is pushed into the ground using standard CPT equipment and samples are taken in thin wall PVC liners, with each sample following on immediately from the previous sample. The sampler is operated by wireline within a casing which supports the borehole at all stages.
