The British Dam Society

Reservoirs in a changing world

Proceedings of the 12th conference of the BDS held at
TRINITY COLLEGE, DUBLIN
4 – 8 September 2002

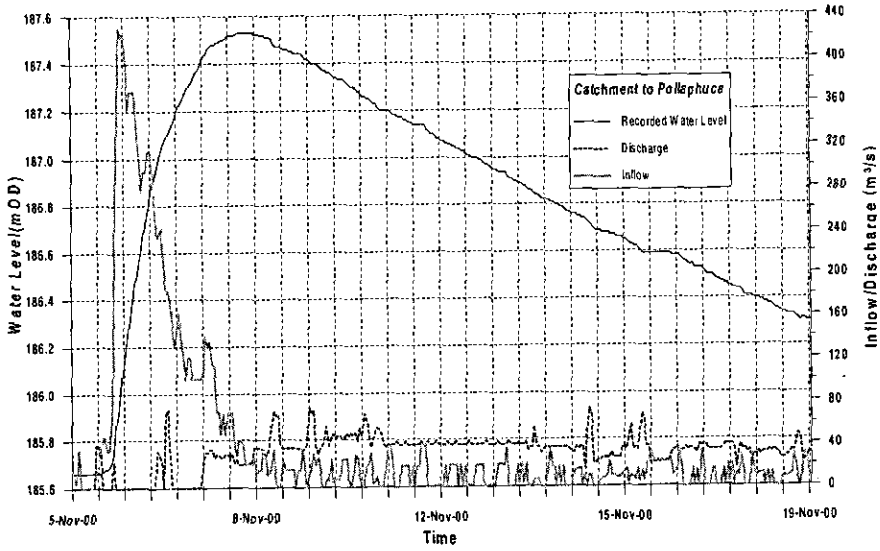
Figure 3. Pollaphuca Levels and Flows – November 2000 Flood

The reservoir above Pollaphuca has a very large storage capacity relative to the catchment inflow. A large element of this storage is reserved for flood mitigation. This has allowed the vast majority of the inflow upstream of Pollaphuca, in the most severe floods, to be stored until the worst of the floods in the river downstream of Pollaphuca has abated. Since the dams were built, the maximum flow in the river down stream of Pollaphuca, during the largest floods has been reduced to less than 25% of what the estimated flow would have been otherwise. Even with this reduction the severe floods of 1954, 1993 and 2000 caused significant damage in the valley downstream of Pollaphuca. This damage would have been many times greater, on these occasion, but for the presence of Pollaphuca Dam. Figure 3 indicates the effect Pollaphuca Dam had on the flood of November 2000.

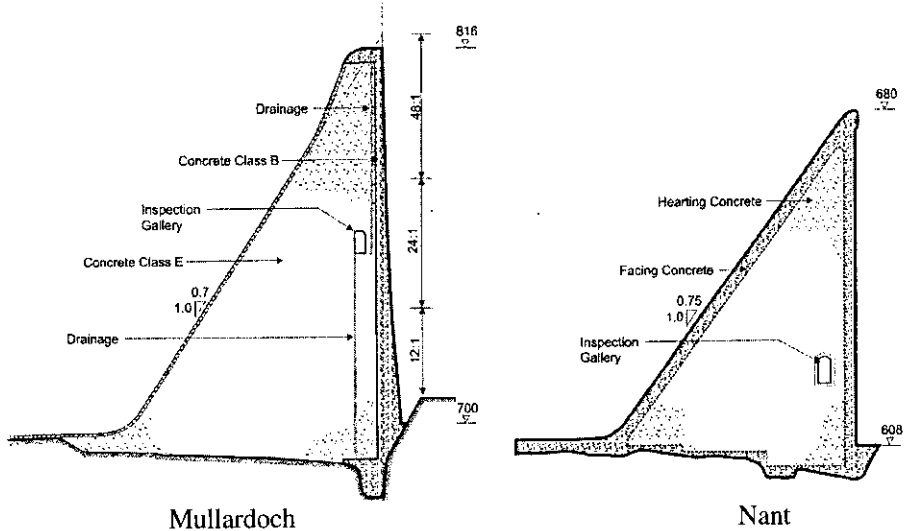
Figure 2. Comparison of Mullardoch and Nant Dam spillway sections.

Conventional rigid block gravity analysis with pseudostatic horizontal loading of the design ground acceleration and factored vertical acceleration showed that both Mullardoch and Nant Dam sections were satisfactory in compression, upstream face tensile stresses were within what could be expected of reasonable quality lift joints and shear-friction factors of safety were satisfactory provided expected values for cohesive shear strength were used. However, if cohesive shear strength

was ignored, the sections would not be restrained from sliding by friction alone with $\tan \phi = 1.0$. Loichel was found to be stable in all respects.

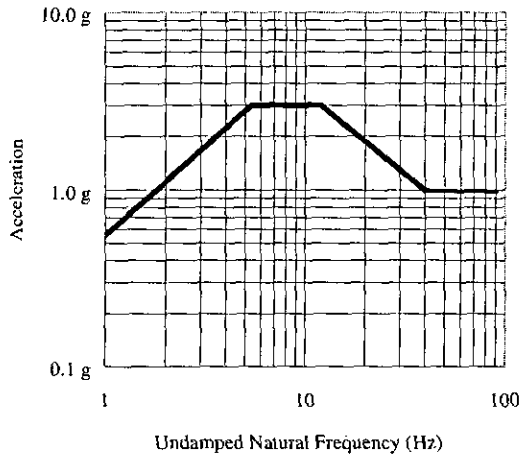
Figure 4: UK Response Spectrum for Hard Ground and 5% Damping Normalised to 1.0g PGA

These results, together with a response spectrum for a typical earthquake at the site, provide useful information on the likely nature of the seismic response of the tower. The response spectrum shown in Figure 4 was used for the seismic analysis of Glascarnoch tower. It is a UK response spectrum for a site with "hard ground" and 5% damping for the structure. The spectrum is normalised for a peak ground acceleration (PGA) of 1.0 g. On the graph, the abscissa gives the natural frequency for a vibration mode of a structure and the ordinate the spectral response acceleration for that mode. It can be seen that the fundamental E-W mode (5.8-6.0 Hz) of the tower falls on the peak of the response spectrum. This demonstrates that the tower will respond dynamically with significant amplification of the ground motion. The selected return period for the Safety Evaluation Earthquake for the assessment of Glascarnoch tower was 10,000 years giving a peak ground acceleration of 0.2g (EQE, 1998). This indicates that at the top of the tower, the gatehouse and the equipment housed within it could be subjected to significant shaking with accelerations up to 0.6g.

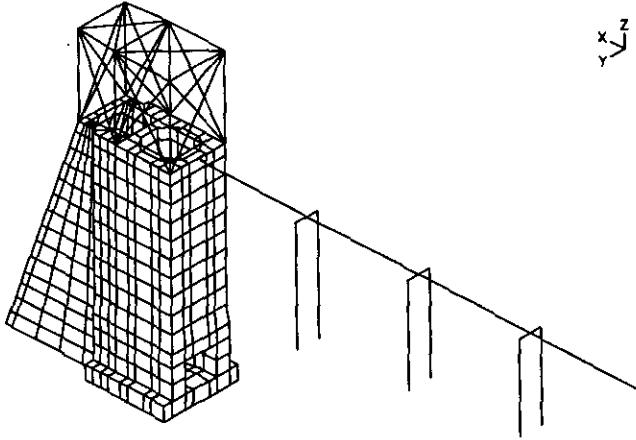
Figure 5: Finite Element Model of Tower, Bridge and Gatehouse

The finite element model of Glascarnoch tower (Fig. 5) included the tower, bridge, gate house and the dynamic effects of the reservoir. Soil-structure interaction was neglected, as the structures are founded on sound rock. The global X and Y axes for the model correspond respectively to the N-S and E-W directions for the real tower.

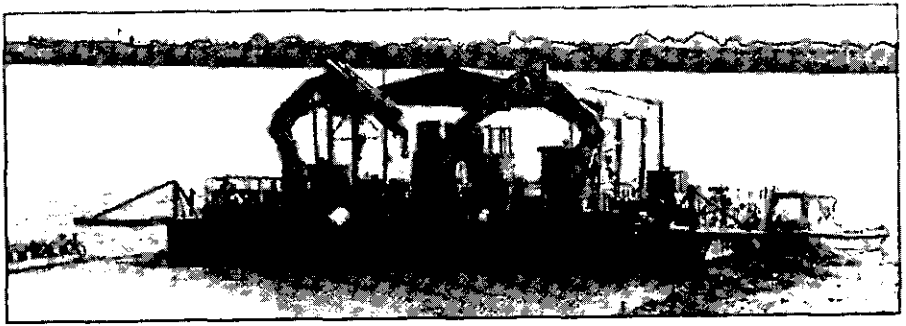
Fig. 6. Pontoon at foot of Slipway

The pontoon performed as a service barge for the bulkhead gate and was constructed of steel, with overall dimensions of 14m x 17m x 2m deep.

Two 100kVA diesel generators provide an electrical power source, primarily to an hydraulic power pack, and for supply to ballast water pumps, a compressor, and lighting and small power. A wind generator provides emergency power. Two knuckleboom cranes with a lift capacity of 7t were installed at the forward end of the pontoon, for fitting to the top of the bulkhead gate in the final stages of ballasting and lowering. Two further cranes of 1t capacity were fitted to the aft end of the pontoon for handling and positioning anchors. Other equipment included various winches, anchors, switchboard and control desk.

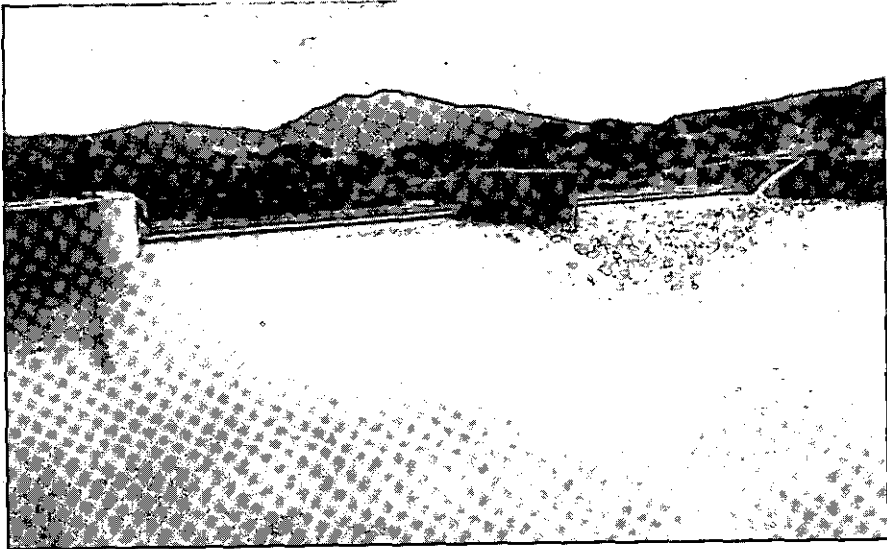
Fig. 7. Gates retaining full 3,5m water

An earth coffer dam was constructed 20m upstream and water then pumped in behind the gates over two days to reach the final depth of 3,5m above sill level. The gates did not show any sign of distress.

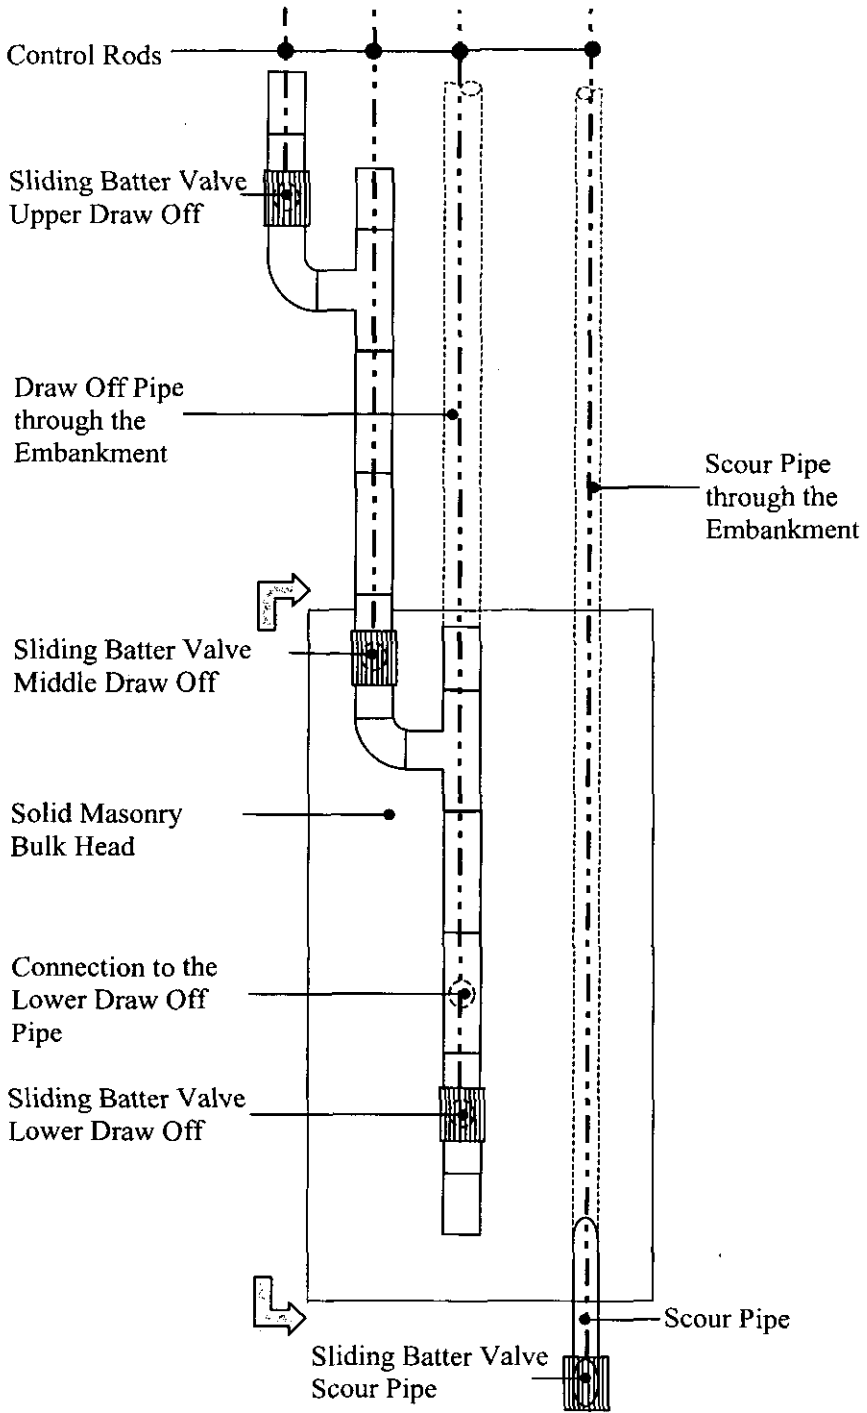
Figure 5 : Original Draw Off - Plan View

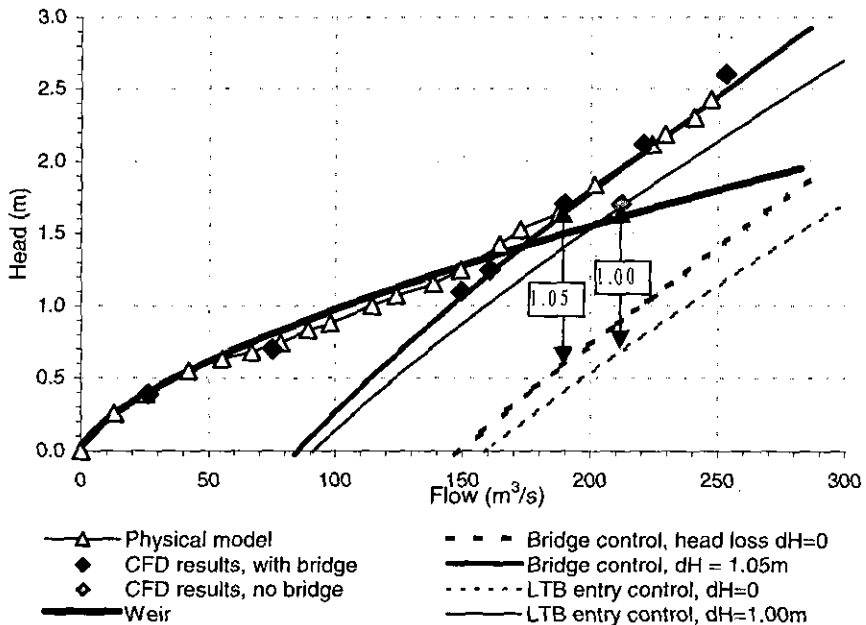
Fig. 6. Physical model measurements and CFD predictions and theoretical discharge curves for bridge and lower tumble bay entry control.

freely. At around $190 \text{ m}^3/\text{s}$ there is a second increase in the slope of the points indicating that another change of control location has occurred.

From the arguments in (d) above, it seems reasonable to suppose that the first change of control is due to the onset of side-channel control in the tumble bay. The second change of slope occurs at around $190 \text{ m}^3/\text{s}$ corresponding to the upper limit in (6). At this point, it is expected that the control has shifted to the bridge section (if present) or the lower tumble bay entry section. The discharge curves for these sections with no energy loss lie some distance from the physical model and CFD results. However, when a head loss $\Delta H = 1.05 \text{ m}$ is assigned to the bridge control curve, it closely follows the physical model and CFD results at the higher flow rates (see Fig. 6). This suggests that the magnitude of the head loss is almost constant over this flow range. Similarly, when a head loss $\Delta H = 1.00 \text{ m}$ is assigned to the lower tumble bay entry control curve, it passes through the single CFD point without the bridge.

Values of H near the bridge control section are around 0.8m in the LHS arch and 0.6m in the RHS arch which corresponds closely with the value of 0.65m (loss of 1.05m from the reservoir) inferred from the discharge curve shown in Fig. 6.

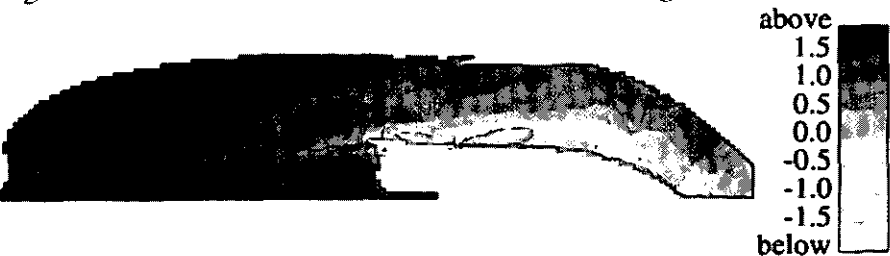
Fig. 10: Hydraulic head distribution for case without bridge (in m)

The hydraulic head distribution can identify the regions of greatest energy loss by the proximity of the shown contour lines. Large losses are shown on the RHS of the tumble bay close to the weir in the previously mentioned supercritical region. This is also where there are highly turbulent regions (turbulent kinetic energy and turbulent kinetic energy dissipation rate plots are not shown here but support this observation). Although it is expected that hydraulic head would reduce down the channel, i.e. the loss in potential energy is not matched by kinetic energy gains because of energy losses in the system, the losses are distorted due to the bends in the channel. It should be noted that cross-channel energy losses can be identified here.

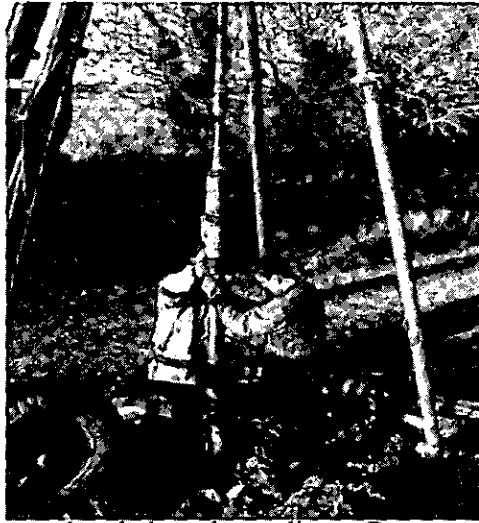
Fig. 2. Shell and auger borehole and sampling at Portumna

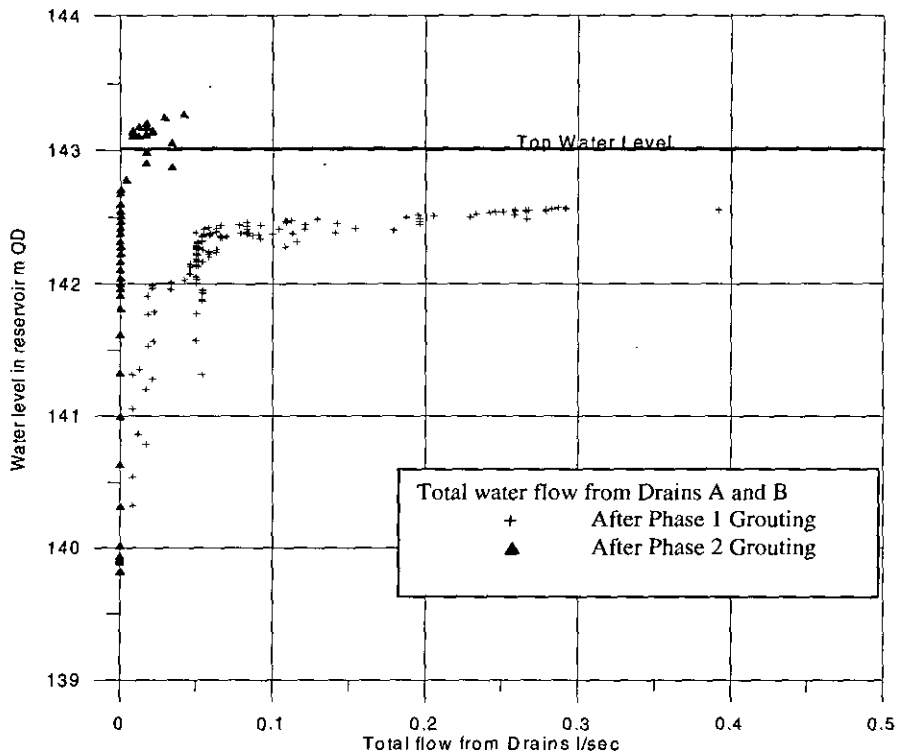
Figure 3. Flow from Drains A and B after Phase 1 and after Phase 2 Grouting vs. reservoir level

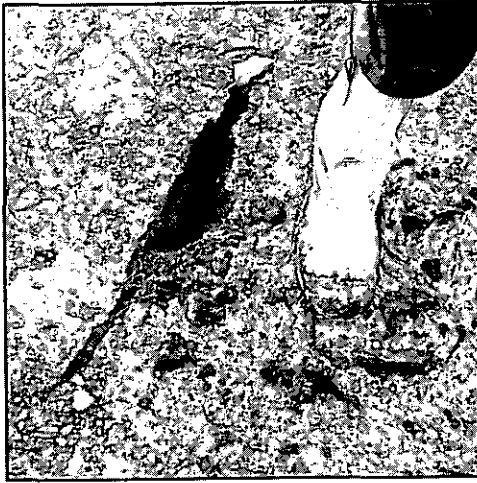
Figure 4 Major defect discovered behind toe beam at chainage 200m

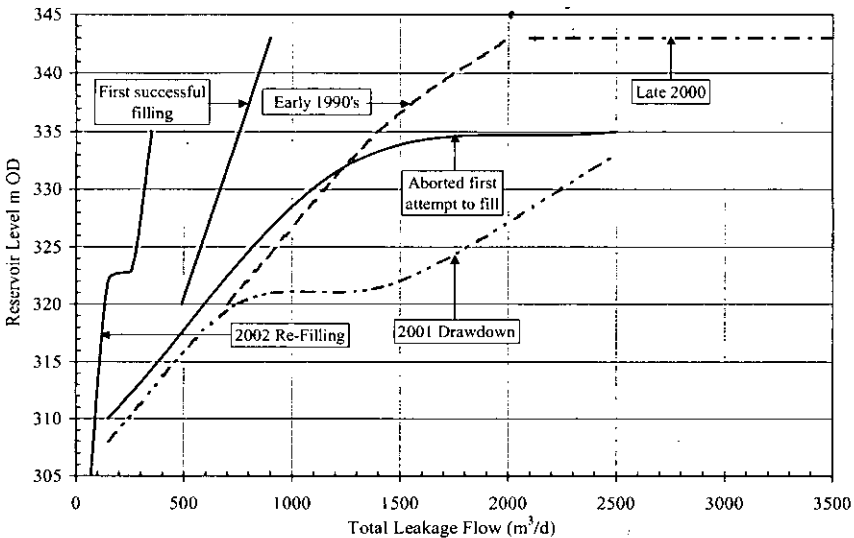
Figure 11 Total leakage/seepage before and after leakage remedial works

The current indications are that total seepage flow has reduced considerably, both against the first successful filling in 1980 and also the situation at the start of 2001. The behaviour can be compared on Figure 11, which suggests an improvement of about 50% against the former and 80% against the latter. In terms of quantities, the estimated daily leakage during January 2001 was in excess of 4,000 m³.

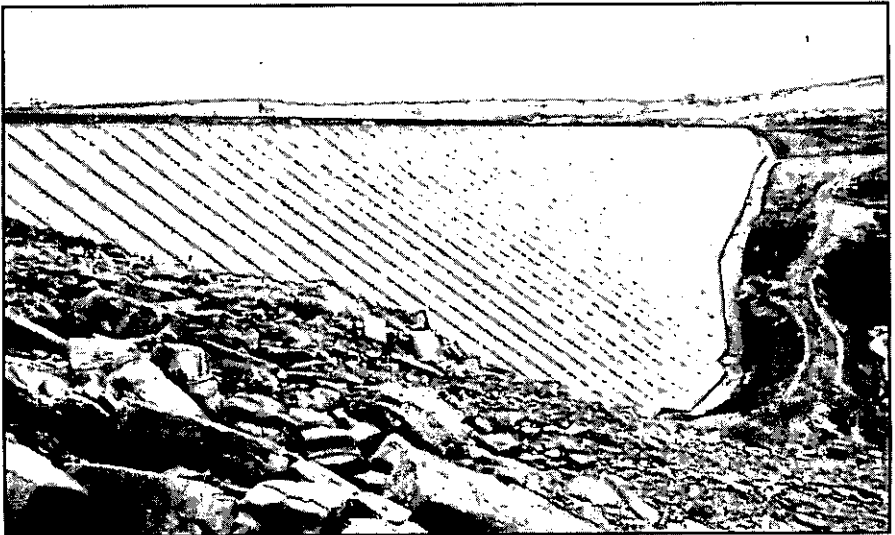
Figure 12 The refurbished upstream face of Winscar Dam

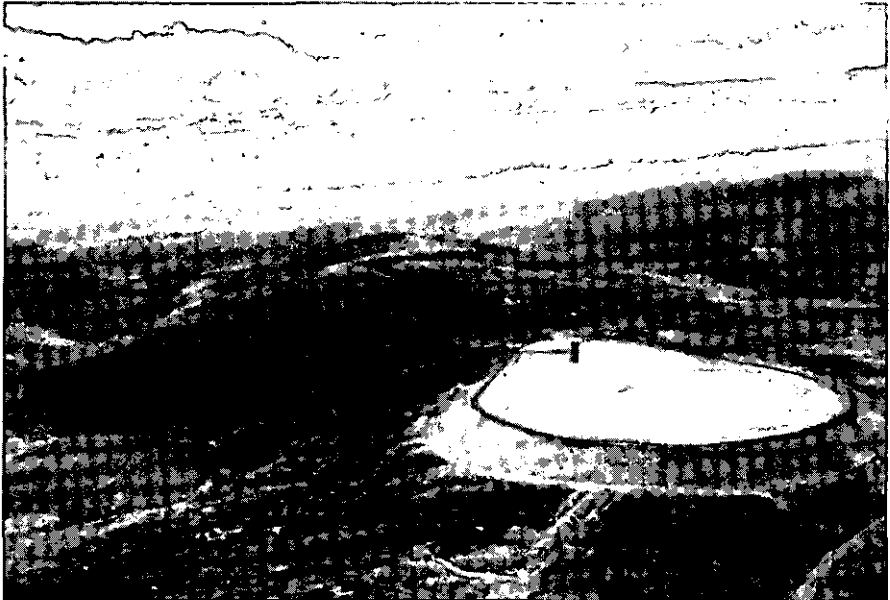
Fig. 1 Turlough Hill Upper & Lower Reservoirs

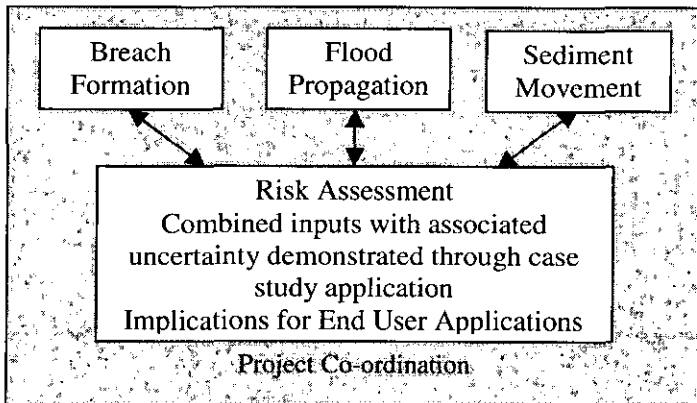
Fig. 1 Research topics within the IMPACT project

Research is focussed around 3 key areas, and combined by an overall approach to identifying uncertainty associated with the prediction of processes in these areas (Fig. 1). The following sections offer an overview of this work.

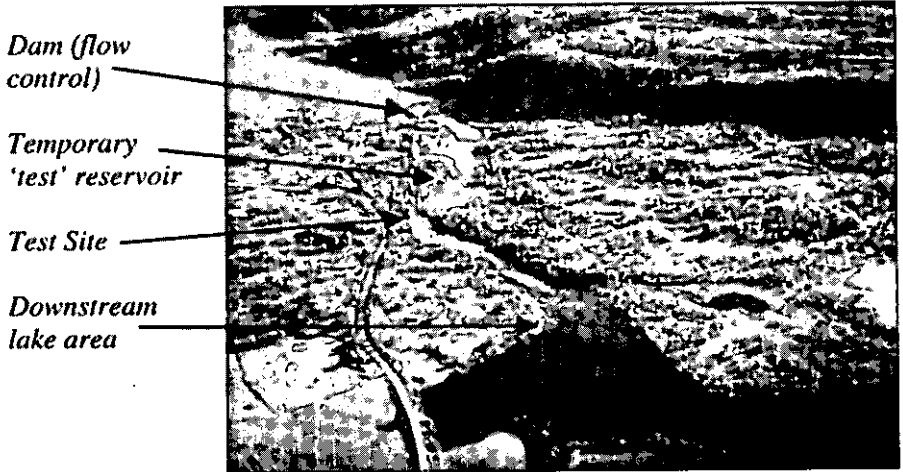
Fig. 2 Location of embankment breaching test site (Norway)

Field Modelling A test site has been established in Norway where a test embankment some 6m high and 30m wide may be constructed across a river valley, allowing the creation of a temporary reservoir retaining up to 100,000m³ water: A total of 5 embankment failure tests will be undertaken, allowing close monitoring of the breach formation process.

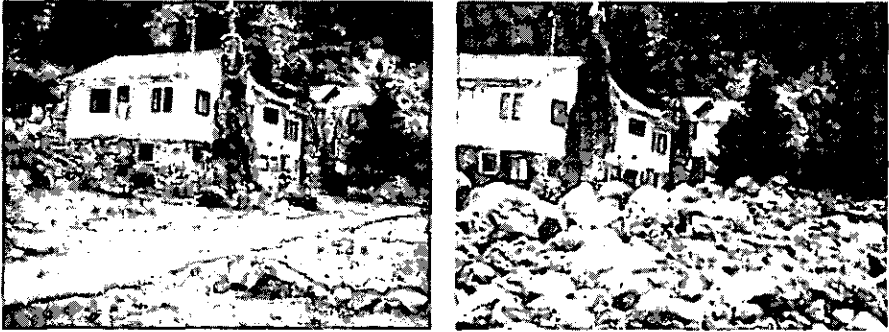
Fig. 5 Sediment movement - before and after a flood event

This area of research considers the need to improve (or even include) the prediction of sediment movement in association with catastrophic flood modelling. Case study data from dambreak events in the US has shown that significant quantities of sediment and debris can move during extreme floods. This in turn can affect the rate of flood wave propagation as well as floodwater level due to potentially large variations in bed level (Fig. 5).

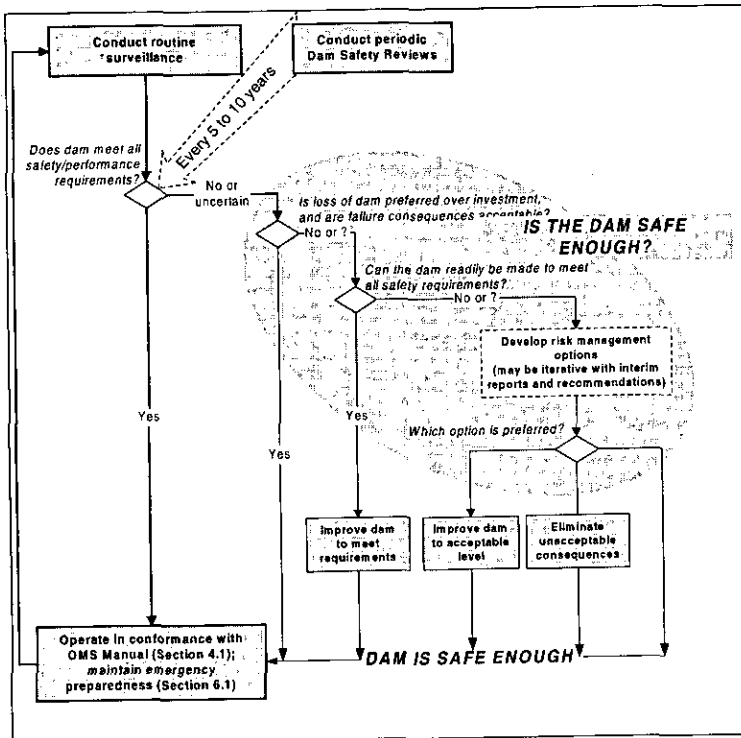
Figure 1. BC Hydro's Dam Safety Management System (BC Hydro, 2002)

The requirements imposed by this risk-regulatory regime are that duty holders are required to identify the hazards, assess the risks and prepare a safety case demonstrating how the risks will be prevented or otherwise controlled. They are also required to set out a safety management system showing how the safety case will be implemented and maintained. Thus in a general way, the requirements of the risk-regulatory regime are comparable with accepted dam safety management procedures which include hazard identification, various forms of risk assessment, and documented rationale for the risk control measures. Although we have yet to document a formal safety case, the essential elements of the safety case are embodied in our dam safety management system (Figure 1).

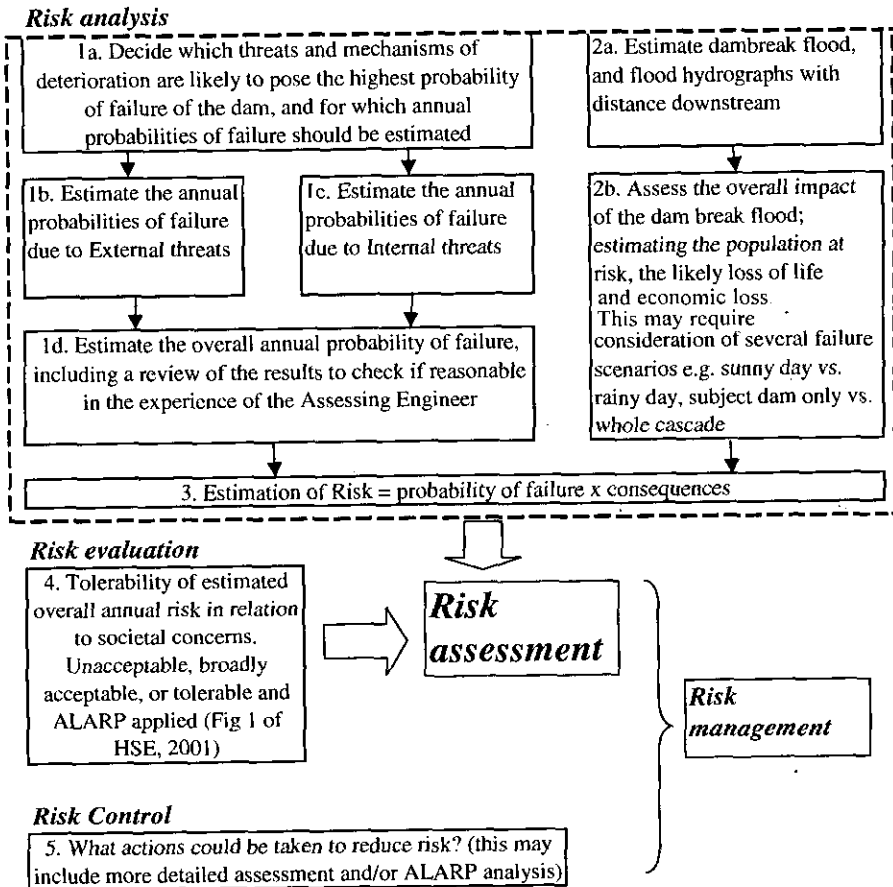
Fig. 1. Main elements in an Integrated system for Risk assessment of dams (based on Kreuzer, 2000)
