**MATTERS RELATED TO ADVERSE INCIDENTS ASSOCIATED  
WITH DAMS AND THE ROLE OF REVIEW PANELS :  
THE GEOFFREY BINNIE LECTURE 2004**

**By R. E. Coxon**  
**Presented at the BDS Biennial Conference/  
ICOLD European Symposium**  
**University of Kent, June 2004**

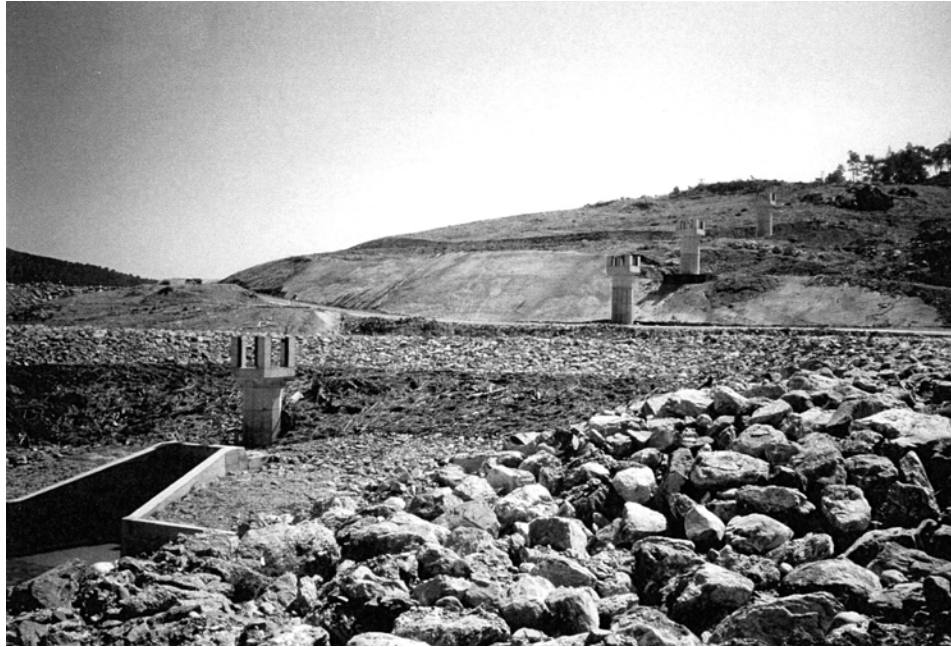
**Gadouras Intake Structures**

On one, Gadouras, on the island of Rhodes, the system has been further developed in that vertical inlets are taken from the surface direct into the diversion tunnel. The vertical shafts are cored down to intersect niches in the tunnel walls, and short intake structures are constructed at the surface level of each. A sloping track down the slope will afford access for maintenance, or they can be reached by boat. The system is economic and could, in fact, justify a modified alignment of a diversion tunnel, though this was not necessary in the case of Gadouras.

The design of intake structures, particularly for water supply projects, is now being reconsidered, particularly for seismic areas. Historically, in U.K. at least, water intakes have been contained at several levels within a vertical tower. Access to the tower is by bridge. At several reservoirs, including Sulby, Westwater, and Windscar, inclined galleries down the abutment upstream have been adopted (16). Operation and maintenance of these are said to be practical. There are some other such galleries in the U.S.A. and in North Africa, and the approach is now being pursued on several dams under construction in Greece.

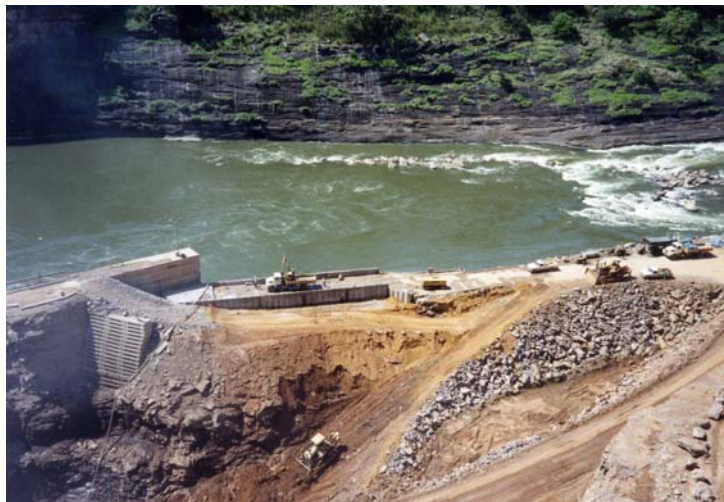
**Capanda Powerhouse Cofferdam**

During construction the power station area was protected by a cofferdam, partly formed by a concrete wall and partly by an embankment, the toe of which was protected by a thick layer of large rock armouring mostly of the order of 1m in diameter. This section of the cofferdam was breached at the end of March 1990 triggered by erosion/collapse of the armouring following scouring of the bed of the main river channel by discharge of the diversion tunnel.

The hole formed by the scouring was estimated to have an in situ volume of some 25000m<sup>3</sup>, the deepest section being 7m below river bed level. The side slopes were at some 30° but showed stepping due to the layering of sandstone. One impact of the event was that the scoured material formed a berm downstream which changed the pattern of flow in the river.
