## **The Discontinuance of Devils Dingle Ash Lagoon**

A.K. HUGHES, KBR, Leatherhead, UK  
D.S. LITTLEMORE, KBR, Leatherhead, UK

**SYNOPSIS.** Devils Dingle Ash Lagoon is the principal means of ash disposal for Ironbridge Power Station. The lagoon is impounded by an embankment constructed largely of PFA with an upstream clay core. Filling of the lagoon is entering the final stages and plans for the restoration of the site are currently being formalised.

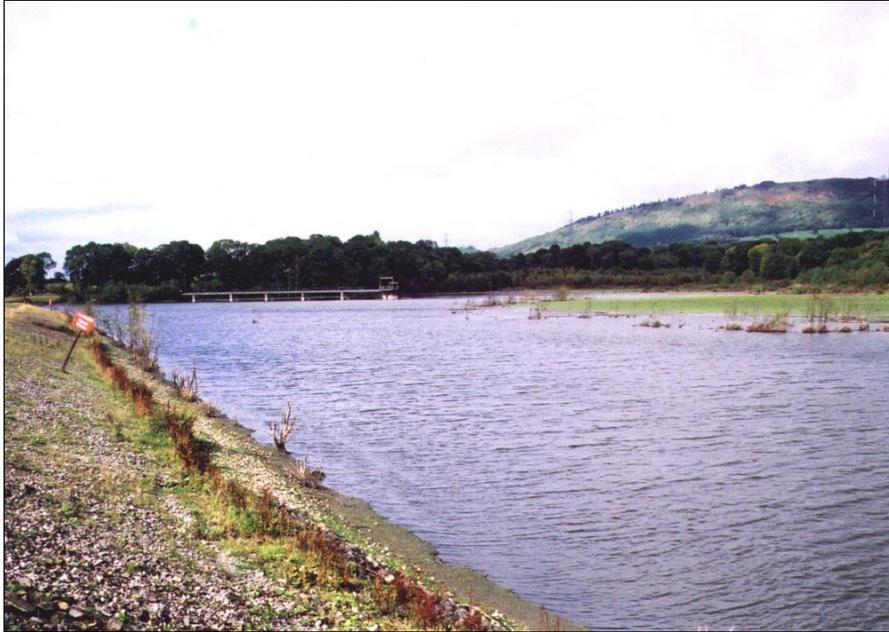
Plate 1: The reservoir at the Devils Dingle Ash Lagoon with draw-off tower access walkway in the background

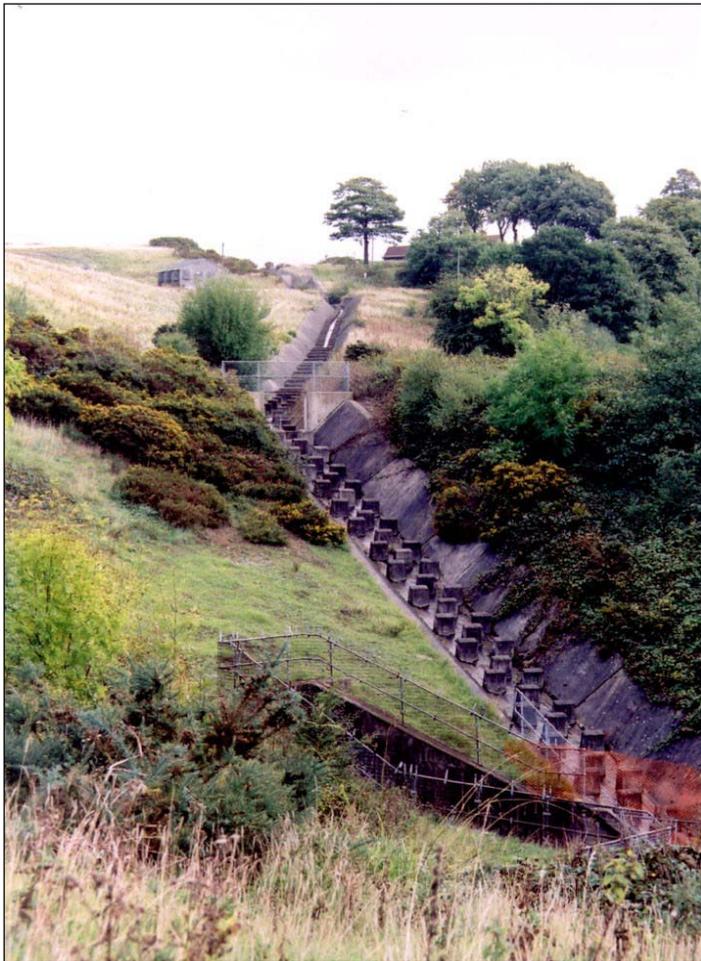
Plate 2: Eastern cascade channel on the left mitre of the embankment
