How Design/Build at Pine Brook Dam Dramatically Reduced Schedule and Costs

DEL SHANNON, ASI Constructors, Pueblo, Colorado, USA

ROBERT DE HAAS, Pine Brook Water District, Boulder, Colorado, USA

SYNOPSIS. The design/build approach has been successfully used to expedite the design and construction process of many heavy civil construction projects, including bridges, highways, and multi-story buildings. One of its first applications for design/build in dams began when the Pine Brook Water District – a small water district serving only 400 taps or about 1200 customers, located two miles northwest of Boulder, Colorado (USA) – sought to build a new dam with an extremely aggressive schedule and budget. Given these constraints, Pine Brook believed a design/build approach was the only viable method to design and construct this new roller-compacted concrete (RCC) dam.

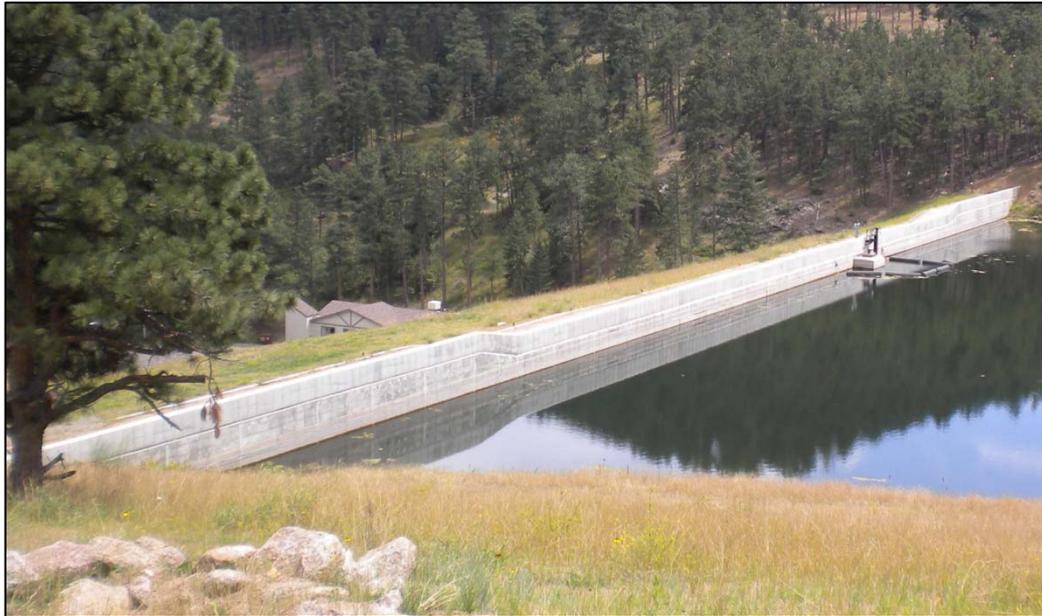
Figure 5. Upstream face of dam and emergency and service spillway.

The emergency spillway section is similar to the non-overflow section. The 3.83 ft (1.2m) high parapet wall has a top-of-wall elevation of 6295 ft (1918.7m) and the crest elevation of the vertical "chimney" section is at 6291.17 ft (1917.5m). The emergency spillway crest is 290 ft (88.4m) wide at elevation 6295 ft (1918.7m). No stilling basin for the emergency spillway was designed. Though turbulent flow conditions are expected at the dam toe when the emergency spillway operates, foundation erosion or undermining is not expected. Stability analyses demonstrated that the dam will be safe for the PMF event without the soil backfill.

A 6 ft (1.8m) high and 0.5 ft (150 mm) deep low flow notch was constructed in the emergency spillway to focus low flows through the spillway at one location, so that they can be more easily identified and handled.

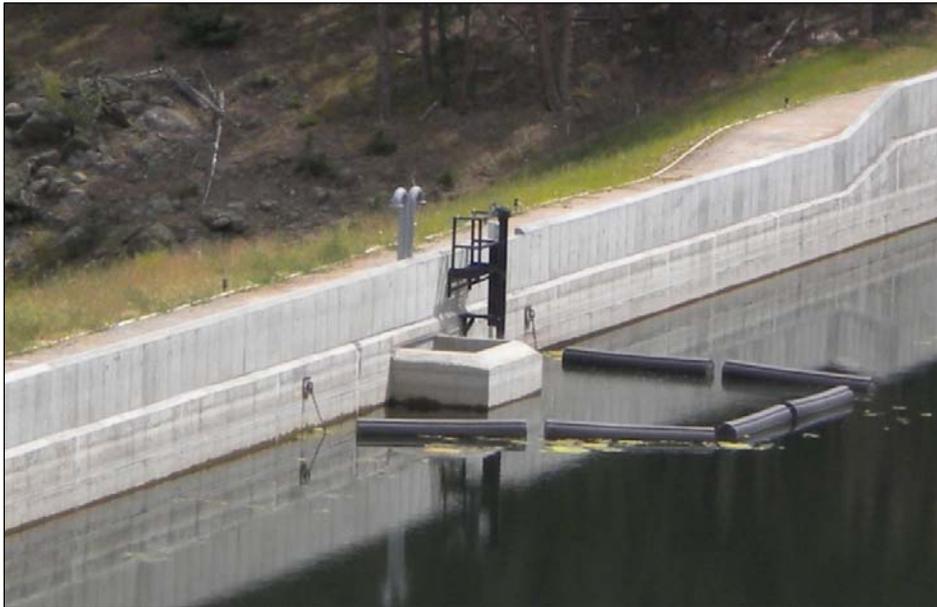
Figure 6. Service spillway on upstream face of dam.

The service spillway is a drop inlet structure founded on RCC and anchored to the upstream face of the dam. The outlet conduit discharges flood water through the RCC dam and downstream soil cover to an energy dissipation structure at the toe of the downstream soil cover. The flow area of the drop inlet portion of the service spillway is 5 ft by 7 ft with a crest elevation of 6290 ft (1917.2m). The conduit through the dam is 7 ft by 7 ft cast in-situ concrete. It has an initial invert elevation of 6224 ft (1897.1m) and a slope of 1.5%. The outlet conduit is designed to discharge service spillway flows as open-channel flow up to 500 cfs (14.2m³/s). Flows between 500 cfs and 1,000 cfs (28.4m³/s) will flow through the outlet conduit under pressurized conditions. Flows in excess of 1,000 cfs (28.3m³/s) will be passed over the emergency spillway.

- Two 6-inch-diameter (152mm) stainless steel pipes are attached to the service spillway tower with intakes at elevation 6260 feet (1908m) and 6229 feet (1898.6m) and gate valves at the downstream end of the pipes. There are no upstream guard gates installed for the outlet works.
- An inlet screen is installed at each intake.
- The outlet works are encased in concrete through the dam and soil blanket.
- Outlet works are controlled from downstream valves located at the water treatment plant, located near the downstream toe of the dam.

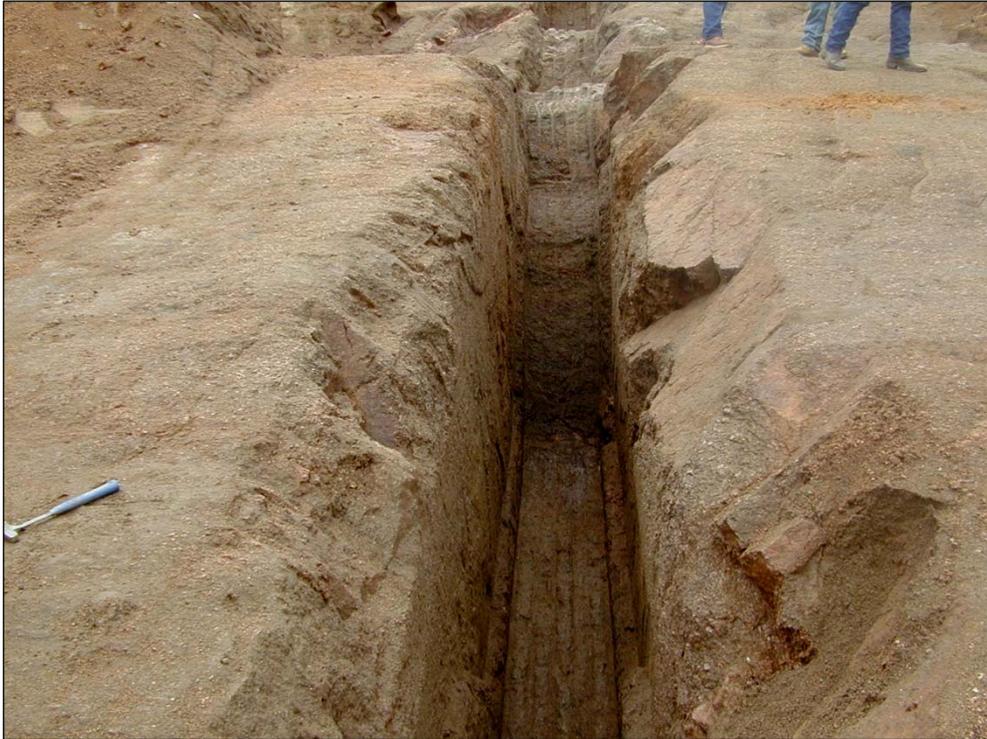
Figure 7. Foundation cutoff trench.

Foundation preparation and treatment under the dam consisted of the removal of all overburden and highly-weathered bedrock; removal of rock overhangs; shaping of rock foundation; rock cleaning; and dental concrete treatment of cracks and cavities of the rock foundation. In the central valley section and along the left abutment, the depths of weathered rock excavation varied between one and 10 ft (0.3m and 3m). In the right abutment section the depths of weathered rock excavation were less than five ft (1.5m).

As with most new dams, the foundation can pose one of the greatest construction and design risks. The design plan included excavation of the foundation in stages to identify stable foundation material and determine the refusal point for the seepage cutoff wall. The ability to plan for this approach was a significant benefit of the design/build process. It also eliminated a considerable interim design phase that would have involved additional foundation exploration.

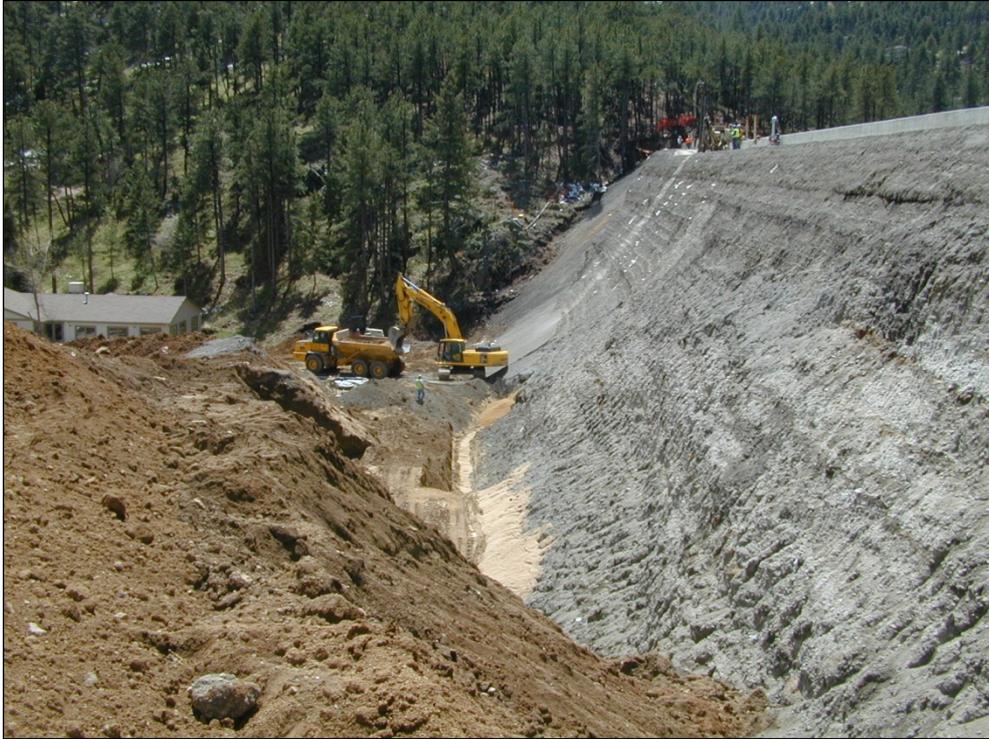
Figure 8. Unformed downstream face and installation of toe drain.

No foundation drain holes or grouting were designed for this dam as the structure was designed to resist full hydrostatic uplift. Seepage through the dam foundation is collected with a toe drain, placed at the downstream toe of the dam. This toe drain discharges into the creek channel immediately downstream of the principal spillway stilling basin.

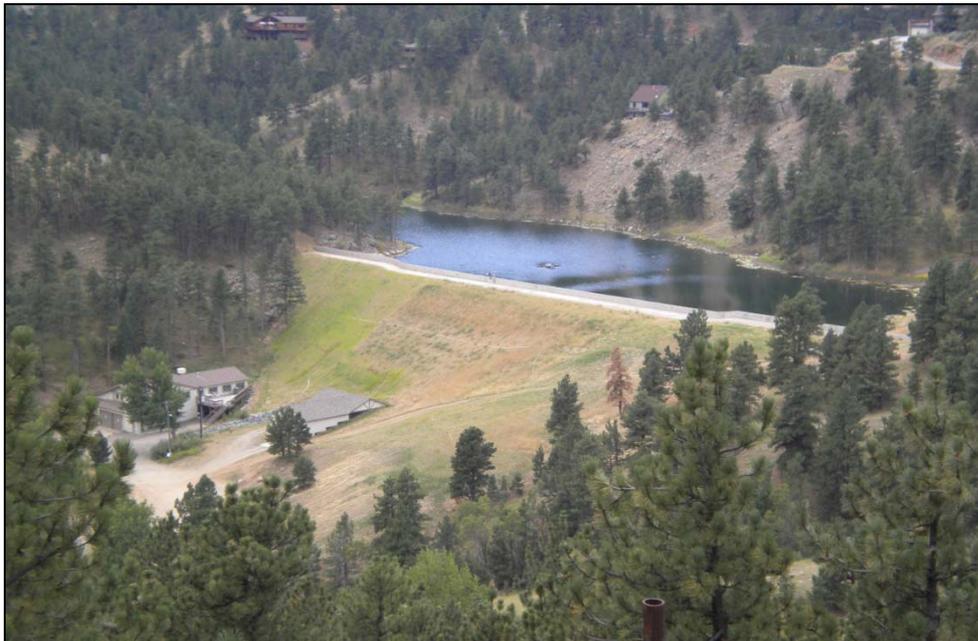
Figure 9. Completed dam with downstream soil cover.

Approximately one year after initial filling of the dam, the downstream face of the dam was covered by a soil cover with a slope of 2H:1V (horizontal:vertical). The downstream soil cover was not incorporated into the structural design of the dam but was important for economic, environmental and aesthetic purposes. A chimney drain was constructed at the RCC/soil interface to collect, control and monitor seepage through the dam. The RCC structure is founded on bedrock, with a bottom-of-structure elevation of about 6210 ft (1892.8m) at the maximum section. A 10 ft deep (3.1m) key was excavated into the weathered bedrock below the base of the dam as a seepage cutoff. The downstream face of the RCC is unformed RCC and the upstream face is conventional concrete facing.
