Internal Erosion at Existing Dams: an Outline of a Proposed ICOLD Bulletin

RODNEY BRIDLE, Dam Safety Ltd, Amersham, HP7 0DT, UK
JEAN-JACQUES FRY, EDF-CIH, Le Bourget du Lac Cedex, France
ALAN J BROWN, JACOBS, Leatherhead KT22 8JB, UK

SYNOPSIS. The improved understanding and investigations on-going at dams and levees in Europe and elsewhere (notably Australia, Canada, Australia and USA) has led to a proposal to draft an ICOLD bulletin on assessing the vulnerability of existing dams without filters to internal erosion and how to deal with any deficiencies. The paper is an early version of the proposed bulletin.

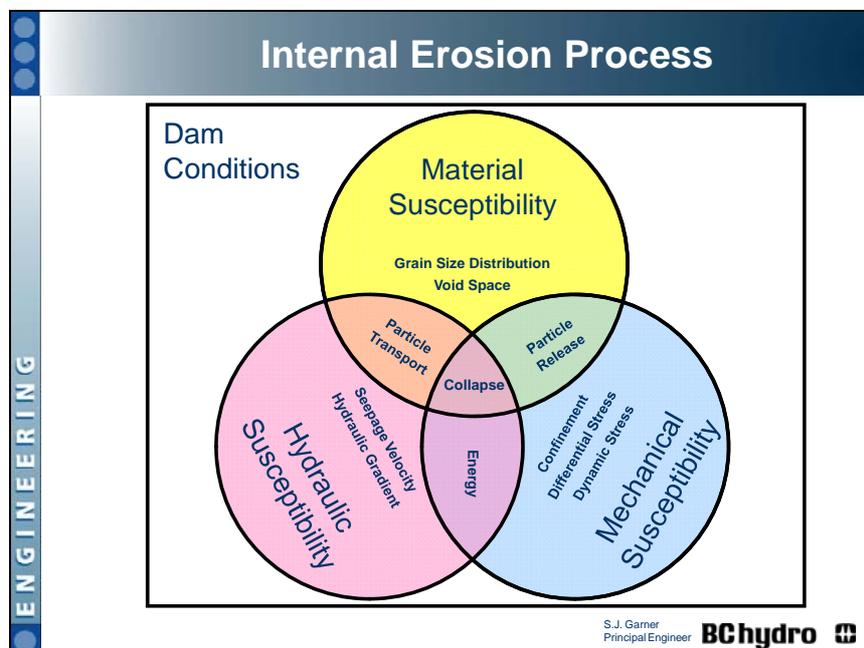
Figure 1. Venn diagram illustrating interaction of geometric, hydraulic and mechanical susceptibilities of soils to internal erosion (courtesy of Garner, Fannin and BC Hydro)

How the energy to cause erosion comes to be present is the result of the interaction of all the properties of the dam and reservoir, particularly the geometric, hydraulic and mechanical susceptibilities of the materials in the dam and foundation. This interaction is illustrated by the Venn diagram (Figure 1) below, developed by Steve Garner of BC Hydro during and after the 2009 workshop of the ICOLD European Working Group on Internal Erosion (Garner & Fannin, 2009).

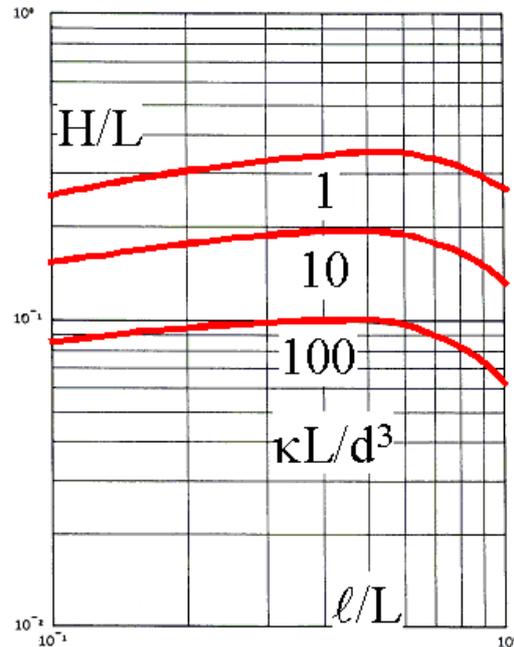
Figure 2. Sellmeijer's design rule

The formation of erosion pipes in a granular layer directly underneath a cohesive layer has been of particular concern in the Netherlands, where sand boils often occur at the toe of dykes protecting the low-lying hinterland. In the early 1970s a research program was started in the Netherlands to develop a sound risk assessment methodology to assess the safety of flood protection embankments prone to sand boils. Two decades later, this research program resulted in Sellmeijer's design rule (Figure 2), which is now commonly used in Dutch engineering practice and included in guidelines [TAW, 1999].

In Figure 2, H is the head difference, L is the flow path length, l is the worm-hole length, κ is the geometric permeability, and d is the effective grain diameter of the sand layer. Note that the geometric permeability, κ , is the (D'Arcy permeability * viscosity of water)/ (density of water * g). Density* g is 9,800, say 10^5 , viscosity is about 10^{-3} , κ is therefore about D'Arcy permeability $k*10^{-8}$. The effective grain size, d , is the d_{15} (in metres) of the sand layer. Using the rule to estimate the wormhole length, l , the increased seepage gradient can be evaluated, and its impact on the stability of the downstream toe assessed.
