## **Guidelines from hydraulic model tests on stepped masonry spillways**

**SYNOPSIS** As part of an Environment Agency funded project to produce new guidelines for stepped masonry spillways, laboratory tests were performed to investigate the pressure distribution on the spillway walls at the steps and to determine factors that would influence the failure of an individual masonry block.

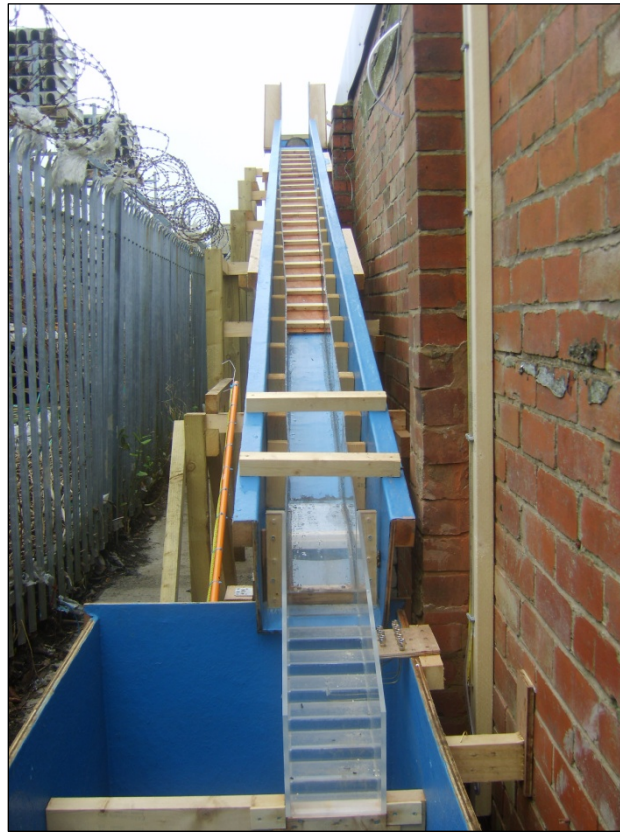
A 300mm wide chute with a gradient of 1 in 3 and slope length of 7.32m was constructed down the outside of CRM's laboratory at Farnworth, Bolton, Figure 1. Water was fed to a stilling tank on the roof of the building at flow rates up to 70 l/s by the laboratory pump recirculation system and allowed to accelerate by gravity down the chute. For some tests the chute was left smooth, in others it was roughened with strips of timber.

Figure 1. Test Facility

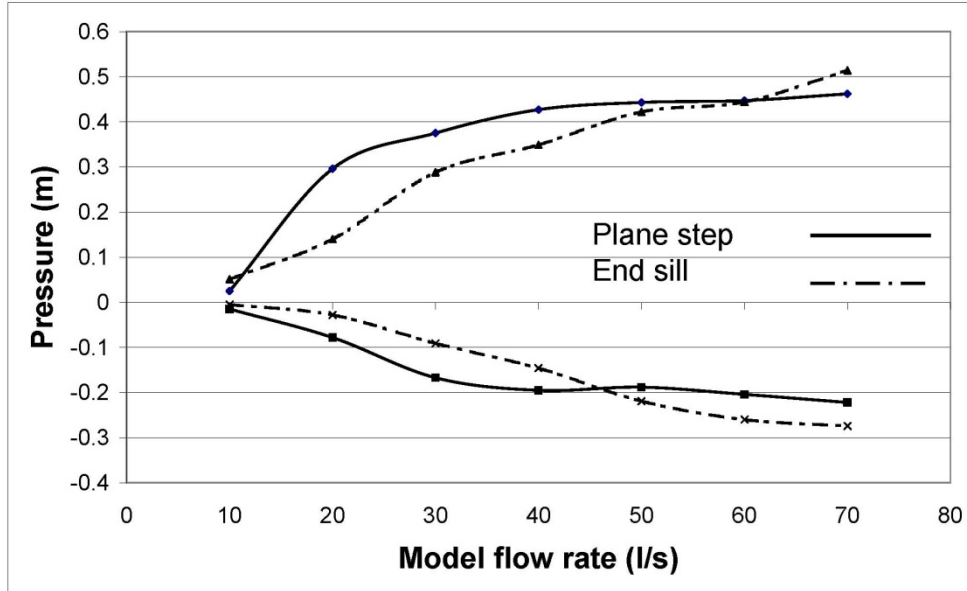
expect the difference between the peak fluctuation either side of the block to be in excess of 6m water pressure. It should be noted that invert blocks could also experience this pressure differential across a step. Figure 6 compares the data for the cases with and without the end sill and suggests that at higher flow rates the end sill makes the pressure differential worse.

Figure 6. Development of peak pressure differential with flow rate
