**The Reservoirs Act: Past, Present and Future – Papers**

| Ref | Author(s) | Paper Title |
|---|---|---|
| 1.01 | Blower & Golds | Potential applications of a ground risk management system to reservoir safety under the Reservoirs Act |
| 1.02 | Hughes | The use of site-won and non-standard fill materials in the creation of embankment dams |

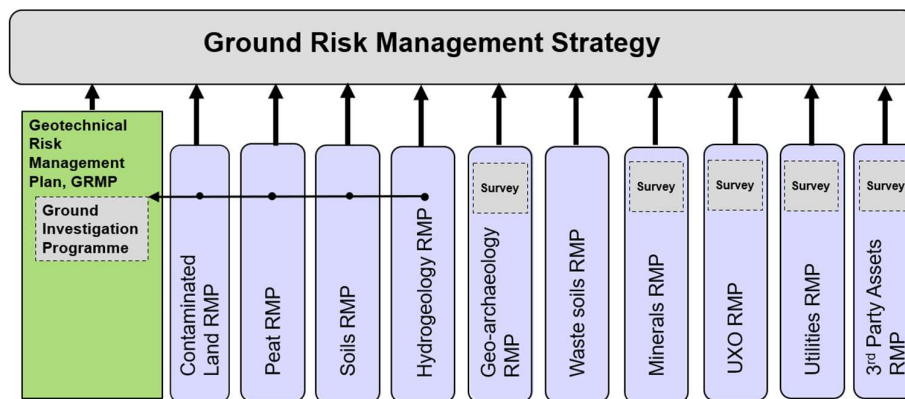
In order to capture in one place all of the elements that could be considered 'ground risk', the ground risk management plans encompassed a very broad range of matters in the ground, from peat and hydrogeology to UXO and utilities as well as purely geotechnical matters, as shown in Figure 1.

*Figure 1. RMP's supporting the Ground Risk Management Strategy*

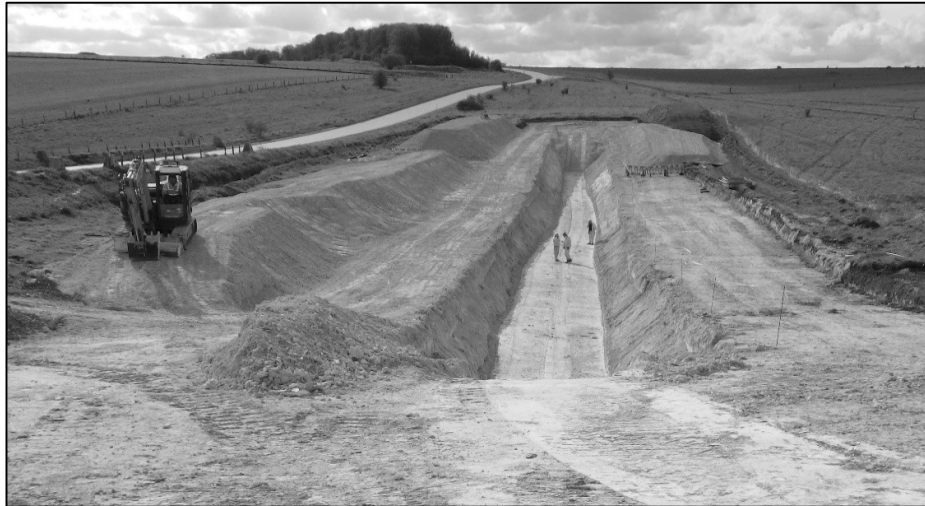
*Figure 2. Inspection of cutoff trench, note the prepared stockpiles of excavated chalk intended for re-use*

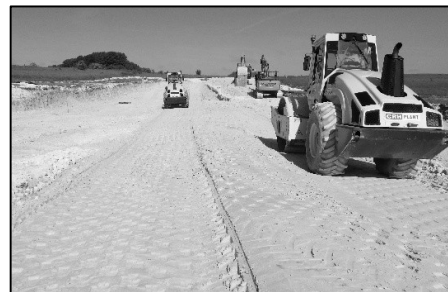
*Figure 4. Compaction using both padfoot and smooth rollers*

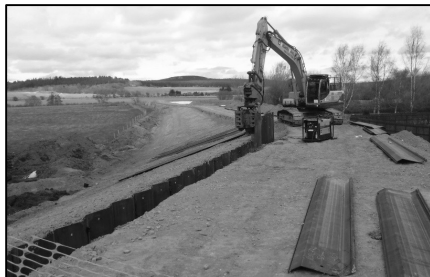
Figure 6. Installation of sheet piles

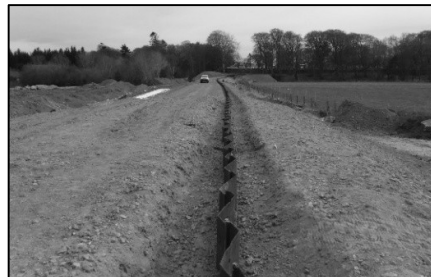
Figure 7. Completed partial cut off

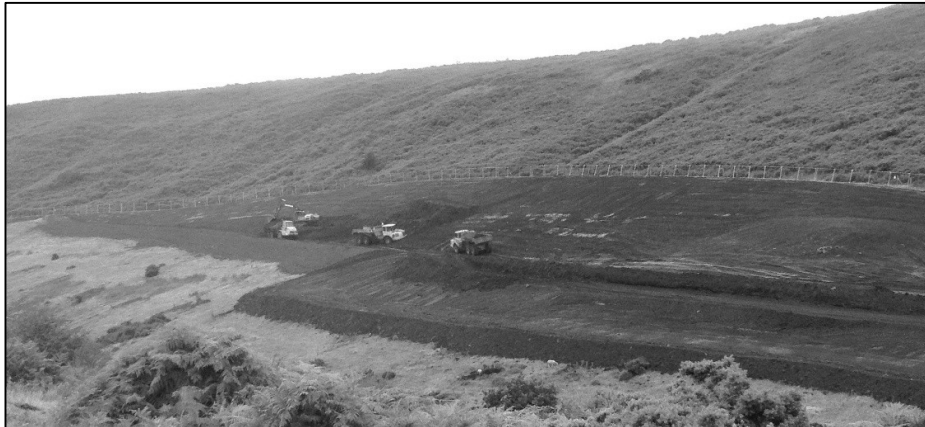
*Figure 9. Colliery spoil being sourced as fill for the embankment dam*

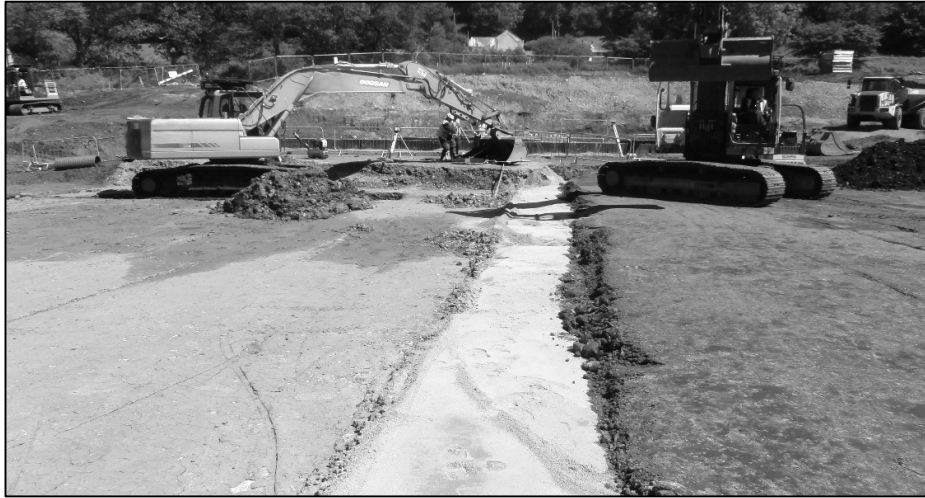
*Figure 10. Chimney drain between core (left) and downstream shoulder*

- A chimney filter to intercept seepage through any developed cracks and prevent internal erosion.
- A 'core' of modified spoil, with added bentonite clay to increase plasticity and thereby reduce the potential for cracking.

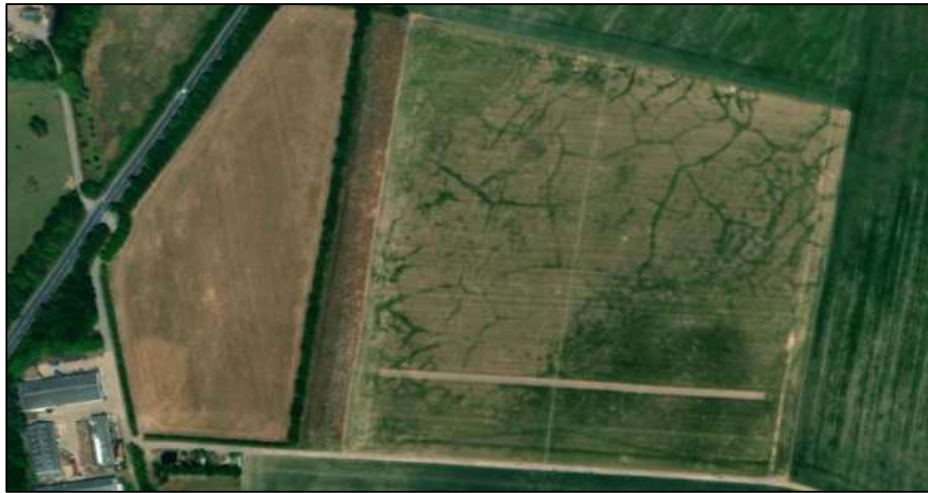
Compelling evidence for ground ice formation within the bedrock soils at the Fens Reservoir site was identified, with aerial imagery identifying probable ice wedge polygons. These form due to ice generation, under periglacial conditions where ground cooling is sufficient to overcome the tensile strength of the clay, causing cracks. As groundwater enters the cracks and refreezes, this process is intensified by the expansion of groundwater. Ice wedge polygons can disturb ground structure and influence both strength and permeability. An example is shown in Figure 2.

*Figure 2: Ice wedge polygons within the Fens site (GR: 541175E, 290567N). Source: Esri, Intermap. Maxar (Vivid) imagery captured 11 July 2022.*

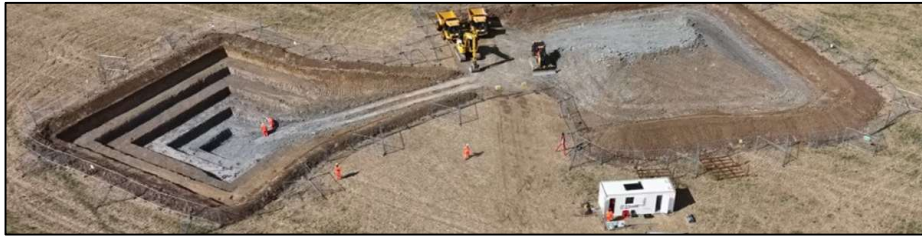
The OTP geometry was designed to investigate bedrock zones most likely affected by glacial / periglacial processes. As outlined by Spink and Norbury (1993), understanding weathering profiles in bedrock clays is key to identifying horizons where such features are likely encountered. A minimum excavation depth of 6m was selected to adequately observe the weathering profile; this was constrained by the considerations noted above and represents a compromise. An example in progress OTP is shown in Figure 6

*Figure 6: OTP at the Lincolnshire Reservoir site 2025, Blackwell Earthmoving Limited and Anglian Water.*

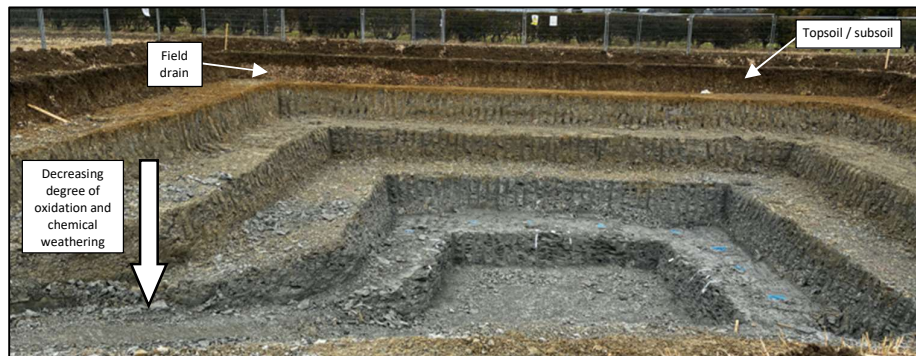
Observational trial pits were excavated within the reservoir footprint in 2025 (Figure 4). Typical plan dimensions were 25m x 25m, with a depth of around 5m. Access was made for person entry and logging. Results of geochemical tests on samples were not available for review at the time of writing. The pits offered an opportunity to document chemical weathering including the

Figure 4. Example observational trial pit (Oxford Clay, (OxC) at surface).

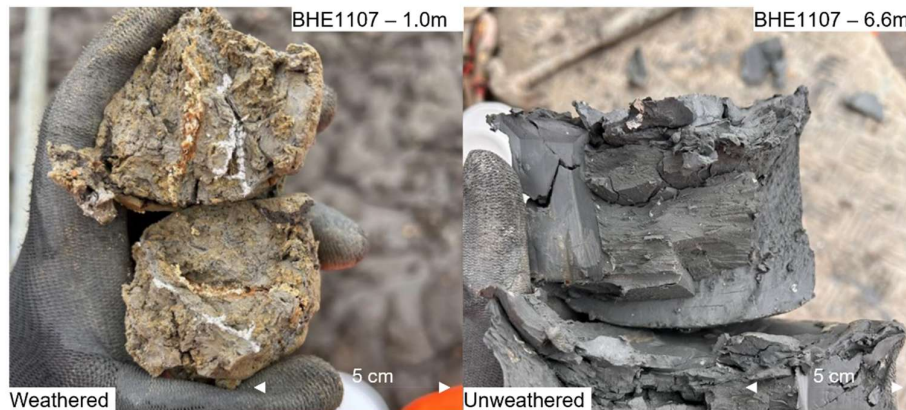
*Figure 1. Colour changes identified between weathered (note the gypsum crystals within the sample) and unweathered Jurassic Clay.*

predominantly a stiff to very stiff dark grey slightly sandy clay, with rare fossil fragments. Fissures are often encountered, typically described as sub-horizontal to sub-vertical, very closely to medium spaced, planar and smooth. Sub-ordinate beds of predominantly extremely weak to weak grey slightly sandy siltstone are commonly present. A comparison image is included in Figure 1.

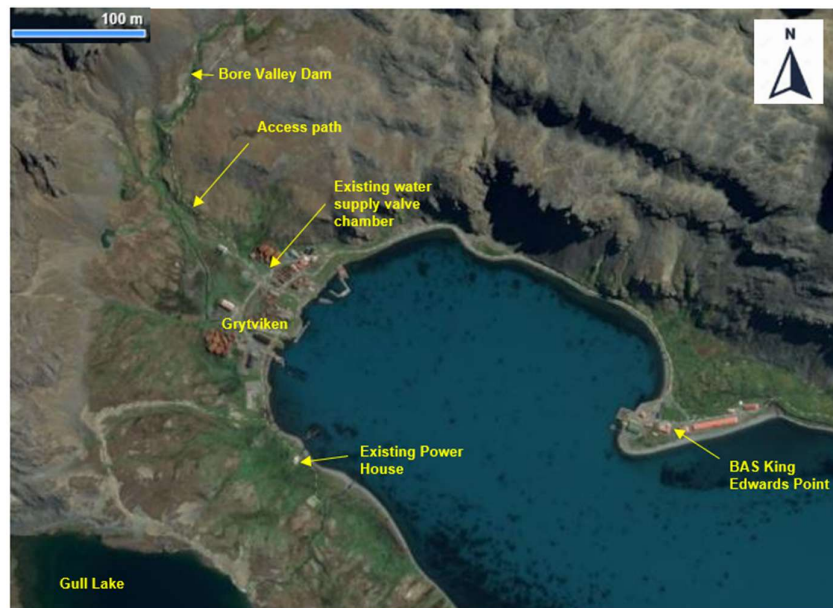
Figure 3. Location of reservoirs at Grytviken on South Georgia

South Georgia hosts small reservoirs at Bore Valley and Gull Lake, originally constructed c.1912–1914 and commissioned in 1914 to support whaling operations and later adapted for water supply and hydroelectric use for the BAS Research Station at King Edwards Point. These assets are located close to the eastern coast of the island close to the former whaling station of Grytviken (Figure 3 and Table 2).

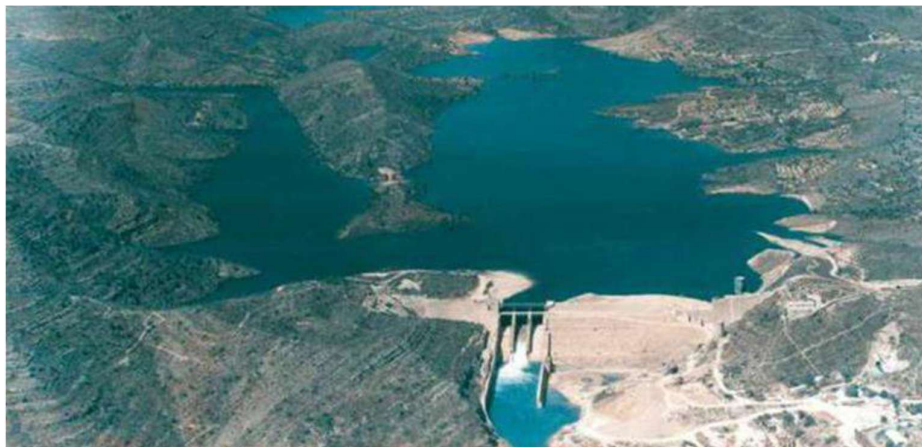
*Figure 1. Tous Dam before the failure. Source: ICOLD (n.d.).*

The dam was initially designed as an 80m high concrete structure, and construction started in 1958. However, during construction, two geological faults were identified in the riverbed, which led to the suspension of the works in 1964 and a subsequent redesign of the dam. After a 10-year redesign period, construction resumed in 1974, with the original scheme modified into a zoned rockfill embankment with a central clay core, integrated between the previously constructed concrete abutments. At completion, in 1978, the dam had a crest elevation of 98.5m with approximately 122 million m<sup>3</sup> of reservoir capacity and included provisions to increase its height to an elevation of around 142m in a second phase that was never executed. The normal operation level was at 84m elevation, with a reservoir capacity of 51.5 million m<sup>3</sup>.

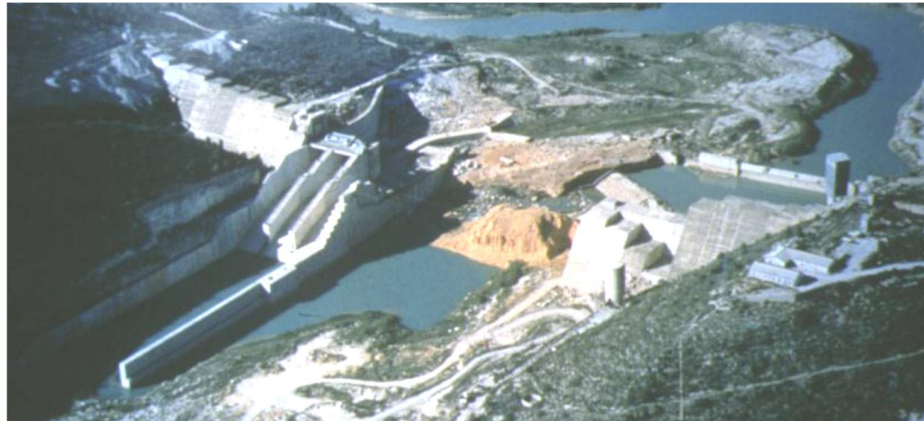
Figure 3. Tous Dam after failure in 1982. Source: Fleitz, J. (2013).

A significant part of the dam is considered to have failed at 19:15, close to peak reservoir level. The dam was overtopped and then washed out within roughly one hour. Erosion removed a large part of the shoulders and the central rockfill. Additionally, overtopping also led to the loss of the leftmost gate and its supporting structure.

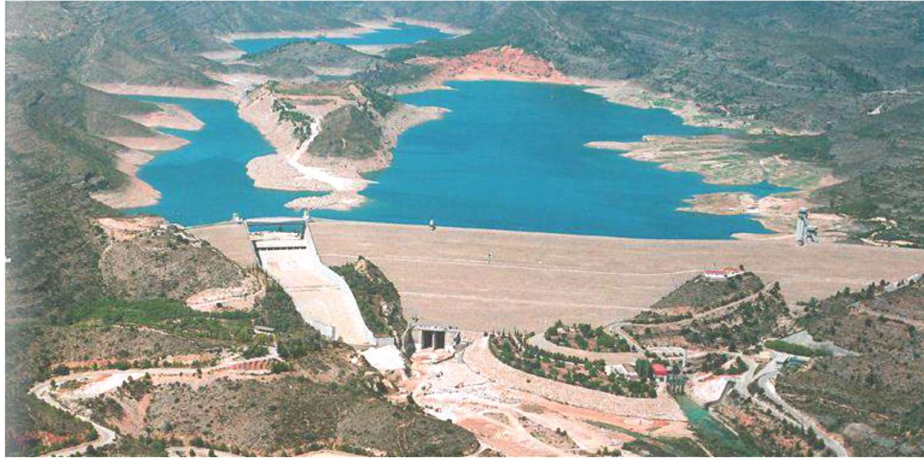
Figure 5. The new Tous Dam. Source: ICOLD (n.d.).

From a hydraulic perspective, the most significant change is the spillway concept. The original dam relied on a gated spillway with a capacity of about  $7,000\text{m}^3/\text{s}$  (500-year return period), while the new dam is equipped with an ungated spillway with a much higher capacity, around  $20,000\text{m}^3/\text{s}$  (10,000 - year return period). This represents a clear shift away from reliance on gate operability under extreme conditions.

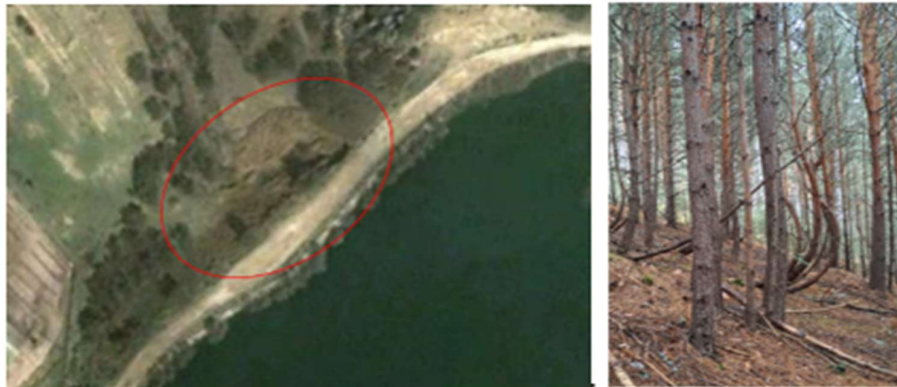
*Figure 2. Slope instability and dense vegetation on the downstream slope*

Many dams suffer from at least inadequate maintenance. A considerable number of embankment dams have been constructed without a supporting technical design, through the accumulation of impermeable material until reaching the required elevation. As a result, dams have been identified presenting slope instability mechanisms, such as slip circles, as well as extensive vegetation on slopes, including trees whose curved trunks indicate ongoing or past sliding processes.

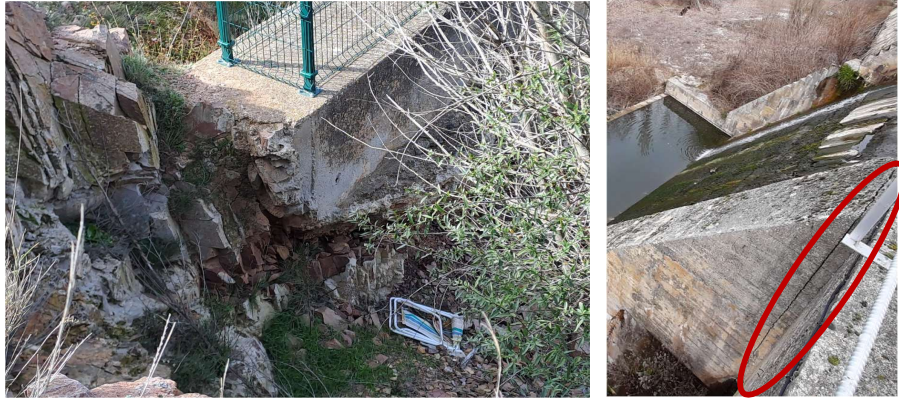
*Figure 3. Inadequate abutment support and longitudinal cracking in the spillway*

In masonry dams, it has also been common to identify significant uncontrolled cracking, lack of proper seating at abutments, and relative movement between adjacent blocks. Some structures are located at high elevations where freeze-thaw action is frequent. Observed issues include material detachment, the presence of cyanobacteria, and evidence suggestive of alkali-aggregate reactions, such as crack mapping patterns or calcareous efflorescence. In certain concrete dams, the growth of trees on the downstream face has also been observed.

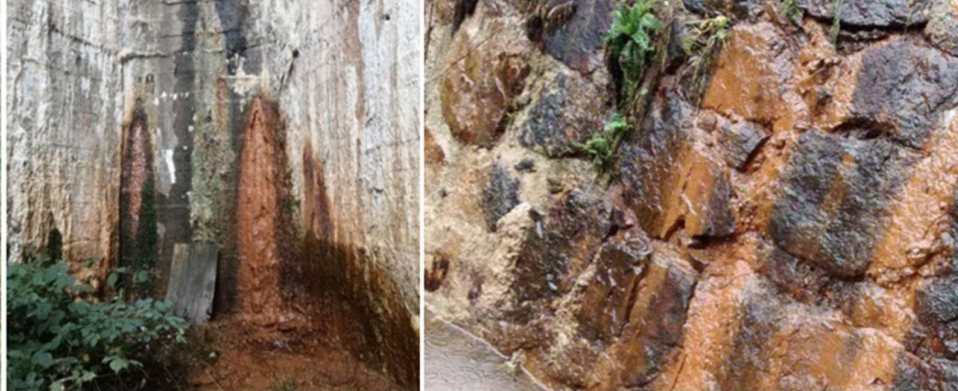
*Figure 5. Clayey seepage*

In dams lacking adequate maintenance, the appearance of seepage over time is common. The problem lies not only in the origin of the seepage itself, but also in the absence of proper monitoring, both in terms of flow rate and water characteristics, such as color and potential material transport. Clayey seepage has been identified in some cases, which may indicate the loss of impermeable material from the dam body.

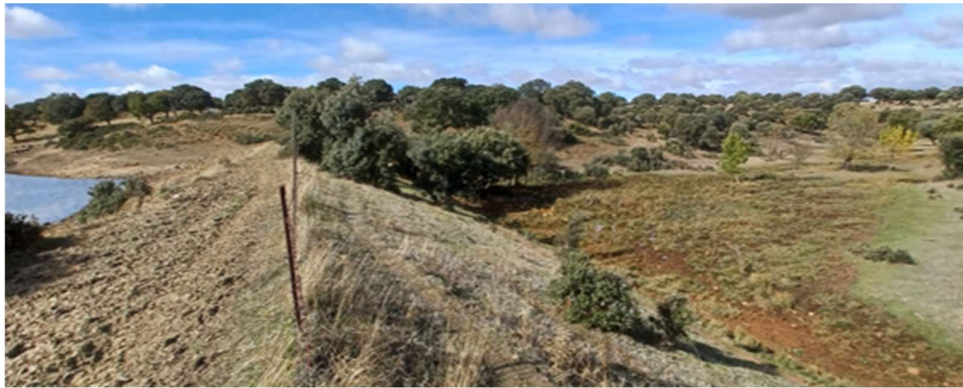
*Figure 6. Seepage through the foundation*

The presence of water at the downstream toe of the dam has also been observed, the origin of which may be associated with seepage through the foundation.

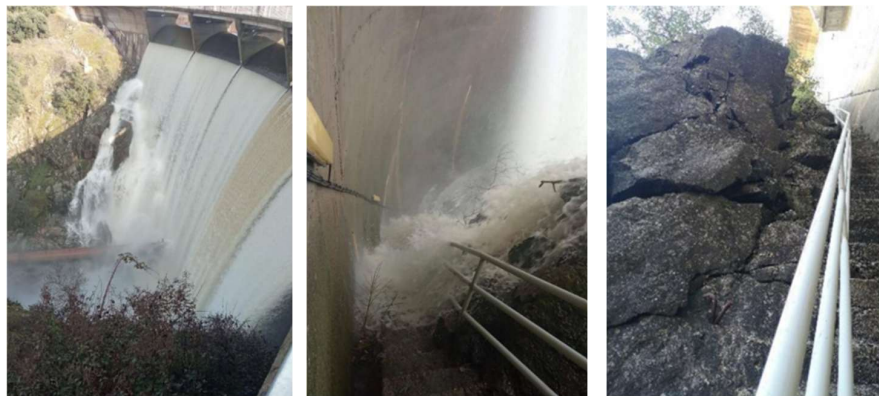
Figure 8. V Spillway discharge over abutments and access staircase to the bottom outlet

In other situations, the problems have arisen due to insufficient forethought during the design phase, such as the discharge of the spillway directly onto bottom outlets or onto the dam abutments themselves or structures without erosion protection..

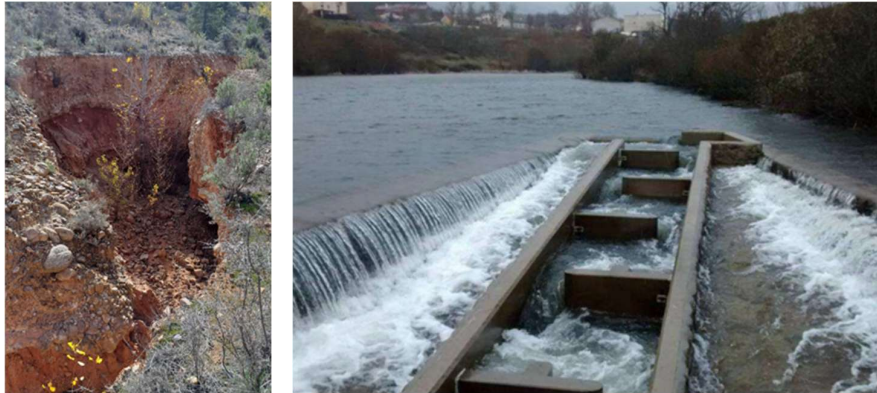
Figure 9. Erosion of the spillway and presence of a “foreign object” within the spillway

It goes without saying that the presence of “foreign objects” within the spillway prevents the proper evacuation of the design flood flows, and such obstructions must be removed in all cases.

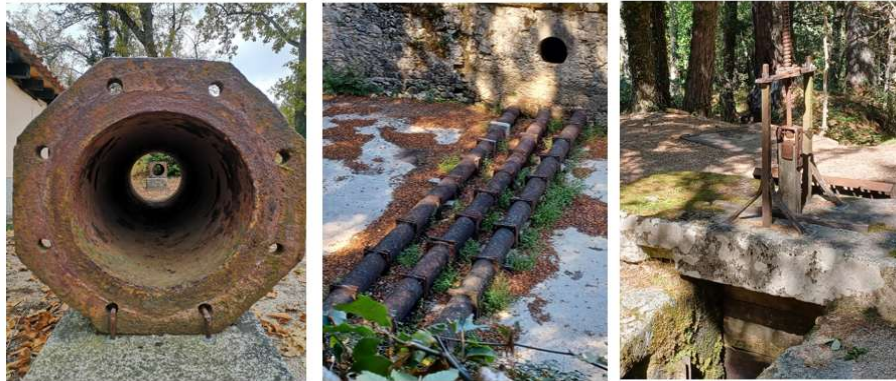
*Figure 10. 18th century dam and reservoir facilities*

A particular challenge is posed by historic dams, such as an 18th-century masonry dam built under King Felipe V, now classified as Category A and protected as cultural heritage. Lacking a conventional bottom outlet, this structure highlights the difficulty of applying modern regulations to pre-engineering designs. In such cases, a comprehensive technical and historical assessment may allow legacy elements, originally conceived as water intakes, to be reinterpreted as functional equivalents to bottom outlets, achieving safety objectives while preserving historical integrity.

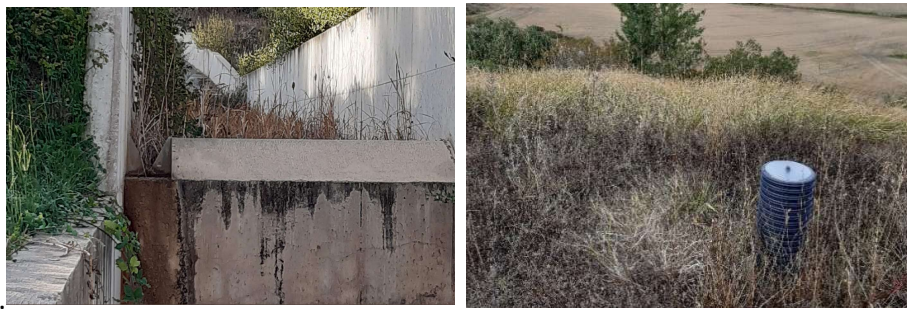
*Figure 12. Examples of non-operational monitoring.*

Although many dams in Spain have adequate monitoring systems in place, greater emphasis is now required on improving their quality, maintenance, and systematic data analysis. High-quality instrumentation has already enabled the detection of anomalous behavior in several cases. However, a significant number of dams, particularly smaller ones, still suffer from deficient, abandoned, or nonexistent monitoring systems, often due to limited technical capacity of their owners. This highlights the need for enhanced technical support and increased awareness of regulatory obligations.

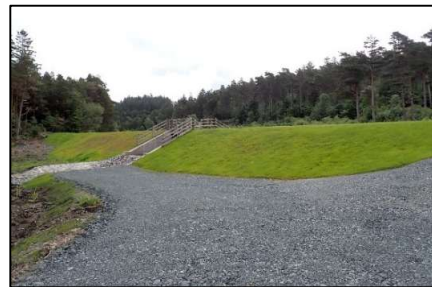
At the site of the previous breach, excavated in 1976 for water abstraction, a new spillway and bottom outlet structure has been constructed. The initial S10 gave a capacity ~20,000m<sup>3</sup>, the bathymetric survey indicated a capacity of 9,234m<sup>3</sup> and a surface area of 7,600m<sup>2</sup> when full to its top water level. Safety works revealed silt levels were deeper than indicated in the bathymetric survey.

*Figure 5. Pandora Reservoir in 2024 following completed capital works*

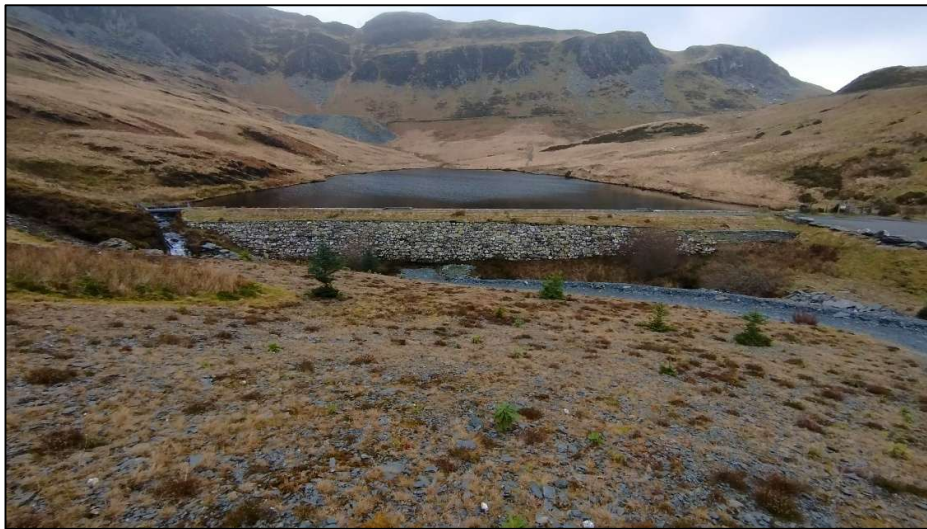
The reservoir was originally constructed to support local slate mining. Formed with a masonry dam 4.6m high, 100m long and with a 5m wide crest the reservoir stores 23,000m<sup>3</sup> above adjacent natural ground.

*Figure 1. Llyn Ffridd y Bwlch Reservoir*

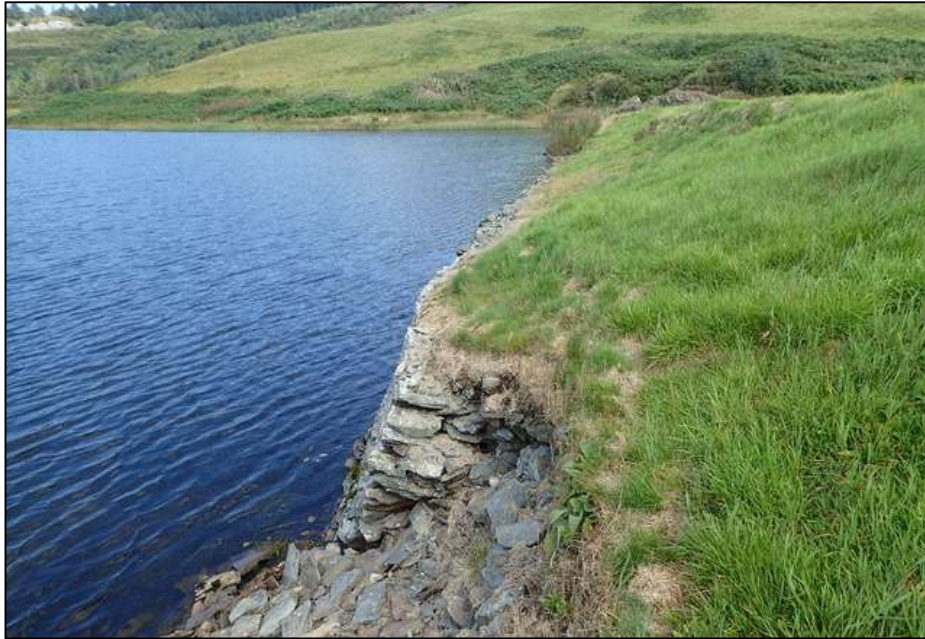
The reservoir is impounded with a 5m high earthfill embankment dam, 80m long, 5m high and has no operable installed drawdown facility.

*Figure 3. View along the dam at Llywernog Pond*

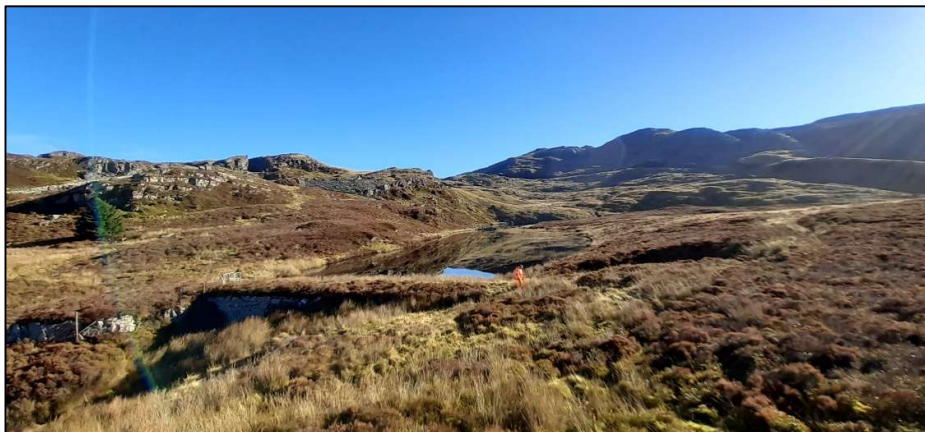
This reservoir, storing 40,710m<sup>3</sup> above adjacent natural ground was identified as a large raised reservoir under the 2016 review process. The reservoir had a masonry dam with peat core, 3.3m high and 23m long.

*Figure 4. Llyn Du Bach Reservoir, now discontinued*

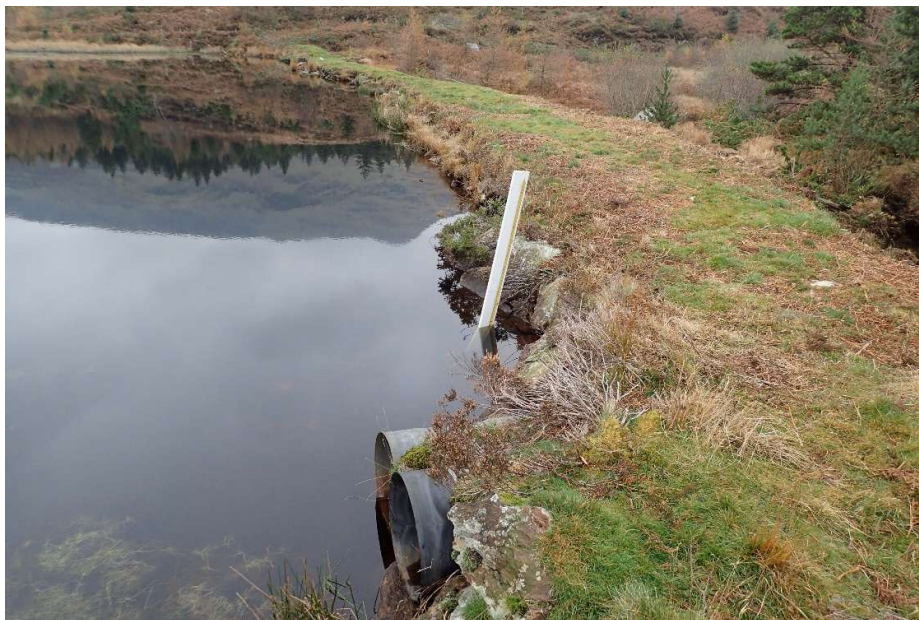
- Overflow arrangements at SRRs may take the form of a concrete or masonry lined channel, or as a channel cut through rock around the abutment area (Llyn Du Bach). Often, however, the overflow will be one or more pipes through the upper part of the dam (Llyn y Garnedd, Llywernog Pond). Almost invariably these arrangements will have insufficient overflow capacity, resulting in insufficient freeboard, when assessed against current standards.

*Figure 5. Example of inadequate overflow arrangement and freeboard*

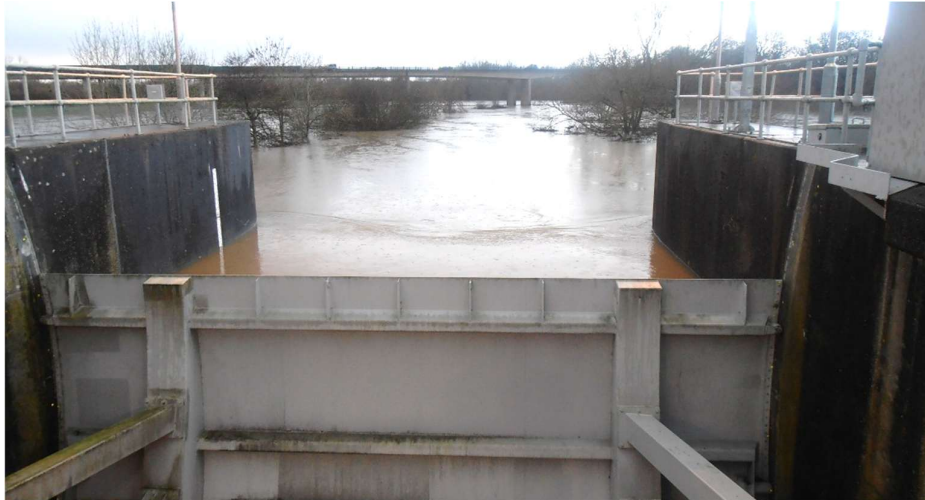
*Figure 2. Peak water impounded upstream of the control structure during the December 2013 floods.*

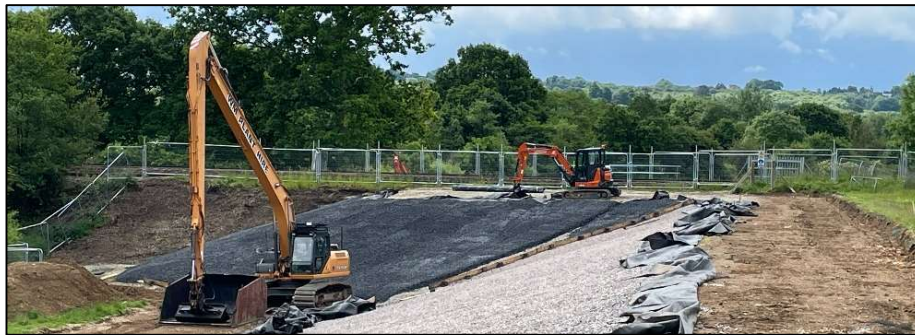
*Figure 4. Installing OSA between the control structure and the railway in the north spillway section.*

Following optioneering, open stone asphalt (OSA) was selected for the northern and middle embankments because it provided the required erosion resistance with lower carbon and cost than concrete mattresses. The southern embankment retained an open mat geotextile system, and the downstream toe drainage was replaced to improve performance.

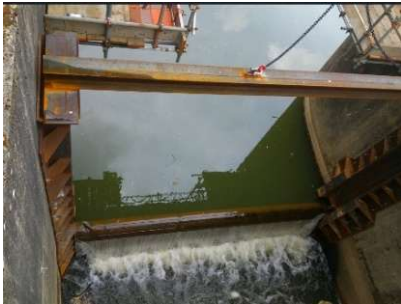
Figure 7. Low flow stoplog weir.

When the centre gate was replaced, a low flow weir was developed to maintain upstream levels for landowners. CFD modelling was used to confirm its hydraulic performance, and contingency arrangements were prepared so that it could be removed quickly if a major flood was forecast.

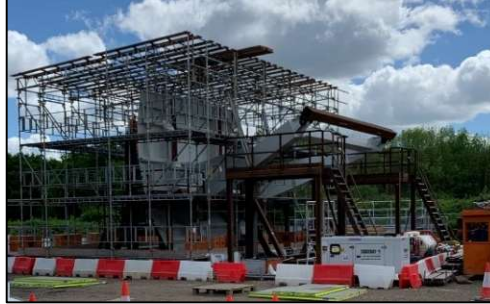
Figure 8. Gate assembly jig and scaffold for enclosure on site.

The revised strategy extended the life of the M&E works, shifted fabrication into a controlled workshop condition, reduced site safety and pollution risks, and limited operational disruption. It also introduced major delivery challenges, including redesign to suit the as-found geometry, transport of oversized gate components, provision of a 300t crane on weak ground, controlled on-site welding and coating, and the design of stoplogs that became critical to reservoir safety during the works. For example, the gate shields were delivered to site in two parts due to height, then positionally set, welded and joint painted on site on a bespoke jig in large tent.

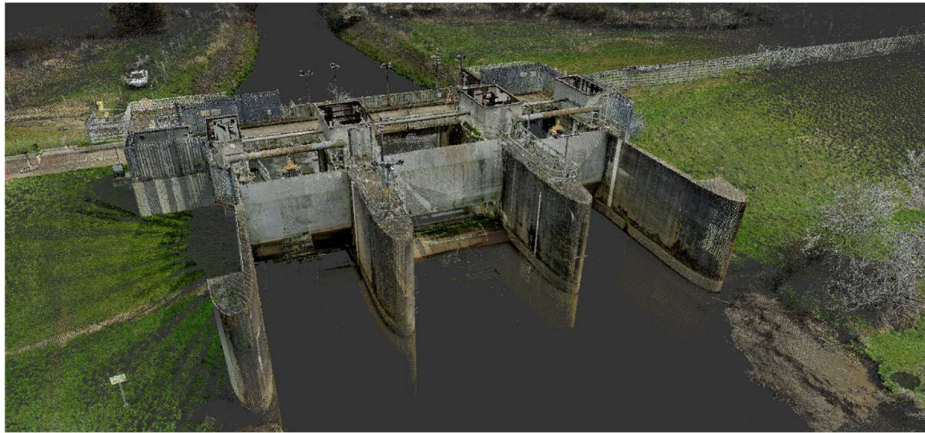
*Figure 9. 3D laser scan & photogrammetry survey.*

Detailed surveys were completed after the removal of the original gates, when the concealed side seal plates and pivot joints could finally be measured. These confirmed that the structure differed materially from the original drawings, with non-plumb walls, mismatched pivot levels and non-parallel seal plates.

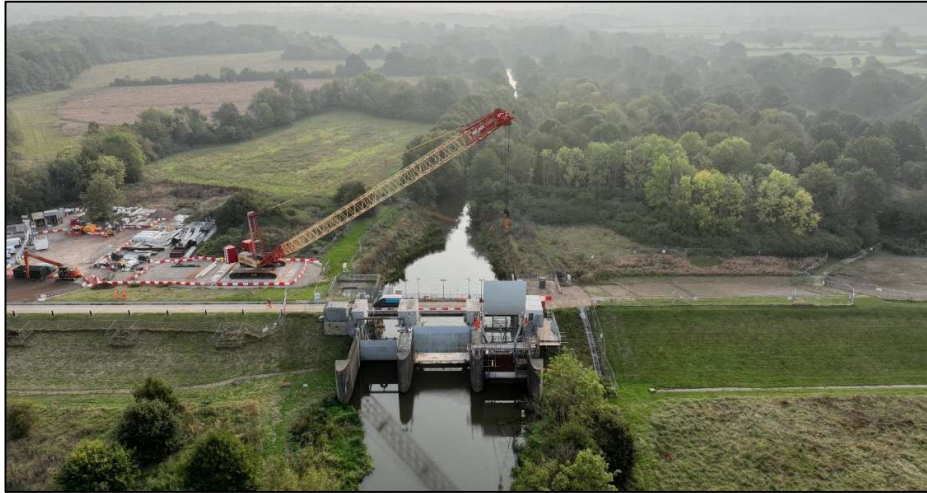
Figure 11. South gate leaf installed by a 300t crane.

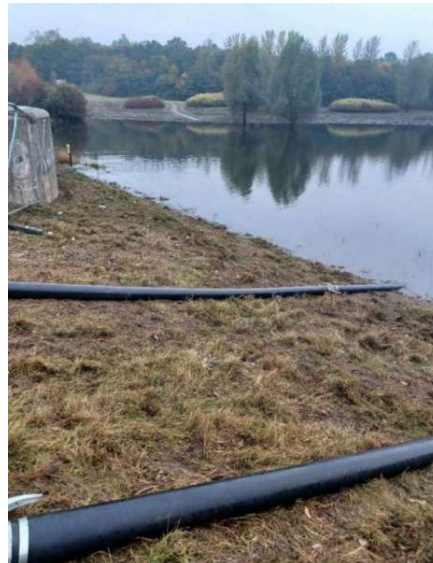
*Figure 3 – Over-pumping*

Emergency over-pumping was implemented under controlled conditions to reduce reservoir levels and hydraulic loading. Once it was confirmed that the upstream penstock was fully closed and hydraulically secure, specialist divers were deployed to inspect and clear the upstream outlet grill. Significant accumulations of grass cuttings and organic debris were removed, confirming that partial blockage had materially reduced outlet capacity.

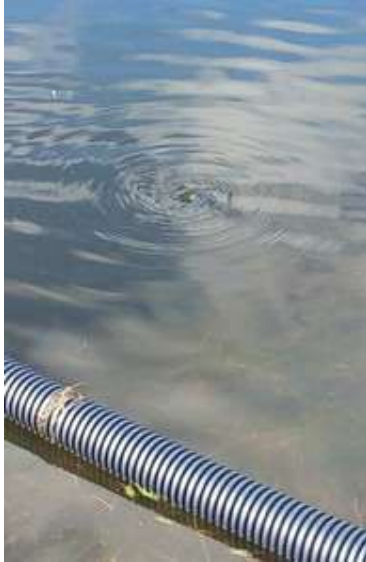
*Figure 4 – Whirlpool above outlet alignment*

Reservoir levels reduced gradually but with a localised whirlpool above the alignment of the outlet, and by 14 October had fallen approximately 2.45m below the overflow crest. At this stage a swallow hole approximately 0.8m by 0.8m in plan and around 1.5m deep was observed within the reservoir basin. The feature was located approximately 3.5m upstream of the overflow structure and aligned with the low-level outlet conduit. The geometry and position of the swallow hole prompted escalation of the event as a reservoir safety incident and the subsequent drawdown of the reservoir using over-pumping in accordance with the onsite plan.

A multi-disciplinary site inspection was undertaken on 14 October 2024 involving reservoir safety engineers, operational staff, maintenance teams, and contractors. It was noted that, prior to this inspection, a persistent whirlpool had been observed at the reservoir surface directly above the outlet alignment. Once reservoir levels fell below this elevation, the whirlpool ceased and the swallow hole became visible at precisely the same location.

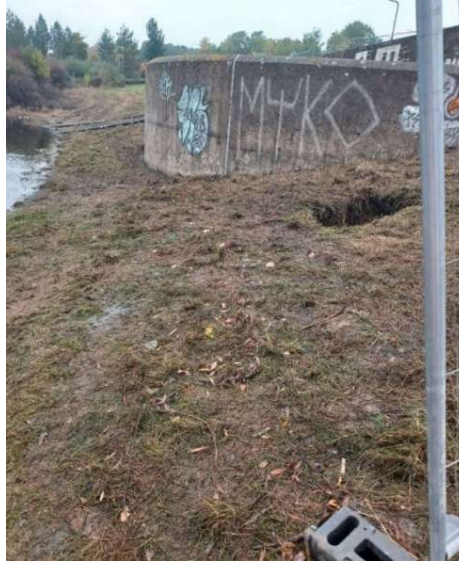
*Figure 5 – Sinkhole at location of whirlpool*

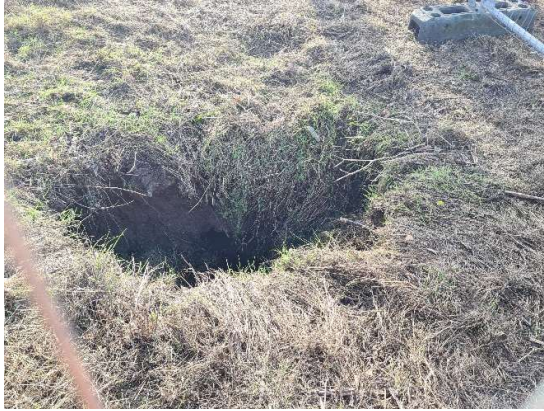
*Figure 6 - Sinkhole*

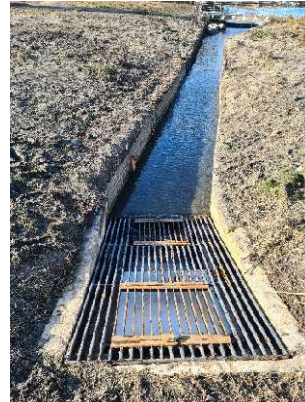
*Figure 7 – Outlet screen and sloping penstock*

The low-level outlet comprises a 586mm diameter conduit with an upstream penstock that is normally maintained in the open position. The outlet discharges downstream beneath an adjacent canal embankment. A single overflow weir provides flood discharge capacity. Safe operation of the reservoir during impoundment is critically dependent on reliable outlet performance to limit both peak water level and duration of storage.

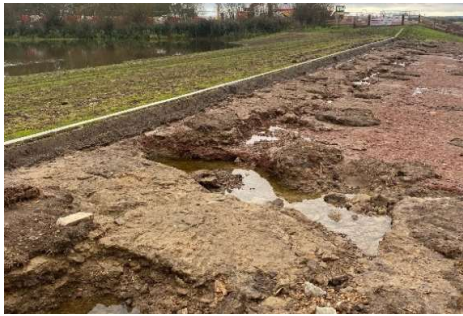
*Figure 4. Isle Spillway erosion following the October 2024 events.*

On 30<sup>th</sup> September 2024, overflowing occurred across the 1V:10H reservoir side slope of the Isle Spillway. As the spillway had only been seeded in mid-September, the limited vegetation cover provided inadequate protection from erosion, which progressed rapidly leading to erosion of the topsoil and underlying embankment fill. As part of the planned contingency, the embankment was temporarily reinstated, which involved installation of heavy-duty plastic sheeting, weighted down with sand bags to allow the spillway to operate safely and reduce further deterioration throughout the winter period.

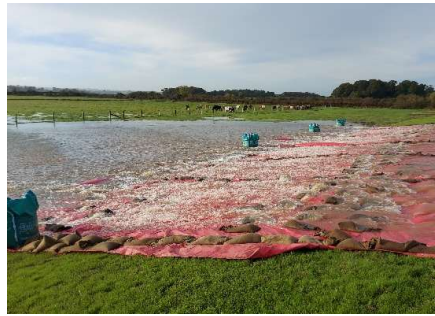
*Figure 5. Temporary winter slope protection measures in operation.*

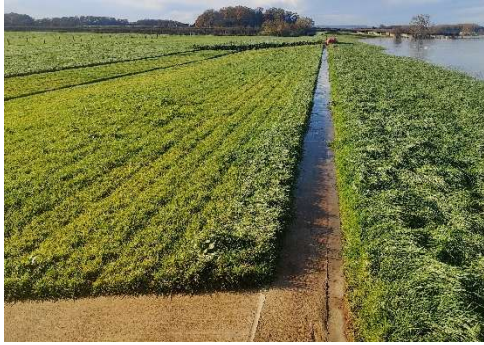
Figure 6. Isle Spillway reinforced with Dycel blocks in December 2025.

Due to the erosion that had occurred, the Environment Agency decided to consider alternative protection systems to enhance resilience during early life conditions. This was to reduce the risks associated with further overflowing of the spillway and subsequent delays to the project, and risk to MIOS delivery. A Dycel concrete block system was subsequently designed and installed to ensure the spillway could operate reliably prior to grass establishment and enable the MIOS requirement to be met ahead of the 2026 deadline, which would not have been certified with a plain grass cover until it had established.

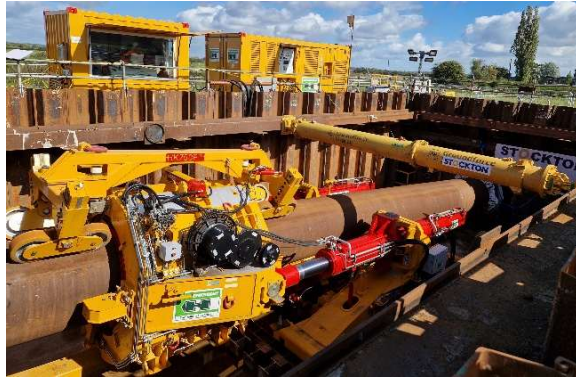
Figure 8. Pipe thruster

The siphon pipe was designed as 2 no. 220m long 1.4m dia. steel pipes tunnelled by direct pipe method under the River Isle. Under this method the pipe is pushed through the ground by a pipe thruster and a micro-tunnel

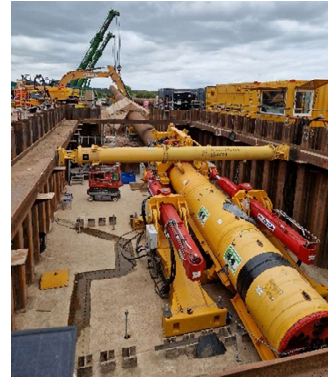
Figure 9. Micro-tunnel boring machine

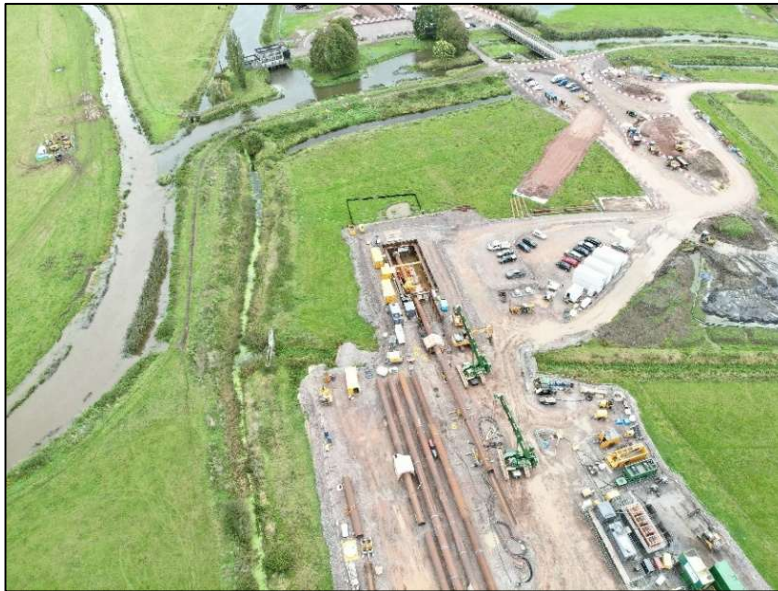
*Figure 11. Temporary works – Pile layout area and plant*

From concept to detailed design, the anticipated scale of the temporary works required grew significantly. For example, when fed into the launch pit the pipe was supported by 2 no. 100t crawler cranes. These cranes in turn required a 1m deep piling mat over the footprint of the pipe laydown area. Additionally, a temporary bridge was installed over the River Isle to allow plant access for recovery of the micro-tunnel boring machine.

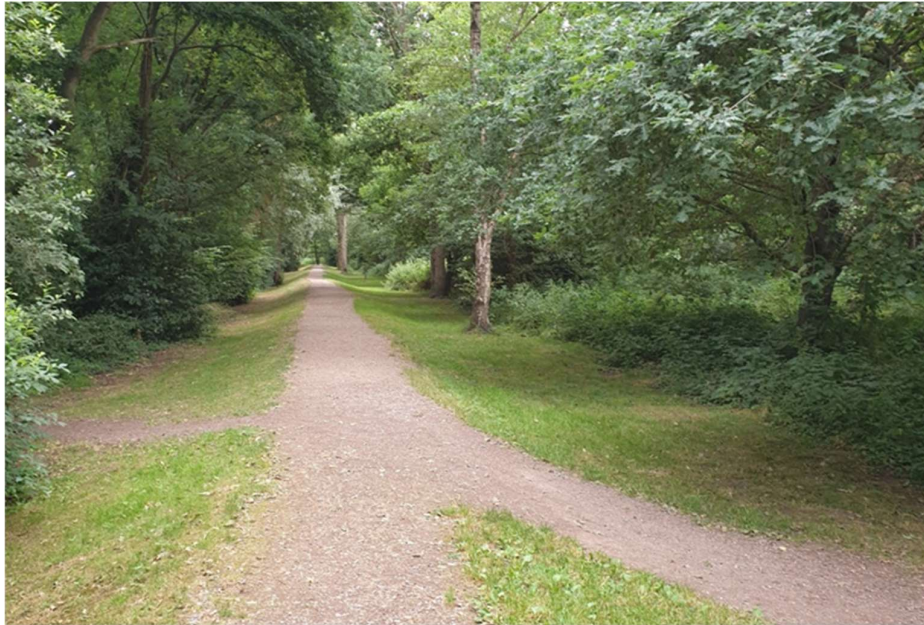
*Figure 1. View of original Cove Brook FSA embankment in public park*

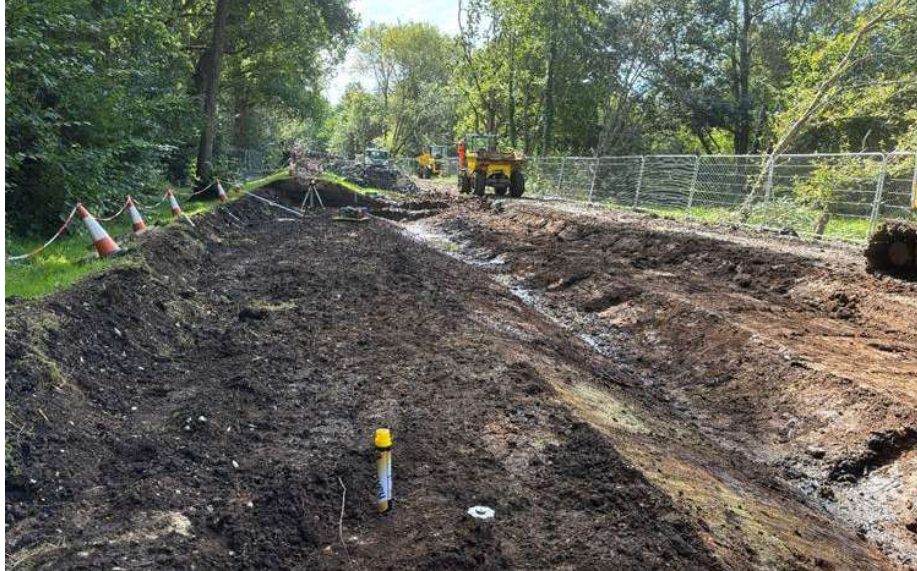
*Figure 4. View of section of old bund (left) and new embankment construction with additional key trench into foundation (right)*

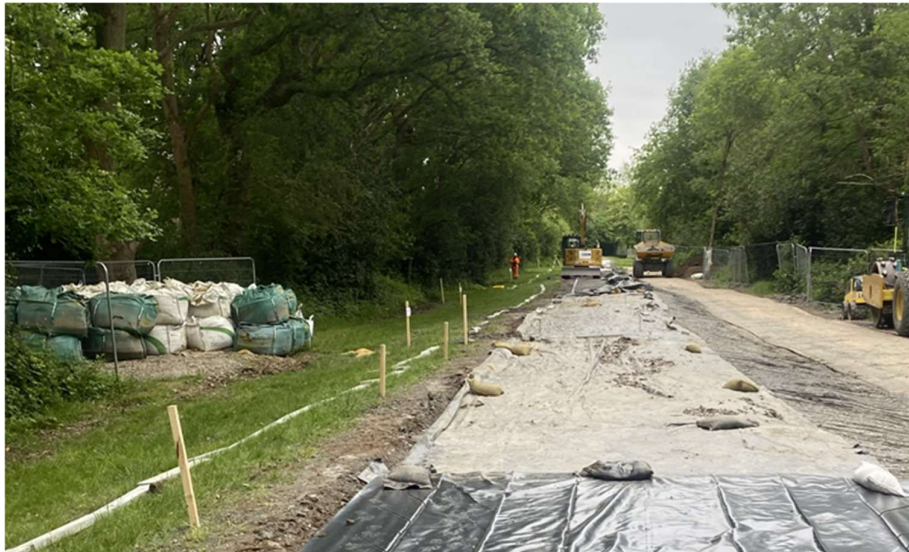
*Figure 5. View of section of work with bulk bags ready for installation*

It is worth adding that temporary flood protection could also be installed at incomplete sections of the embankment over the weekend if weather reports suggested risk of significant rain.

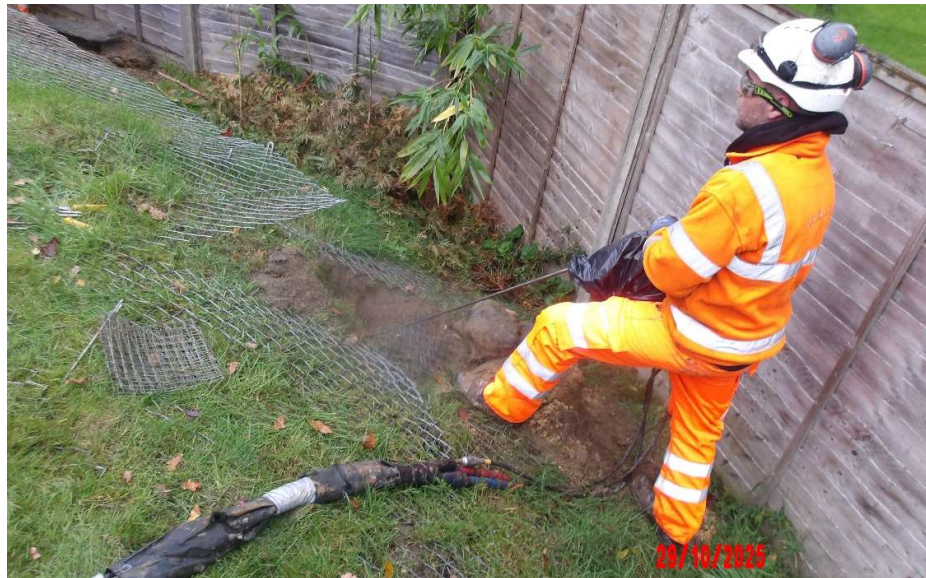
*Figure 6: Pressure injection of resin into centre of sett*

The mesh was locally cut and the clay bags removed to open the entrance points to the sett. To confirm connectivity and better understand the size and shape of the sett, a CCTV camera survey was carried out. With the sett mapped out, the filling process involved injecting warm resin under

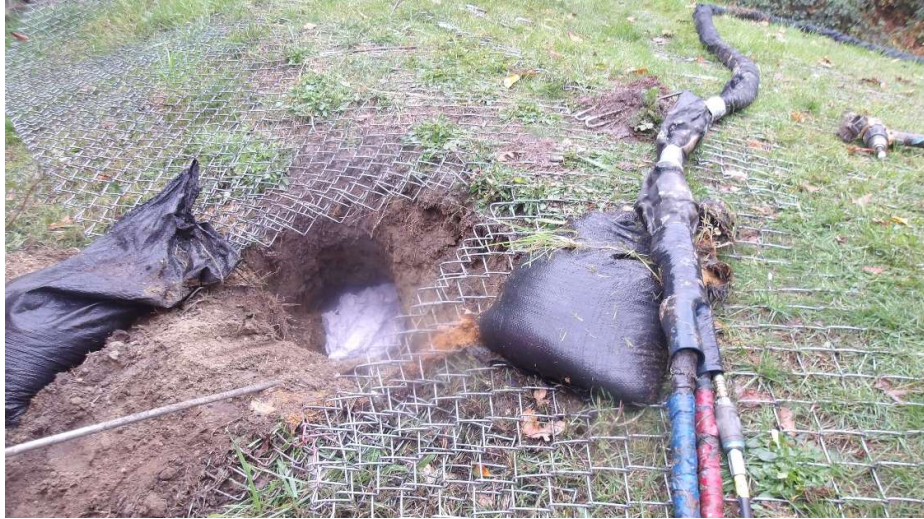
*Figure 7: Resin expanding to fill sett*

A total of 18.5kg of resin, which expands between 10 to 15 times its liquid volume, was injected. This equates to a volume of approximately 0.5m<sup>3</sup>. Resin injection was carried out in one day. The entrances to the burrows were then covered with topsoil and to prevent future burrowing, the entire southern section of the embankment was covered with a badger-proof mesh. The mesh on the surface however presented a safety hazard for the public and grass maintenance due to it being slippery, and therefore a layer of topsoil was added to cover the mesh and allow the existing grass sward to grow through, creating a well-bound surface structure.
