**The Reservoirs Act: Past, Present and Future – Papers**

| Ref | Author(s) | Paper Title |
|---|---|---|
| 1.01 | Blower & Golds | Potential applications of a ground risk management system to reservoir safety under the Reservoirs Act |
| 1.02 | Hughes | The use of site-won and non-standard fill materials in the creation of embankment dams |

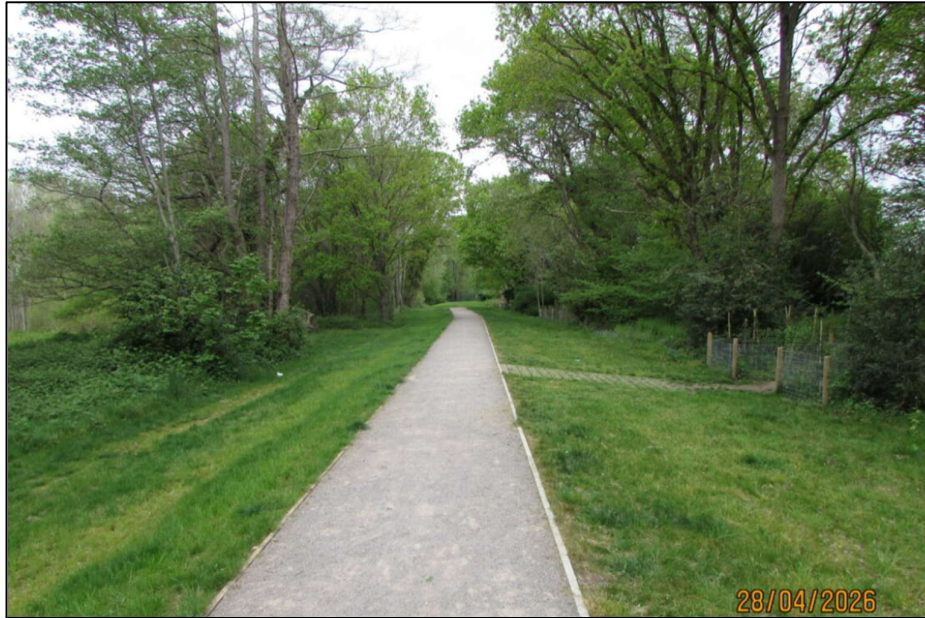
*Figure 6. Emergency spillway embankment upon completion*

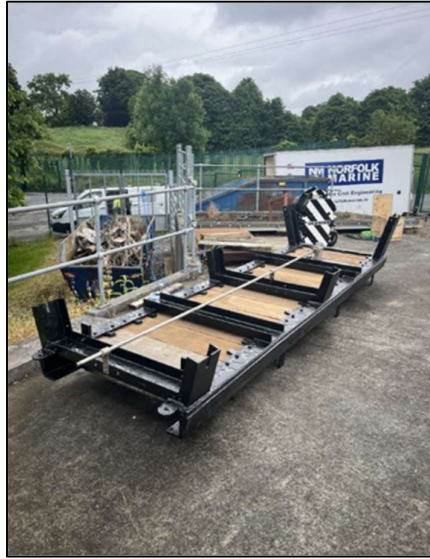
Figure 8: Renovated Limpet Cofferdam On-site Ready for Installation

The above items were actioned by the mechanical contractor and a follow-up inspection of the assembled cofferdam was undertaken prior to the first mobilisation. The completed overhauled cofferdam can be seen in *Figure 8*.

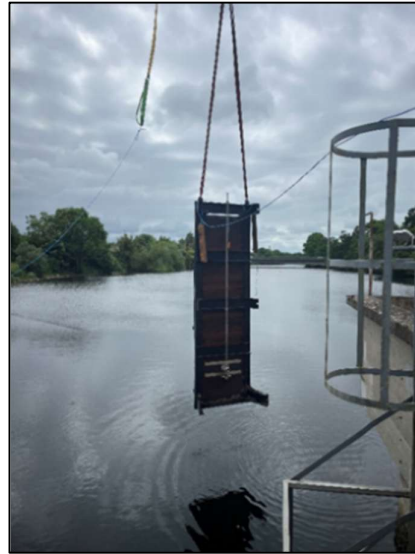
Figure 9: Photo of the Limpet Cofferdam being Lifted into Position for the Diving Contractor

A first attempt to install the cofferdam was undertaken with the diving contractor and crane supplier, see *Figure 9*. This attempt to install the cofferdam reached point 7 in the above sequence when it became clear that there was a gap of 50mm plus between the top seal and the concrete face. The other three sides of the seal between the concrete and the cofferdam were checked, and these seals were found to have a tight fit with the rubber seal in contact with the concrete in all locations.

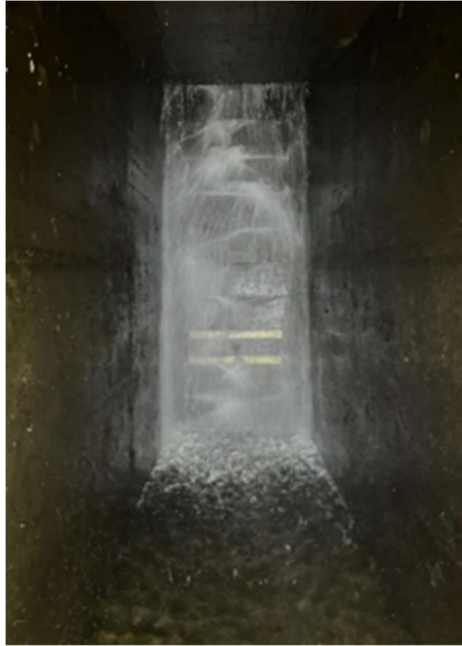
*Figure 13: Downstream Face of the Upstream limpet Cofferdam*

A visual inspection of the downstream face of the upstream limpet cofferdam was then undertaken by the station, see Figure 13. There was leakage from between the timbers and between the steel flanges and the timbers. Given that the cofferdam was retaining circa 20m of water head, the seal that was obtained was considered good.

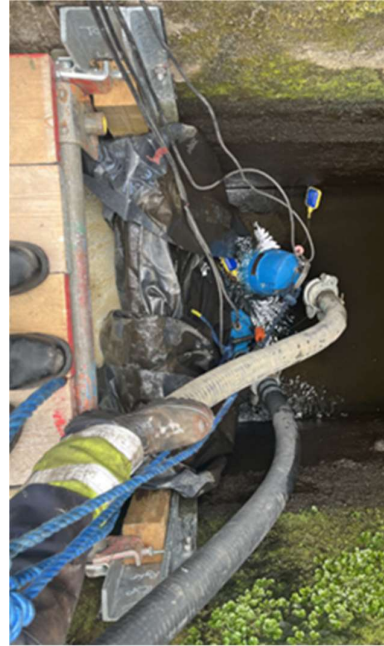
*Figure 14: Installed Downstream Cofferdam with Pumps*

Following installation of the downstream cofferdam the scour culvert was pumped out to observe the leakage occurring from the upstream limpet cofferdam. To clear the area 2 No. submersible pumps (capacity of 1800l/min) were required (Figure 14). The pumps were only turned on periodically when access to the culvert was required. Once turned on the effectiveness of the pumps reduced over time due to debris clogging up the intake of the pumps. When the pumps were turned off, the space filled up to the top of the downstream temporary dam in approximately 30 minutes.

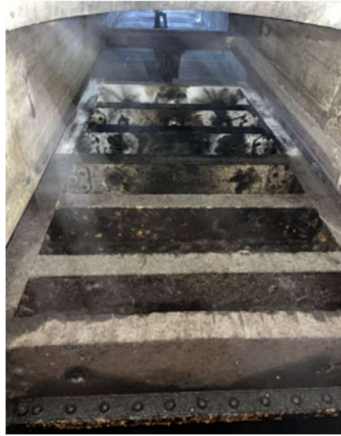
*Figure 15: Scour Gate in Position Prior to Removal*

The scour gate was removed by the mechanical contractor and was taken to their workshop and renovated. See *Figure 15* and *Figure 16* which show the scour gate in-situ and removed ready for transportation. The scour gate was then reinstalled and dry commissioned. The gate was then closed and left

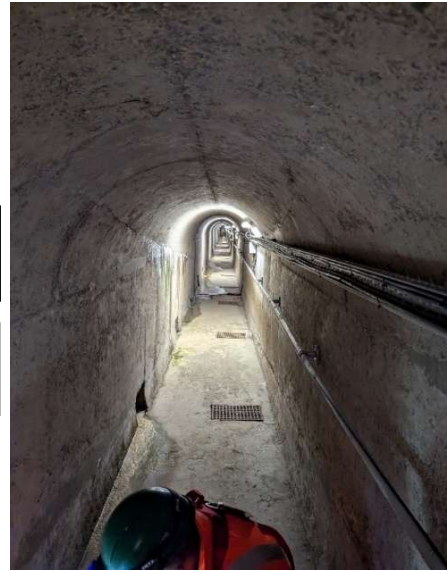
Figure 2. Photograph taken within the eastern drainage gallery

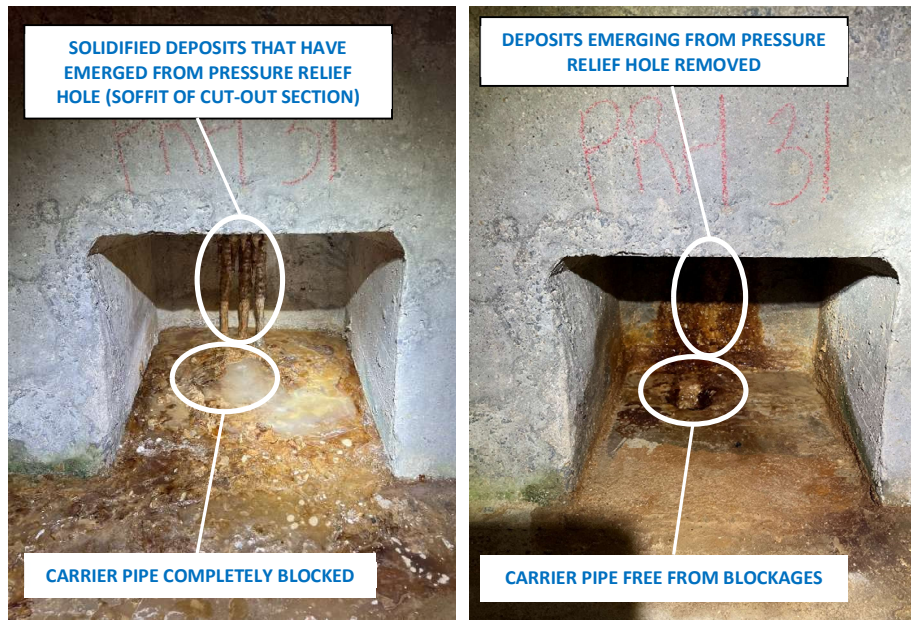
In instances where flow was observed from the pressure relief holes, it was often spilling onto the gallery floor rather being captured by the carrier pipe. On the right, Figure 5 shows the same pressure relief hole following cleaning. All solidified calcium carbonate deposits were removed and the inlet to the carrier drain is now visible. Following the removal of blockages from the pressure relief holes, the sub-contractor noted that frequently an immediate release of water followed, demonstrating it was necessary to free the system from deposits.

Figure 4. An example of a blocked pressure relief hole prior to cleaning works.

Figure 5. An example of a pressure relief hole after cleaning.

Within the pressure relief system, calcium carbonate and other salts naturally leached from the concrete have gradually accumulated over many decades. Due to the physical access and confined space constraints preventing effective cleaning through maintenance, the mineral deposits had accumulated to a level in which parts of the system had become partially or fully obstructed, reducing system functionality. From Figure 4 below, solidified mineral deposits can be seen extending beneath the inlet to the vertical pressure relief hole (accessed on the soffit of the concrete cut-out section). In addition, the inlet to the carrier pipe was not visible at all.

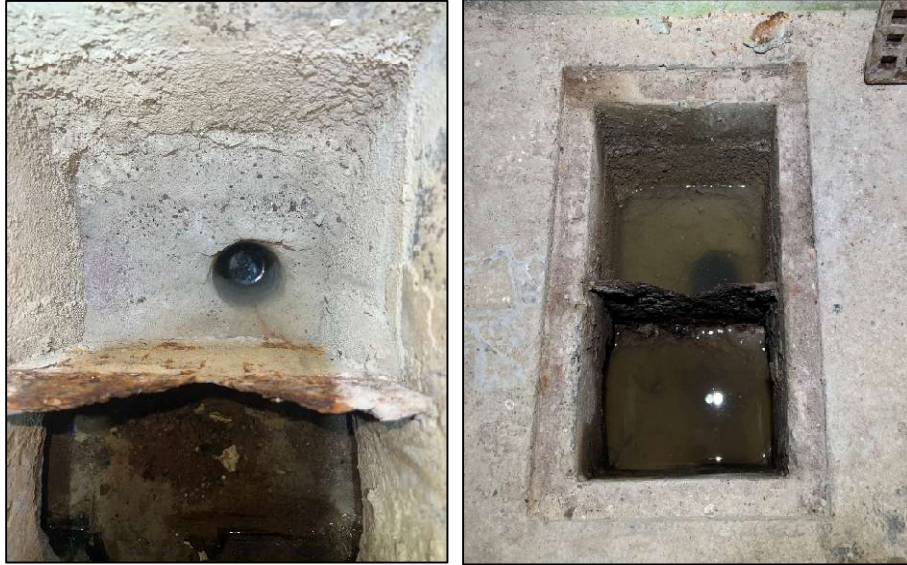
Analysis of the post cleaning flow surveys indicates an increase in the standing water levels of the relief drains, potentially indicating that historic blockages have been removed across these drains, allowing the system to operate as designed. An example of this can be seen in Figure 8 below.

*Figure 8. Relief drain No.40 prior to cleaning (left) and post cleaning (right)*

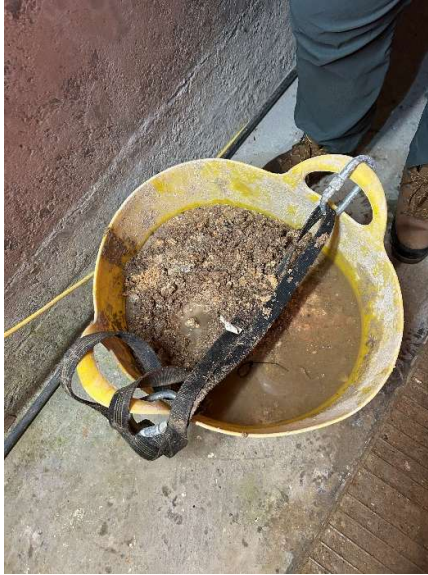
Strict environmental screening measures were implemented during the cleaning operations to capture debris and prevent contamination of the downstream watercourse. Using dry vacs and subsequently jetting, all waste materials were collected and appropriately disposed of off-site, ensuring no pollution entered the River Tees. Figures 9 and 10 below show an example of the waste generated during the cleaning works.

*Figure 9. Example of solids removed from the drainage system*

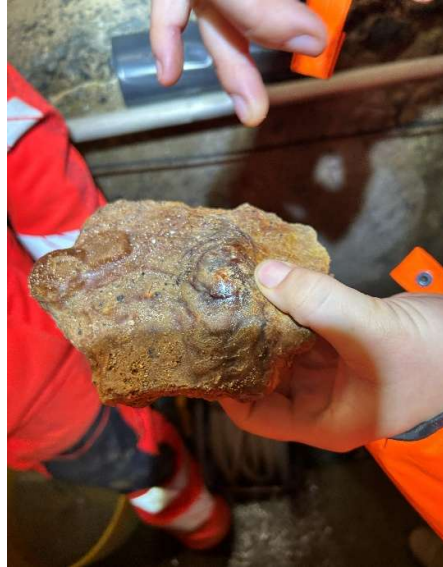
*Figure 10. Example of hardened mineral deposits removed during the cleaning exercise*

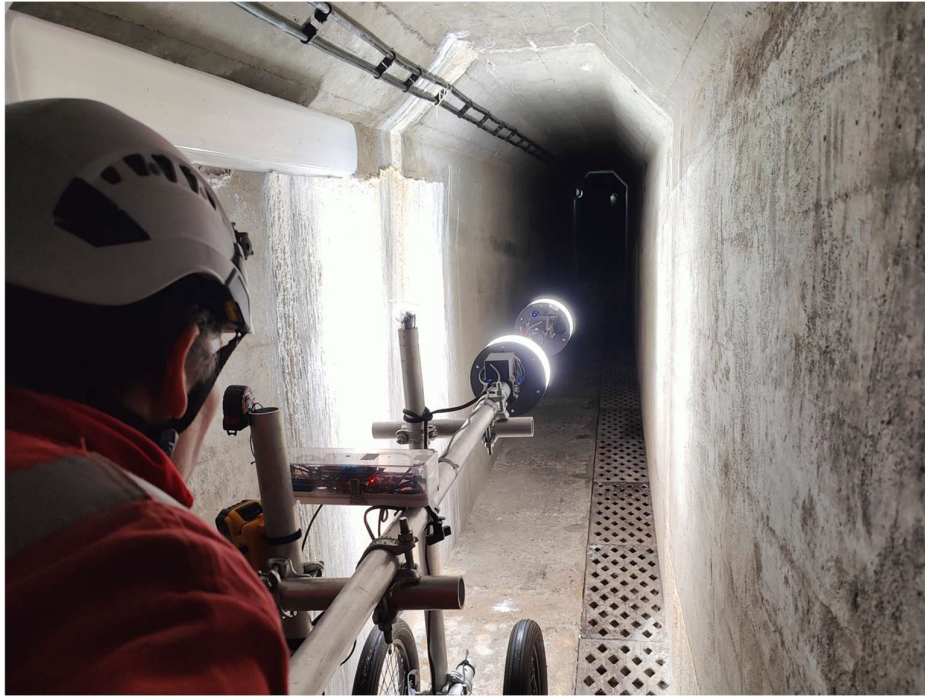
The vehicle was manually propelled through the galleries at a controlled speed. Local variations in floor level and construction tolerances required the survey to be undertaken more slowly than originally planned; however, complete photographic coverage of both the upstream and downstream galleries was successfully achieved.

*Figure 3. Gallery Survey Vehicle*

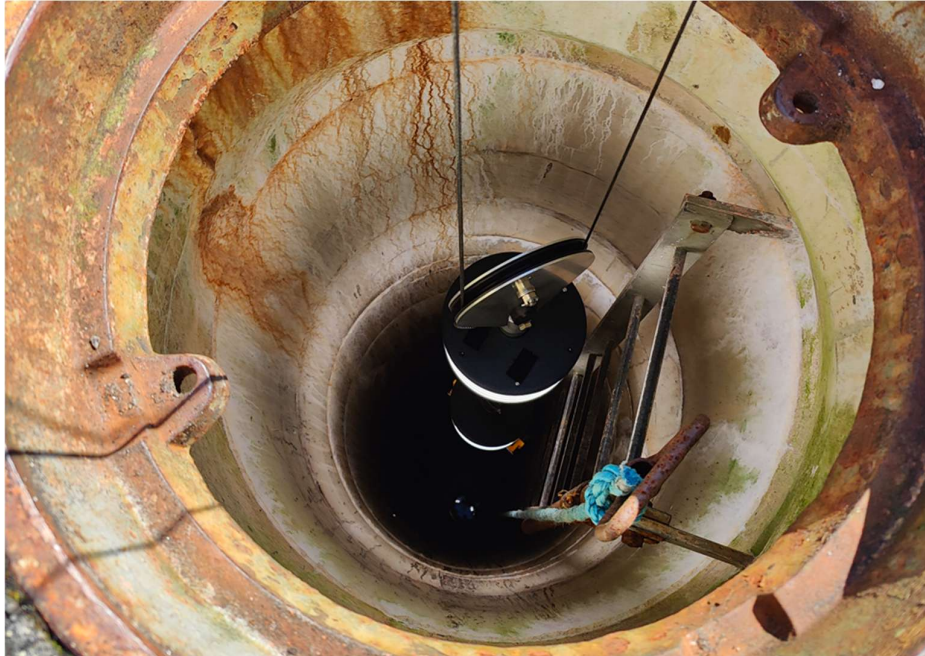
The access shafts were surveyed using a separate deployment system based upon the same camera and lighting arrangement (Figure 4). The adopted solution consisted of a man access tripod with pulley positioned over each shaft opening, allowing the camera platform to be lowered vertically through the structure in a controlled manner via a slow winch.

The shaft surveys required a stable vertical deployment to minimise rotation and maintain image quality. The camera platform was therefore lowered at a controlled speed to provide sufficient overlap between successive frames and ensure complete photographic coverage of the shaft walls. The integrated lighting system provided consistent illumination throughout the shaft depth, avoiding many of the exposure challenges typically encountered when collecting imagery in deep confined spaces. The pulley system was designed to minimise rotation of the platform on descent and ascent.

Figure 4. Shaft survey vehicle

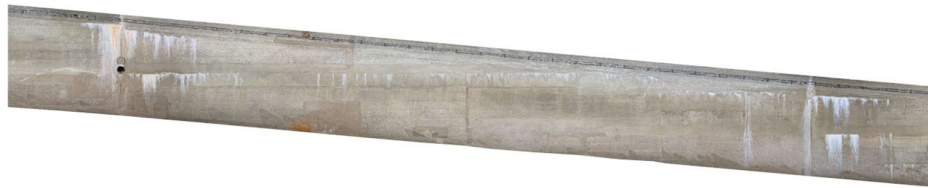
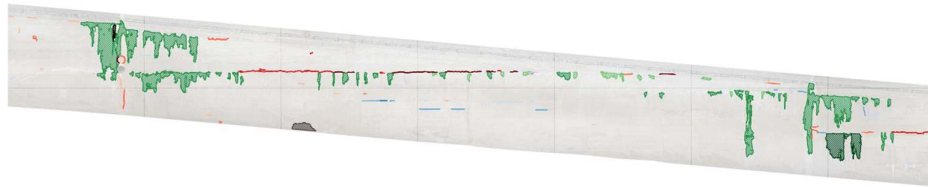
While the system was not configured to directly measure crack widths, the mapped geometry of identified defects provides a repeatable baseline against which future surveys can be compared. Changes in crack extent, continuity, associated calcite deposition and staining patterns can all be assessed through comparison of successive datasets. In addition, changes in the strength and spatial extent of AI detections may provide indirect evidence of changing defect characteristics. For example, while sub-pixel changes in crack width cannot be measured directly, an increase in the consistency or extent of crack detections between surveys may indicate widening or progression of an existing feature. Such observations would not constitute a measurement in themselves, but could be used to highlight areas requiring further engineering review.

*Figure 5. Example of orthomosaic image and identified defects at Block 41.*

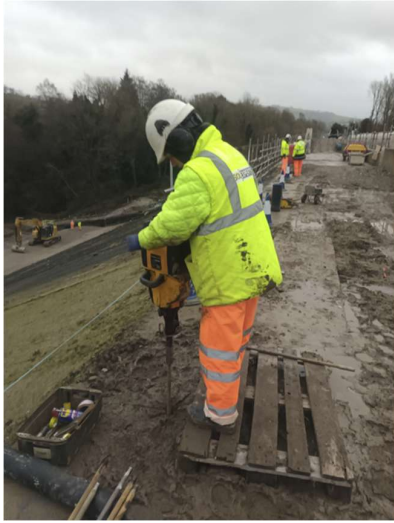
*Figure 5a Ramming of a temperature sounding steel tube at Toddbrook Reservoir*

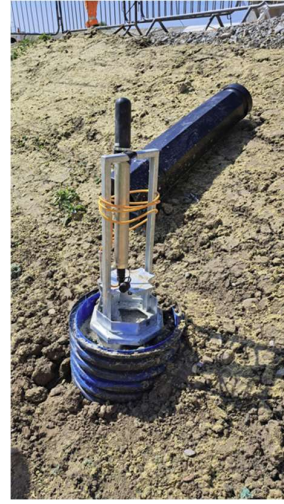
*Figure 5b Data Logger stored in a telemetry pillar*

At the time of writing this paper, temperature measurements from all soundings are recorded at 10-minute intervals. The data are currently uploaded every 12 hours, although the upload frequency can easily be increased if required. Each logger transmits its data independently via a mobile data connection to a central server, where the data are processed and visualised automatically.

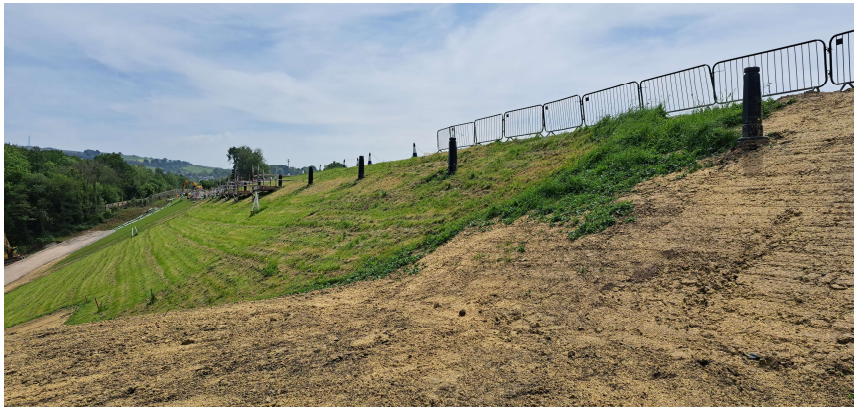
*Figure 5c Several temperature soundings, covered by telemetry pillars, along the downstream side of the dam crest*

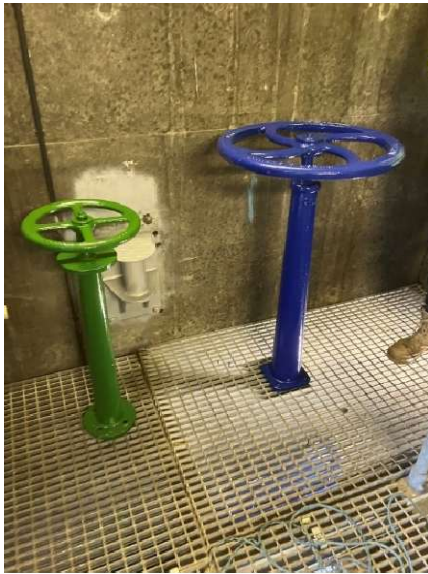
Figure 2. Painted Valve work in Valve Chamber

Several measures were introduced to achieve this; access ladders were upgraded to non-slip designs to improve health and safety during entry, while column markers were installed within each cell to support future inspections. These simple, low-cost additions significantly improve navigability within large, repetitive internal layouts where orientation can be challenging even with drawings. Pipework painting was also standardised to facilitate ease of asset identification; red for inlet arrangements, blue for outlet and green for scour and overflow.

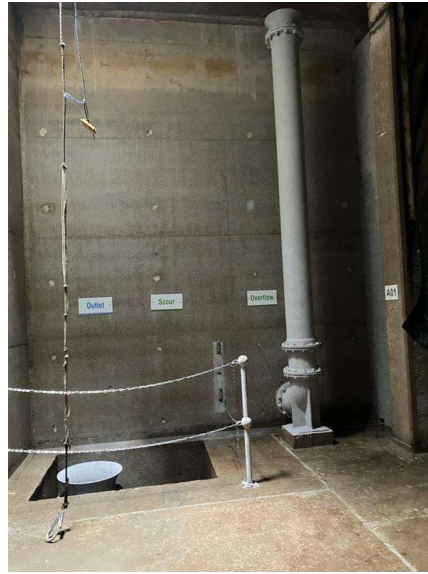
Figure 3. Internal Pipework Painting and Signage including Column Markers

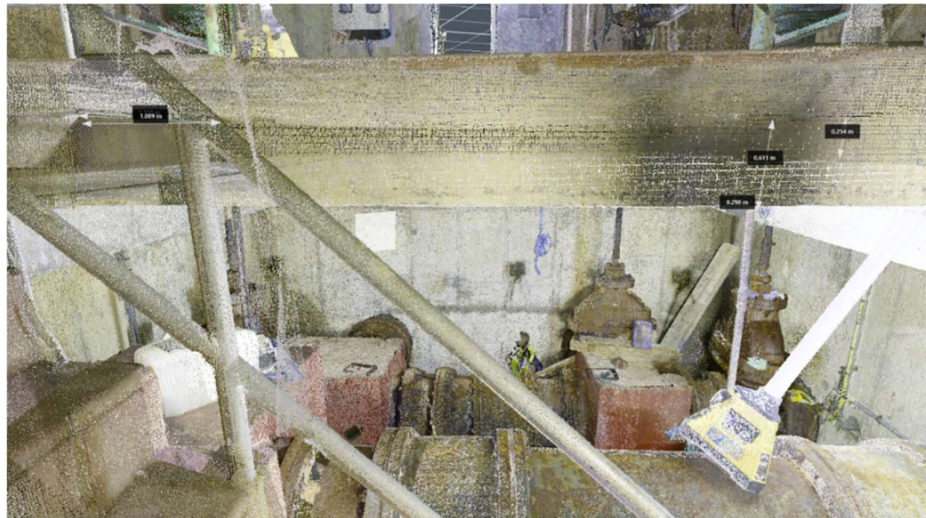
*Figure 7. 3D Laser Scan*

3D laser scans of the valve chambers were conducted to capture precise geometry and identify spatial constraints, with the proposed pipework layouts modelled in Revit software to understand constructability issues and confirm compatibility with existing assets, supplemented by site visits and early engagement with the contractor. This collaborative approach was essential, given the confined nature of the chambers, where manoeuvring pipework and fittings is challenging and weight limits must be carefully managed.

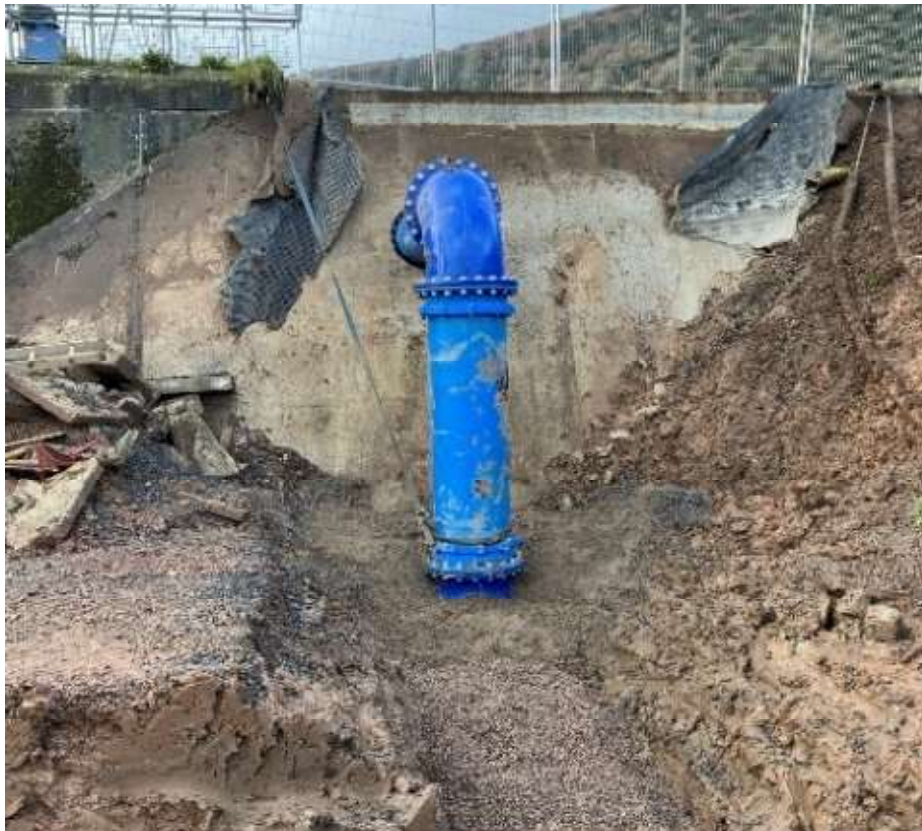
*Figure 8. External Overflow Installation*

Two of the four sites were designed with all additional overflow pipework located within the valve chamber, while the remaining two required external routing to connect to the existing scour pipework. The internal solutions eliminated the need for excavation but demanded meticulous planning for installation in confined spaces. In contrast, the external solutions provided more physical space but introduced additional challenges, such as excavation near the reservoir structure, managing unrecorded buried utilities, and ensuring embankment stability. During the installation of the first external overflow, excavation uncovered an unrecorded pipe at the proposed connection point to the downstream scour system, requiring swift redesign of the downstream alignment to prevent delays and maintain operational supply. The importance of effective and timely communication among the contractor, designer, and site operatives was highlighted to facilitate resolution, enabling timely procurement of materials and allowing work to proceed without significant disruption.

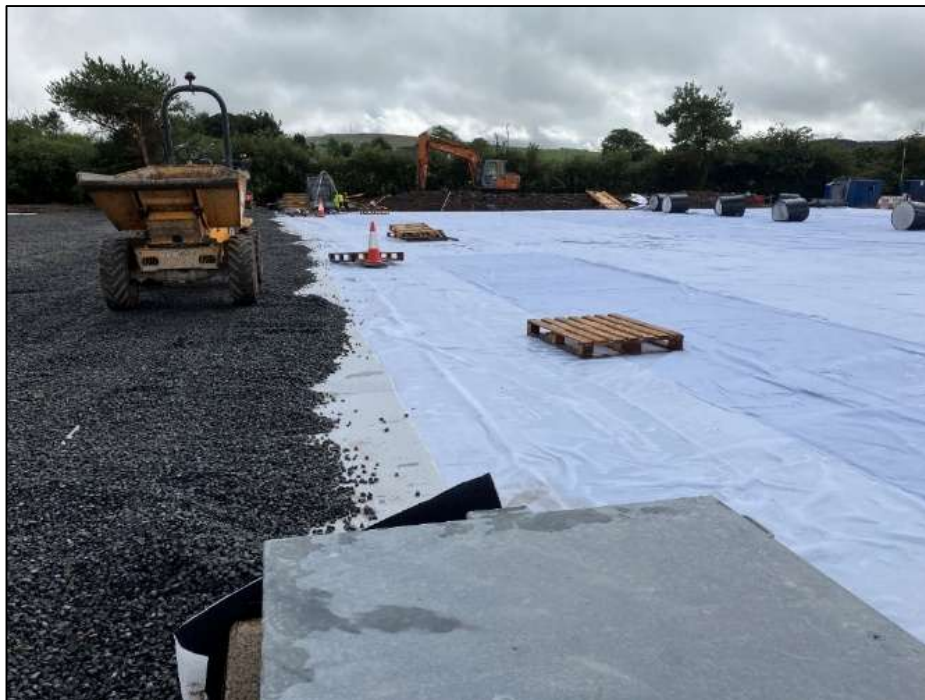
*Figure 9. Membrane Installation*

The new waterproofing system comprised an impermeable membrane, a protective layer, and a drainage membrane, followed by the reinstatement of stone and topsoil as shown in Figure 9. New drainage was also installed around the perimeter of each roof to minimise the risk of infiltration into the reservoir structure.

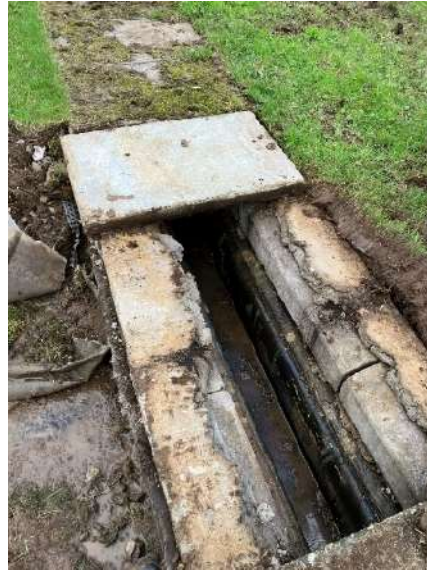
*Figure 11. Exposed Central Roof Trough*

At several sites, stripping the roof overburden exposed degraded membranes, failed bandages, and previously unrecorded elements such as the central roof trough. These findings required close collaboration among the project team to efficiently implement suitable solutions.

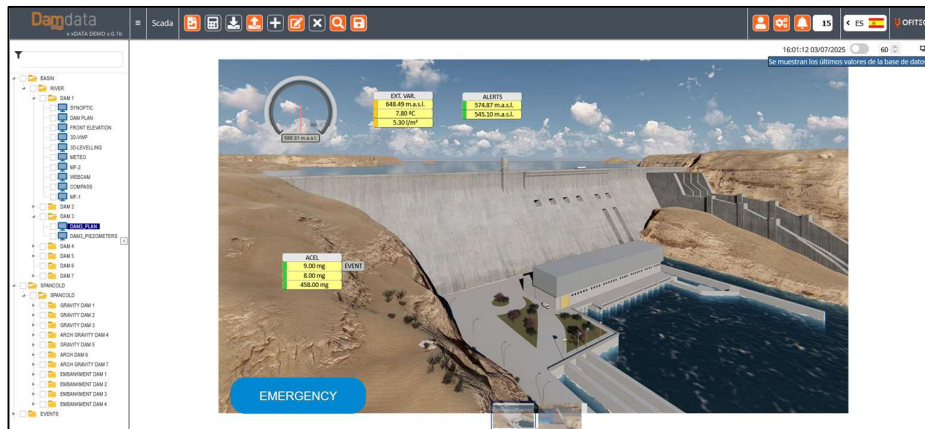
Figure 2. Example of dashboard

The dashboard (see figure 2) summarises information in a visual way and displays sensor readings superimposed on drawings or images. Users can create or modify dashboards by combining external content with elements stored in the system database.

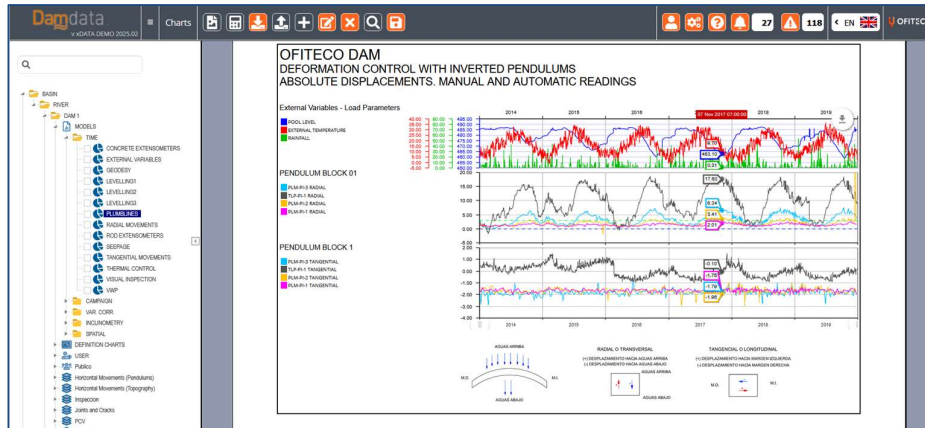
Figure 3: Example of the report layout

The system allows the setup and storage of individualised multivariable charts and report layouts (see figure 3) for helping the visualisation and interpretation of data.

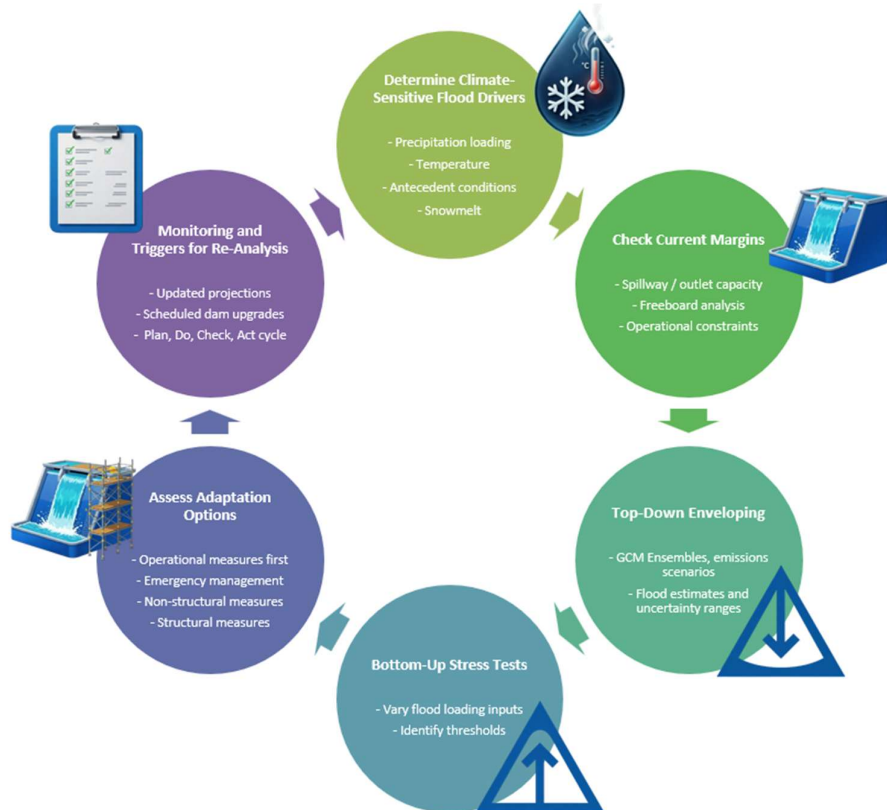
*Figure 2 : Adaptive Management Framework*

The approach is presented in *Figure 2* and in Table 1, along with how the approach aligns with ANCOLD guidance.

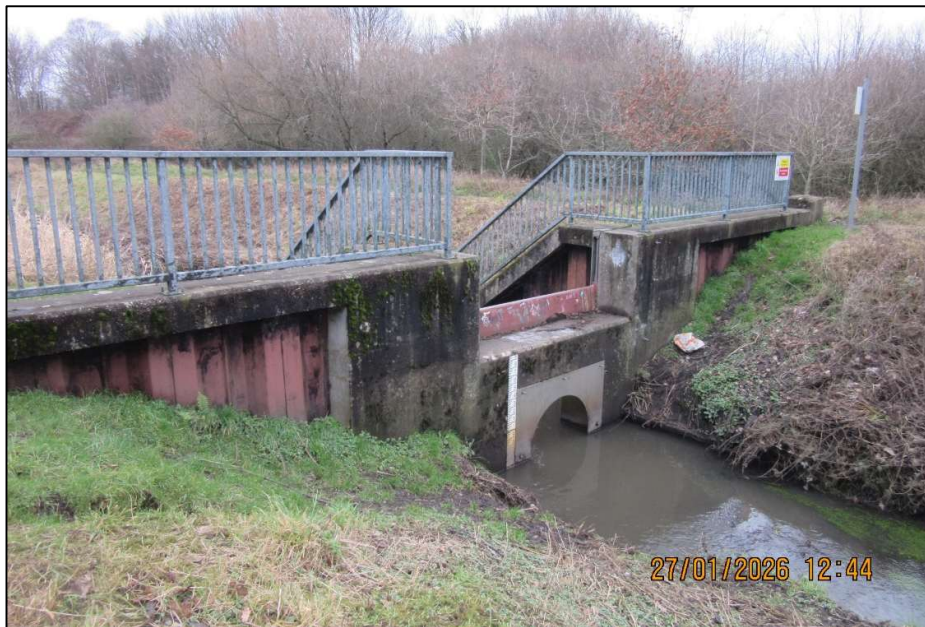
Figure 4. Timperley Brook FSB – In-Channel Control Structure (MM, 2026)

The in-channel control structure is of sheet-pile and reinforced concrete construction (Figure 4). The primary flow control is a 1350mm diameter orifice plate. Above this, a variable height weir controls the water level rise within the upstream watercourse and, as a result, inflows to the storage compartments. The Undertaker stated that the equipment for operating the weir was no longer available and, thus, its position was now effectively fixed.

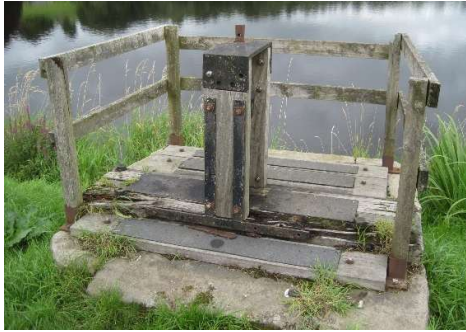
*Figure 4 – Slipper Hill upstream masonry wetwell at low level outlet*

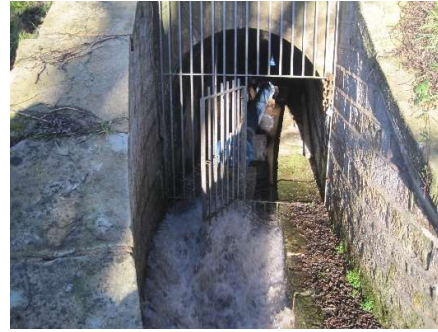
*Figure 5 – Slipper Hill downstream masonry portal at low level outlet*

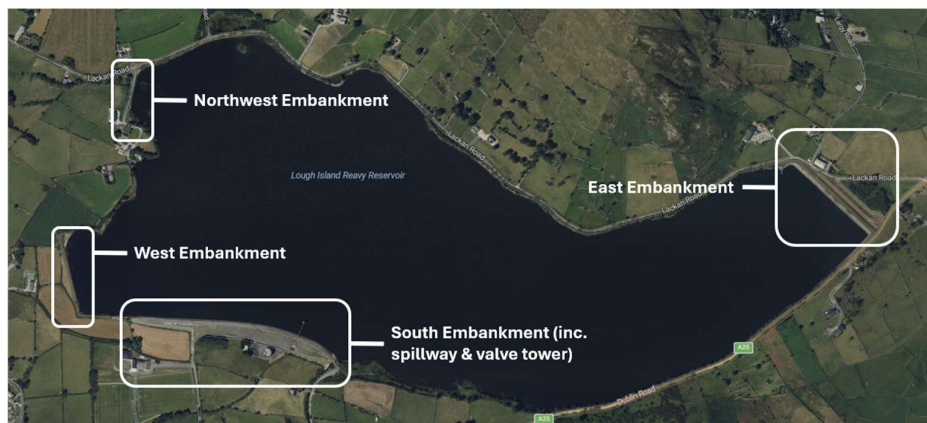
The reservoir comprises four earth embankments (South, East, West and Northwest) with a maximum height of 12.5 m, and a precast concrete wave wall along the East embankment crest. Downstream slopes were originally 2:1 to 6.1m below crest, flattening to 2.5:1, with rockfill berms later added to the South and East embankments. Upstream slopes are 2.5:1 to 6.1m below crest, flattening to 3.0:1. The overflow, located close to the toe of the South embankment, consists of a 19m straight concrete weir discharging to a 4.5m wide masonry channel. The valve tower houses three 450mm draw-off valves and one 450mm scour valve; the draw-off valves feed a 600mm outlet supply pipe. Outlet pipework runs in a culvert from the tower base to the outlet chamber at the downstream toe of the South embankment. The reservoir arrangements are summarised in Figure 2.

Figure 2. Reservoir Arrangement (Map Source: Bing Maps)

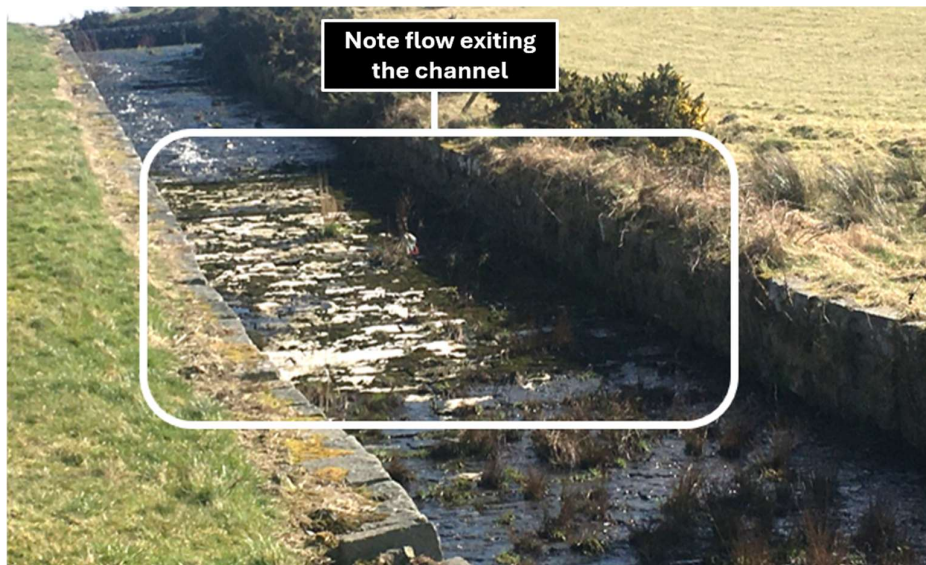
The masonry spillway channel has deteriorated significantly over time, with substantial voids beneath the floor and behind the side walls. This has caused discharge flows to exit the channel through the base, passing underneath and re-entering downstream. In the 2019 Section 10 Report, Inspecting Engineer Robert Mann made the following recommendation:

Figure 3. Spillway Deterioration

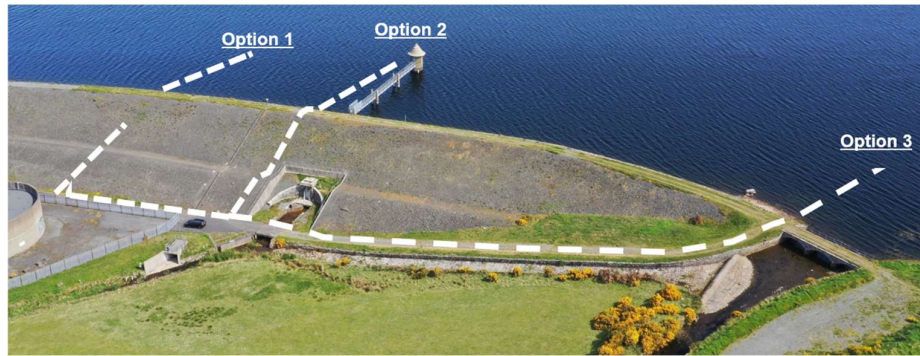
Option 3 was selected, despite being the longest length, to maintain physical separation from the main body of the dam, thereby avoiding new penetrations and minimising the scope and cost of associated support and protection measures. Through the abutment, the pipelines were encased in concrete to control seepage and, as a secondary benefit, provide additional thrust restraint adjacent to the priming chamber.

Figure 6. Siphon Route Optioneering

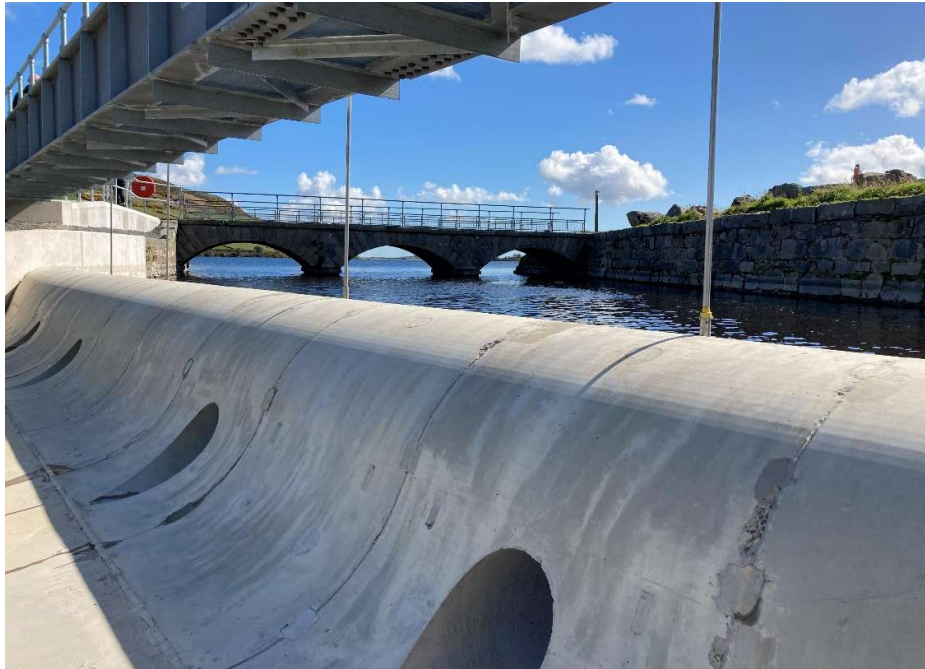
To meet the required rate over the upper operating range of the reservoir, the spillway arrangements were enhanced to incorporate four penstocks in the spillway as shown in Figure 7, with the solution developed through a structured value engineering process.

*Figure 7. Spillweir Penstocks*

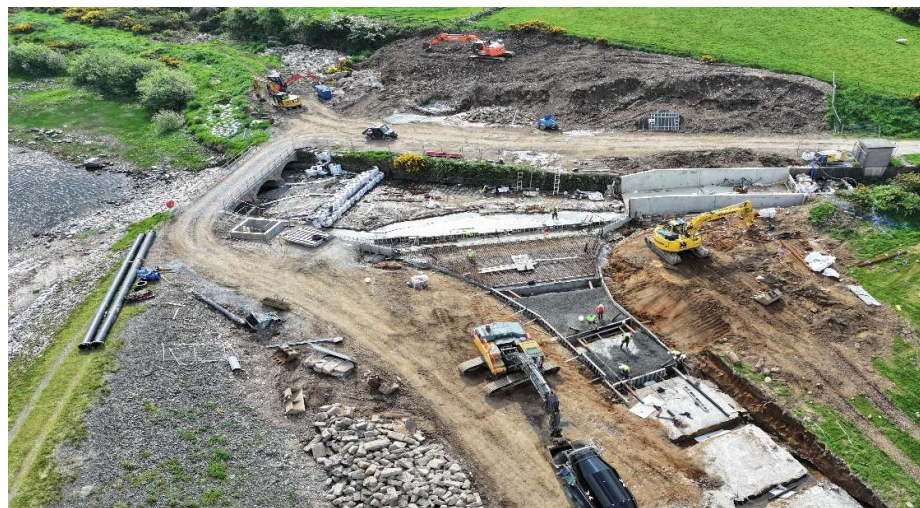
**Spillway Construction:** Another critical safety consideration during the construction phase was the sequencing of the spillway construction to limit the length of exposed foundation to a maximum of 12 m, corresponding to two spillway invert bays. The construction sequence included the following steps; (1) excavating the existing channel to the foundation level; (2) preparing the foundation; (3) installing a no-fines concrete underlayer and drainage pipework to enhance drainage and mitigate uplift pressures; and finally (4) constructing the structural components of the spillway, in a phased manner, with construction squads working in tandem as illustrated in Figure 9.

*Figure 9. Phased Spillway Construction*

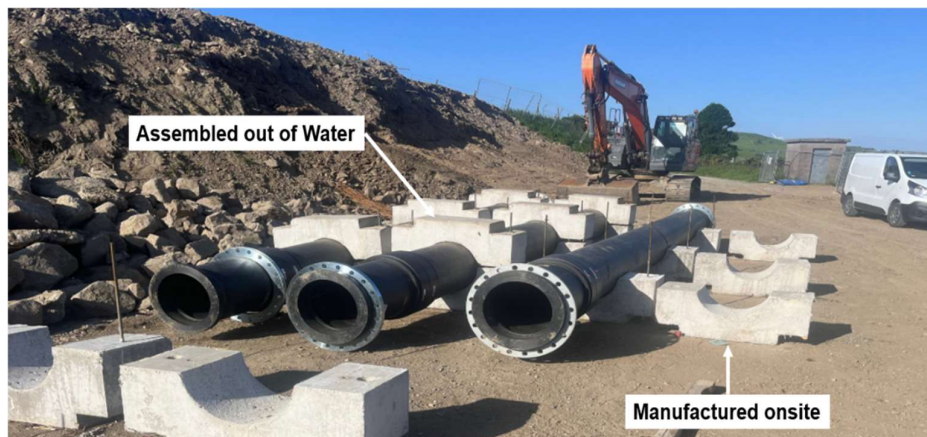
**Siphon Installation:** The installation of the upstream leg of the siphon and its downstream connections were undertaken on completion of the spillway channel works. Engineering divers conducted the underwater installation of intake structures and associated screens. To expedite the installation process, the pipework and anchor blocks were connected on dry land, as shown in Figure 10, and then lifted into the reservoir using airbag support.

*Figure 10. Siphon Pipe Preparation*

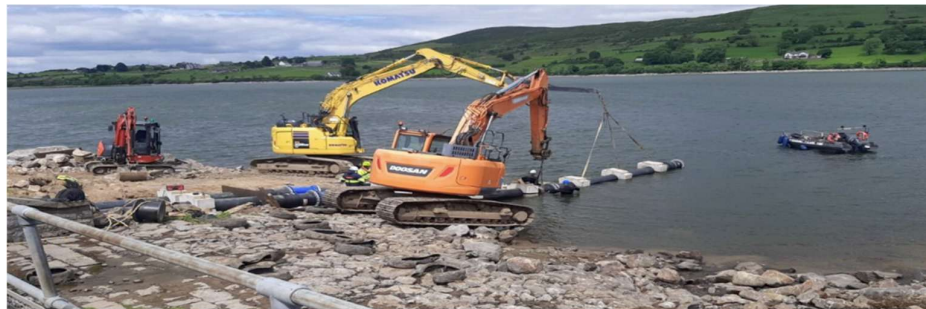
Once in position, the airbags were deflated, allowing the pipework to be lowered to the bed in a controlled manner as shown in Figure 11. Underwater inspections and pressure testing were performed to verify the functionality of the twin siphon pipework.

*Figure 11. Siphon Pipe Installation*

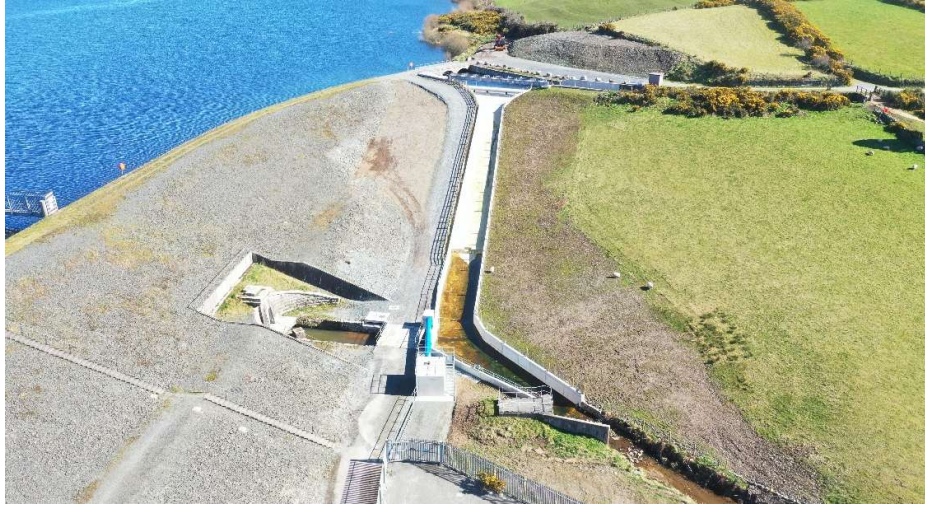
channel under a range of flow conditions. All elements performed as expected, with the completed scheme shown in Figure 12.

Figure 12. Completed Scheme

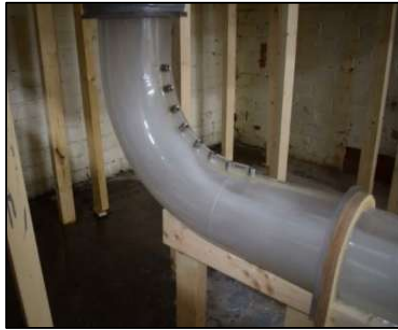
Physical modelling results for both spillways were used to create rating curves for a flood study (as well as to review measured pressures at the 90-degree bend) which showed that at the peak of the PMF the flow split is approximately 290m<sup>3</sup>/s via the existing drop shaft and 230m<sup>3</sup>/s through the new auxiliary spillway. The PMF could now be safely passed with the proposed new arrangement.

Figure 5. Existing spillway physical model (90-degree bend)

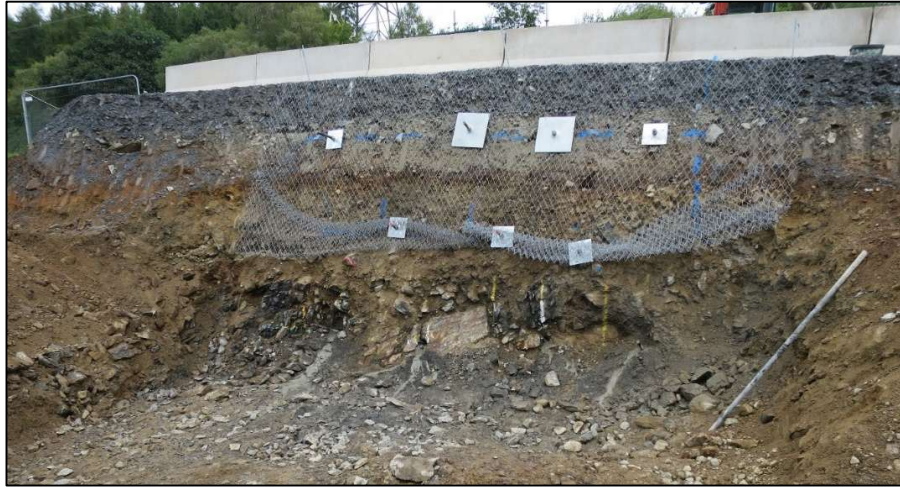
The design was subsequently optimised through collaboration with the installation subcontractor (Colin Jones Rock Engineering Ltd). The trial compared on-site ground conditions with those modelled and the suitability of different nail types resulting in: a change to 25mm hollow bar nails; removal of shotcrete facing that was replaced with Geobrugg's Tecco flexible mesh facing system with smaller P33 spike plates, each weighing 2kg and; a reduction in the total number and length of soil nails. The fully excavated trial panel is shown in Figure 10 below.

*Figure 10. Soil nail trial panel*

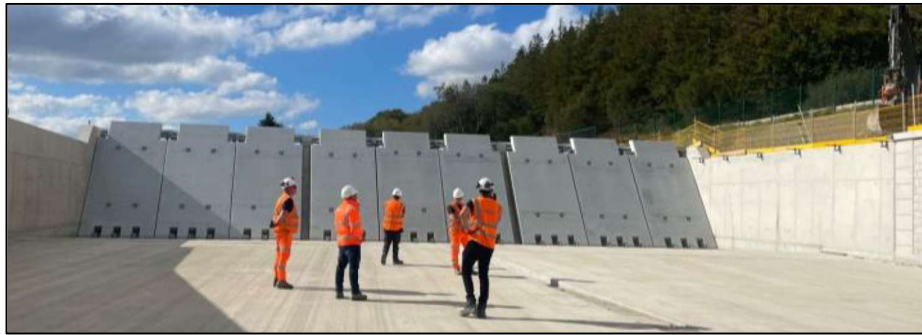
*Figure 13. Tipping gates viewed from downstream*

The new 33m-wide, 4m-high (maxima) auxiliary spillway has been designed to convey flood events up to the PMF but will only operate in return periods in excess of 10,000 years as mentioned previously. A UK-first installation of reinforced concrete tipping gates with an inclined length in excess of 6m reduced the spillway and weir length by approximately 70%, improving hydraulic performance and delivering major savings. The gates would operate without manual intervention, supporting successful and reliable long-term operation.

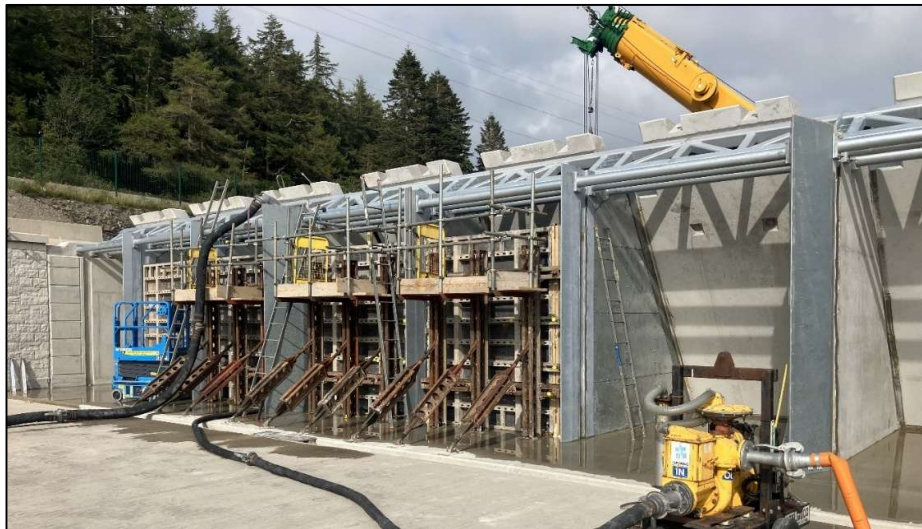
*Figure 14. Tipping gates viewed from upstream during commissioning*

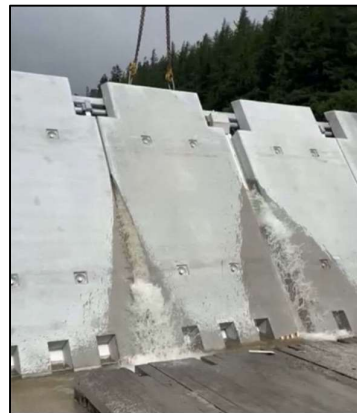
Figure 17. Commissioning the gates: photograph following a small movement away from the supports

Commissioning was successfully carried out by pumping water between a stoplog arrangement and the gates on the upstream side and measuring the depth of water required for the gate to undergo “initial movement” and then “significant leakage”. Once the gate started to move from the truss, and significant leakage occurred, the water level rapidly reduced, and the gate returned to its original position. In the unlikely event that the gate would continue to tip, the crane that was used to install the gates was used to hold the top of the gate as shown in Figure 17 below.

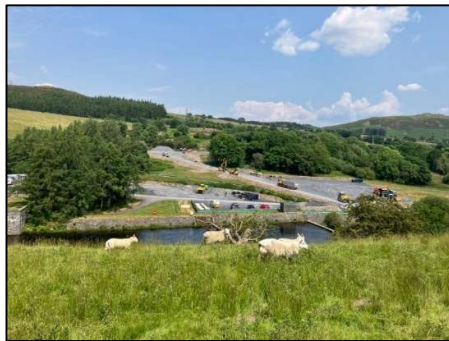
*Figure 18. Enabling works from the hydraulic right side of the valley*

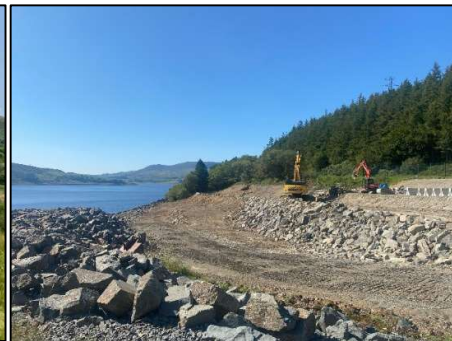
*Figure 19. Enabling works at the new spillway location*

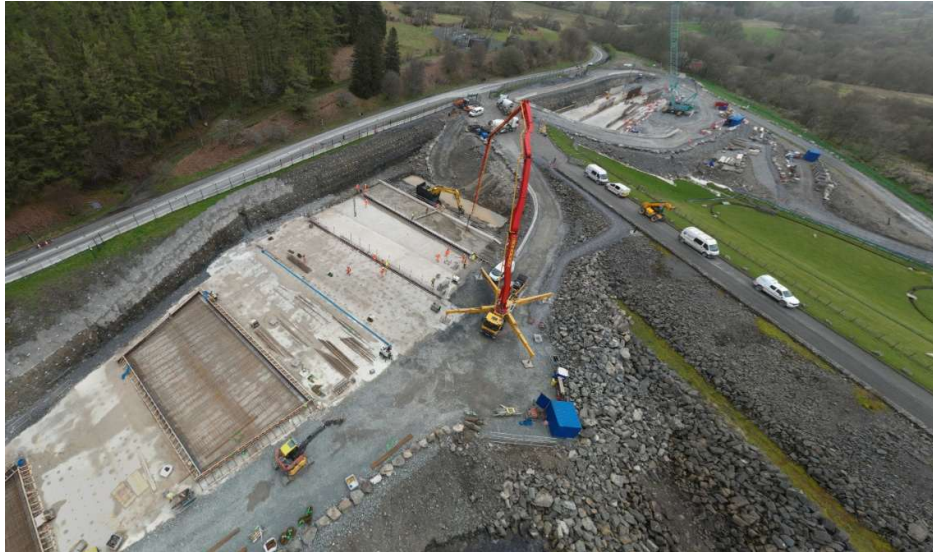
*Figure 21. Reinforced concrete bases under construction upstream and downstream of the dam core*

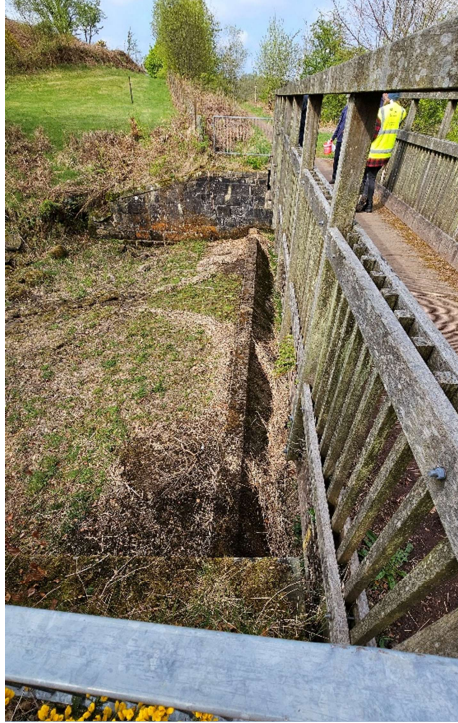
Figure 2. Main Concrete Weir

which allows flows to be released to the canal. The reservoir's original spillway was constructed remote from the embankment through a low spot in the reservoir rim and has a formalised concrete spillweir discharging to a rough rock channel.

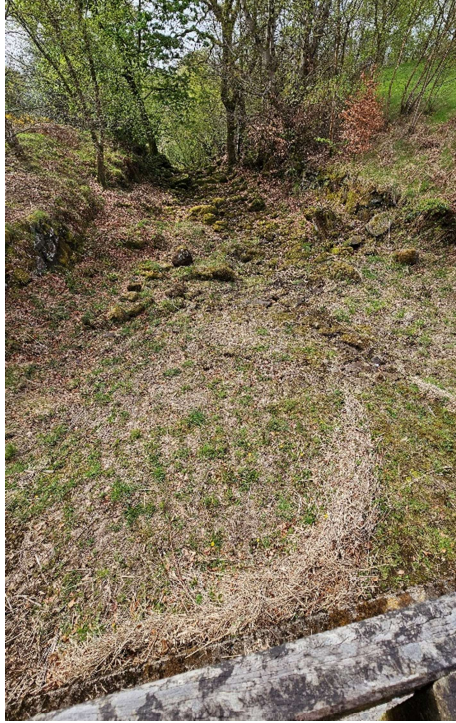
Figure 3. Main Spillway Channel
