**The Reservoirs Act: Past, Present and Future – Papers**

| Ref | Author(s) | Paper Title |
|---|---|---|
| 1.01 | Blower & Golds | Potential applications of a ground risk management system to reservoir safety under the Reservoirs Act |
| 1.02 | Hughes | The use of site-won and non-standard fill materials in the creation of embankment dams |

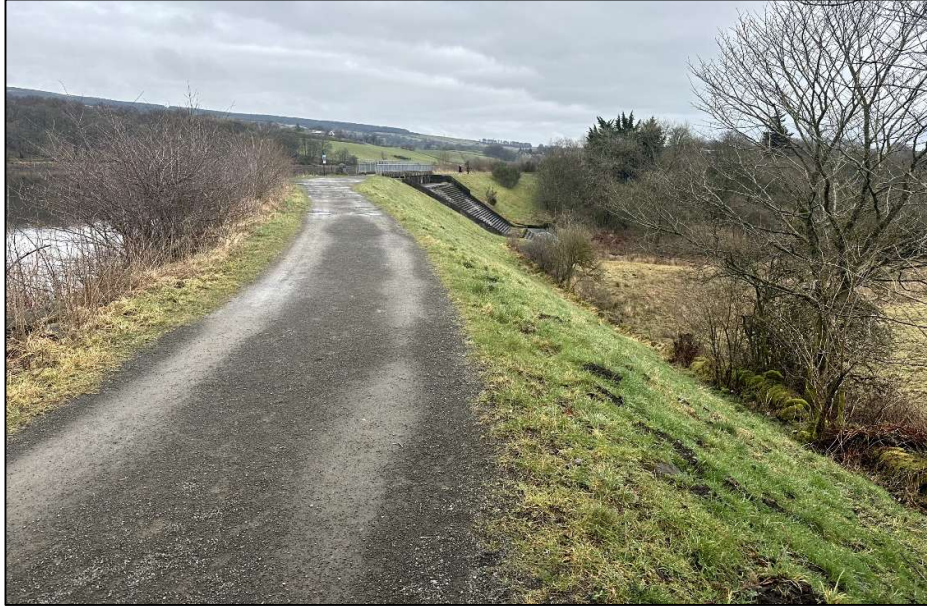
*Figure 5. Crest and Downstream Face of Embankment*

The embankment is fairly typical of the canal reservoirs built at that time, with steep upstream and downstream faces, 1(V):2(H) and 1(V):1.6(H)

respectively and a relatively wide crest of 4.5m. There are no drawings of the embankment, so until recently the internal make-up of the embankment was unknown, but a recent ground investigation has identified a roughly centralised clay core.

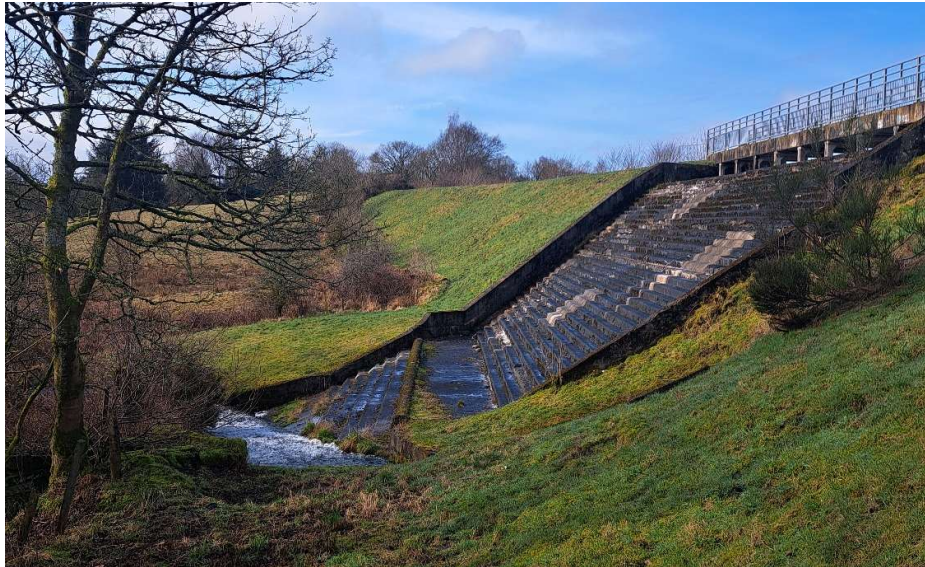
Figure 6. Auxiliary Spillway

In the mid-1930s, in response to the Reservoirs (Safety Provisions) Act 1930, a substantial auxiliary spillway was added to the reservoir. The approximately 27m wide spillweir was constructed within the crest of the embankment, 400mm higher than top water level. Below the spillweir, the spillway was formed from a series of concrete steps leading to the downstream toe of the embankment.

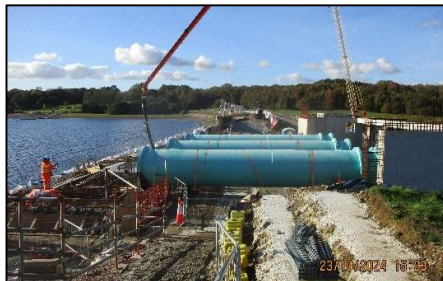
*Figure 2. Installation of pipes through dam, to priming chamber (Oct 2024)*

Construction of the pipes through the crest of the embankment was carried out in autumn/winter 2024 (see Figure 2). To be sure of achieving a fully reinstated dam well ahead of rising reservoir water levels, a design change was instigated where reconstruction of the upstream shoulder was done predominantly with mass concrete to minimise the need for difficult placing and compaction of earthworks materials during the winter months.

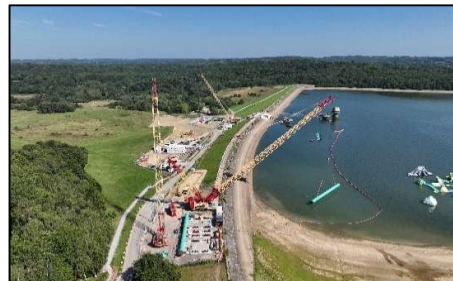
*Figure 3. Lifting and floating of marine side pipes (Aug 2025)*

Marine works to install the pipes on the upstream slope of the dam were carried out during spring and summer 2025 (see Figure 3).

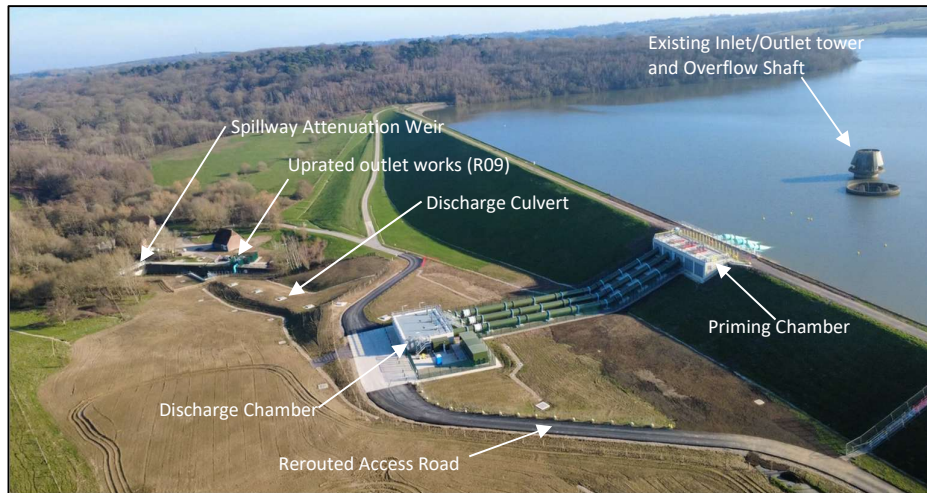
Figure 4: Aerial view of constructed drawdown scheme

Figure 4 shows an aerial view of the constructed siphon works, conveyance system and uprated outlet works. Figure 5 provides a closer view of constructed uprated bottom outlet works (R09).

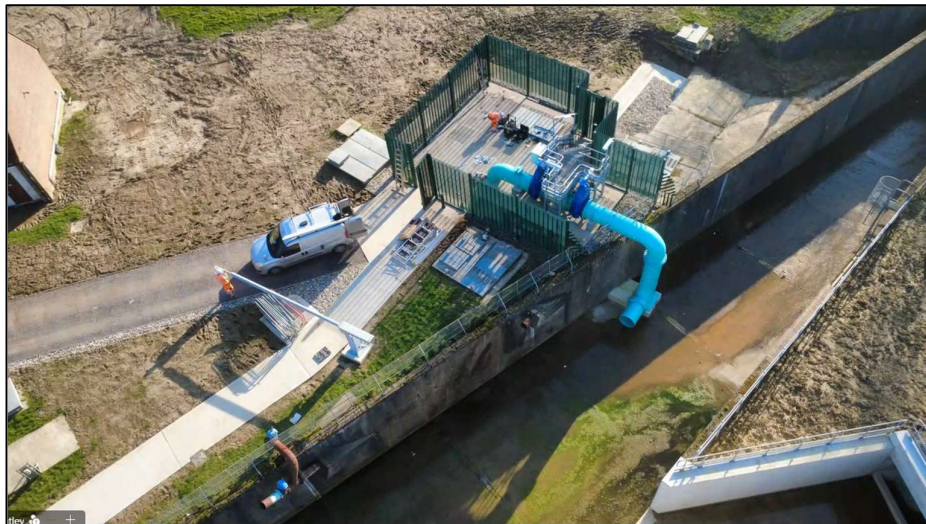
Figure 5: Uprated Outlet works (R09)

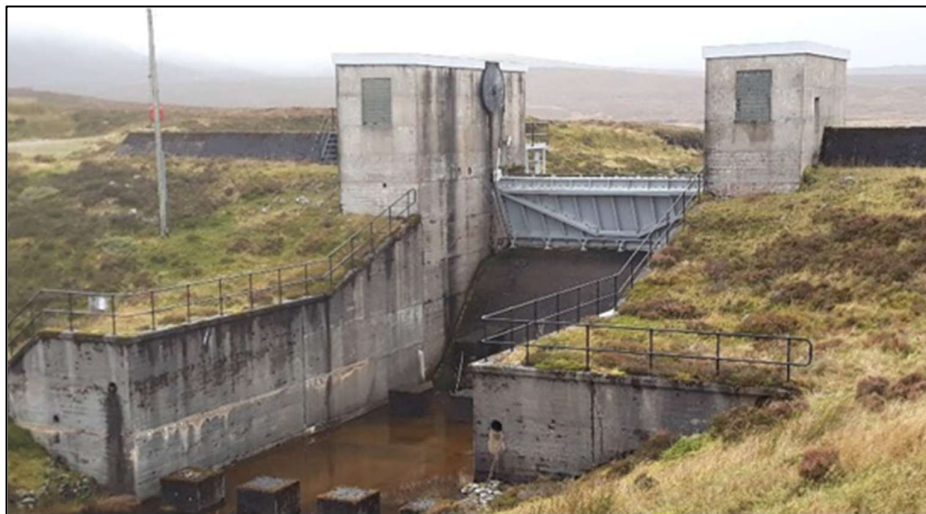
*Figure 1. View of Liath dam and gate from downstream*

The gate is linked to concrete blocks that rise as the reservoir water fills the float chambers with rising water levels, the gate is balanced so the weight of the reservoir water on its upstream face is necessary to open the gate. This makes testing the operation of the gate a notable challenge, as reservoir levels are highly controlled and there are few opportunities for raising the water sufficiently for the gate to open significantly. The development of a satisfactory process for raising water levels in the reservoir and applying a 'pull' to the gate proved elusive. A moderate reservoir rise in January 2022 showed that the gate did operate, but the measurements of the gate movements provided by the instrumentation did not match the expected travel.

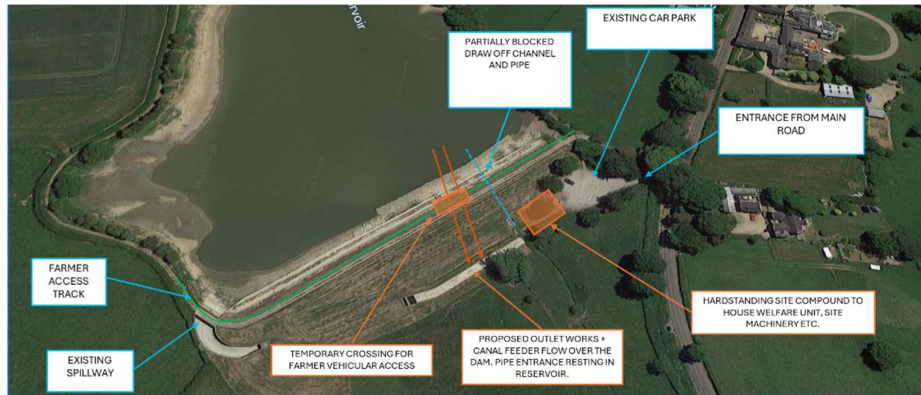
Figure 3. Sketch of syphon route and items of note

- Route syphon to follow the line of the left mitre into the tail-bay > Impossible to enable farmer's access to crest track as ramp cannot be built up in this location.
- Route syphon directly in the centre of the dam into the spillway channel > Chosen option (Figure 3).

Directing the syphon along the centre was the preferred option as it was the shortest length possible and it provided sufficient space for a ramp to be built up which the syphon could go through, and farmer's vehicles pass over.

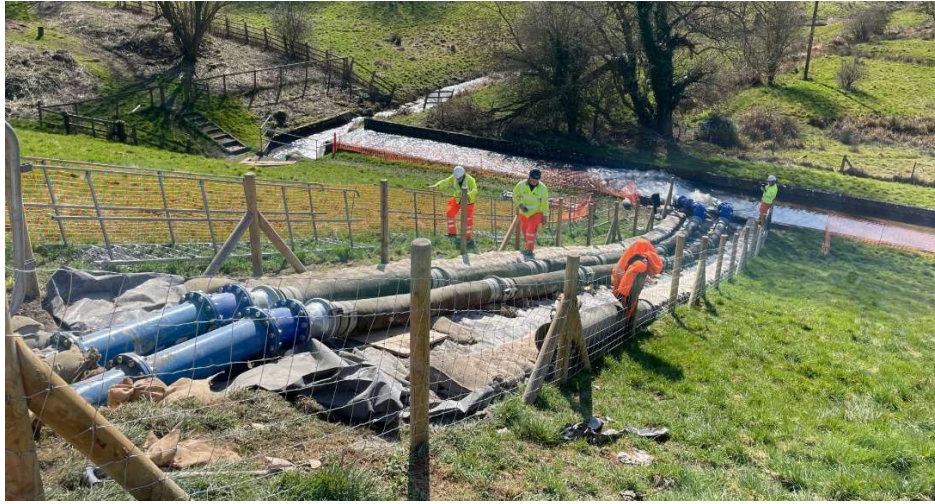
*Figure 7. The finished syphon (looking downstream)*

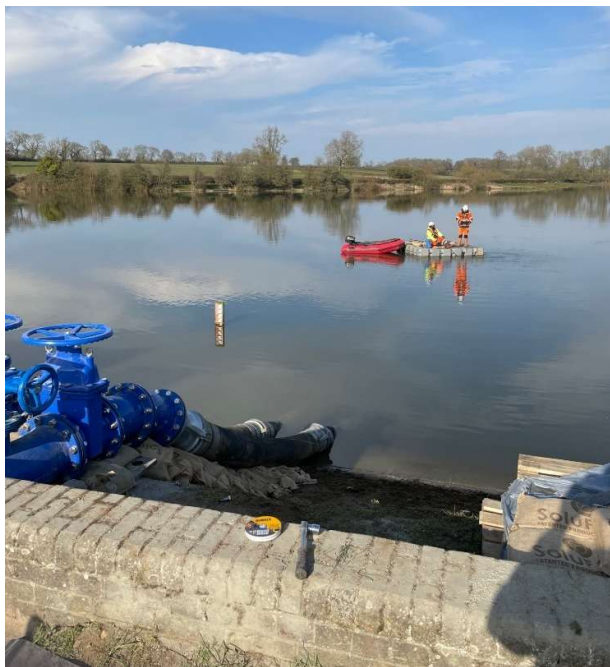
*Figure 8. The finished syphon (looking upstream)*

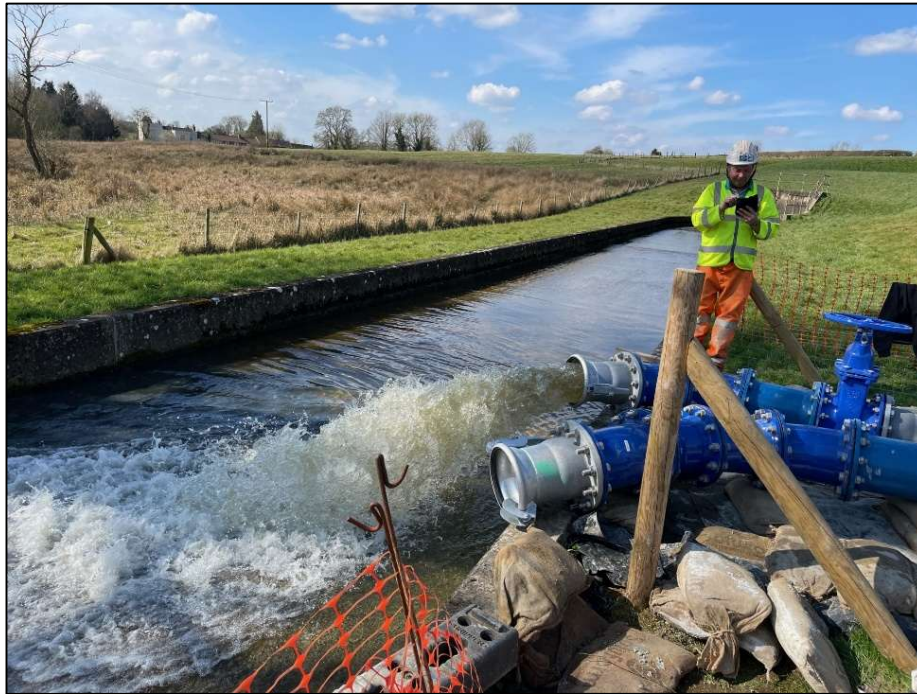
*Figure 9. The outlet of the syphon during discharge*

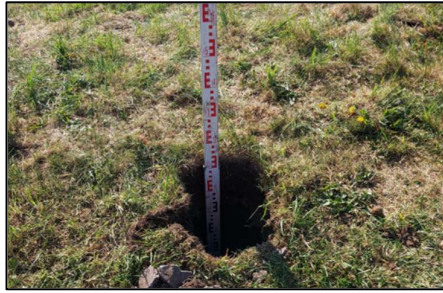
Figure 11 : Modified soakaway hand dug pit at Lower Foulridge.

During excavation, the soil profile is slowly exposed and logged by a geotechnical engineer, with particular attention to colour and soil consistency. When the clay core is found, typically a Disturbed 1l tub sample is obtained, and the excavation is stopped once the top of the core is reached, then extended wider to confirm the upstream or downstream extent, keeping within the pit maximum dimensions. If the upstream or downstream face is not found the next staggered pit is started. The method allows multiple pits to be opened simultaneously to measure the total width of the clay core.

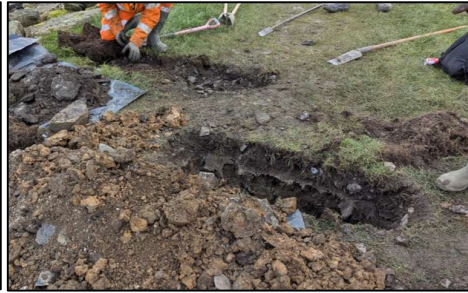
Figure 22: Excavation of a slit trench at Lower Foulridge.

Where a core is suspected within the first metre below crest level, hand dug slit trial trenches along the embankment crest to a maximum of 1.2mBGL were found to be a valuable investigation method. The trial trenches were split in two halves, offset from one another across the crest, to try and visually identify the clay core without compromising the integrity of the potential clay core. During and after excavation, modified soakaway tests were carried out in small pits adjacent to the trenches to measure the relative permeabilities of different fill materials and collect evidence for a less permeable core section. The main benefit of this method was the ability to visually compare the ground conditions across the trench and note any differences in colour or percentage of granular particles of the soil.

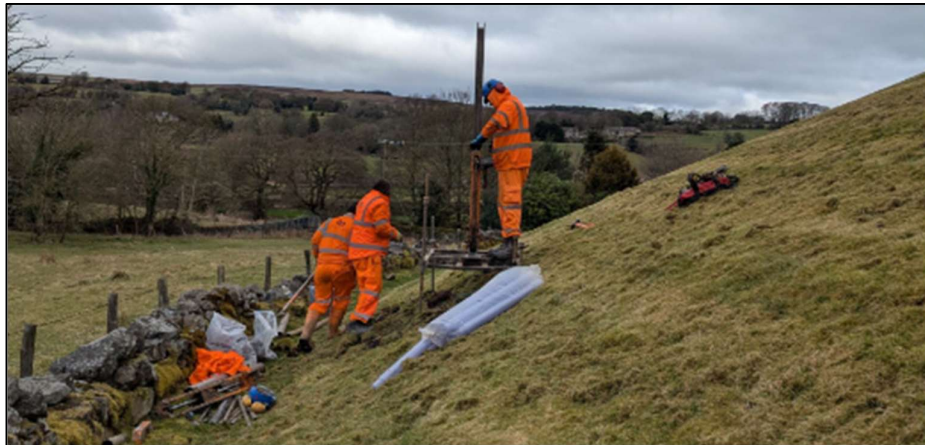
Figure 4 - Mott MacDonald GI at Lower Foulridge Reservoir

A series of GIs have taken place at Lower Foulridge since 2008, including investigation through the spillway and the base of the reservoir. GI was undertaken to ascertain the composition of the embankment and confirm or negate the presence of a clay core. This included cable percussive boreholes to a maximum of 17.8mBGL on the downstream shoulder through the embankment, or directly through the crest to try and locate the clay core and confirm the embankment-founding material interface. In addition, hand dug slit trial trenches along the embankment crest to a maximum of 1.2mBGL with soakaway testing, and hand dug trial pits around the outlets.

Further GI was undertaken comprising dynamic sampling boreholes to a maximum depth of 10.2mBGL, hand dug trial pits to a maximum depth of 1.2mBGL, and hand dug trial trenches along the crest to a maximum depth of 0.8mBGL.

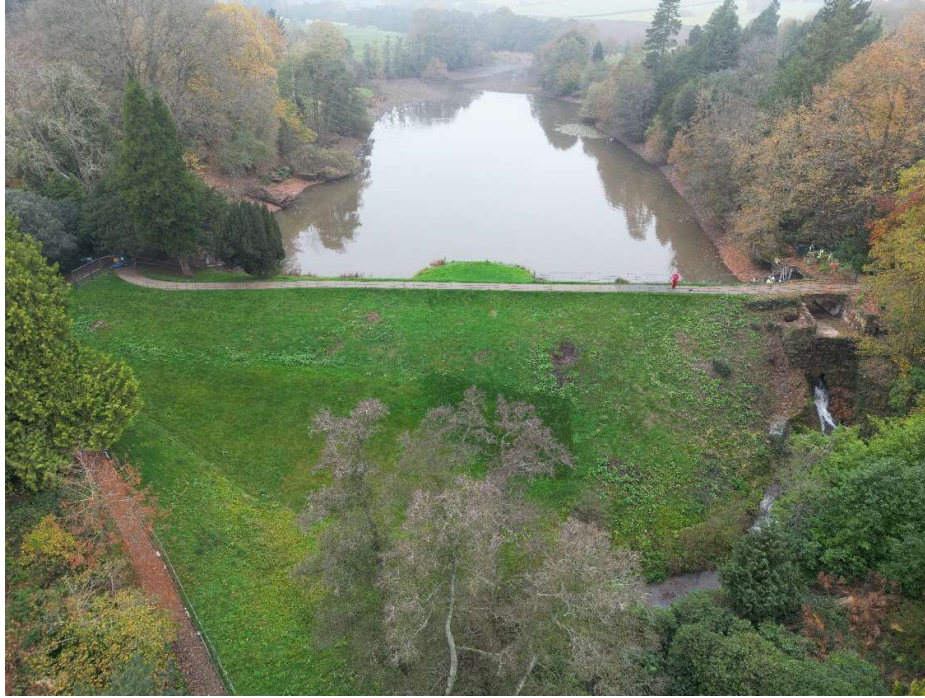
*Figure 1. Overview of the dam embankment and reservoir. The overflow and outlet works are located at the left abutment (right side as viewed).*

Witley Court Reservoir is orientated northwest to southeast with the embankment impounding the southeastern end. The earthfill embankment is 11m high and 95m long with a current crest level of 100.9 metres above Ordnance Datum (mOD). The embankment extends at its upstream mid-point into a semi-circular promontory, and a masonry wall extends the full length of the upstream crest at and below the waterline. The gradient of the downstream face is typically 1:2.5, with significantly steeper sections adjacent to the spillway at the left-hand side. The top water level of 98.9mOD is defined by the overflow channel, comprising a 4m wide concrete slab with masonry and stone-dressed concrete side walls, terminating above a vertical blockstone cascade wall and plunging some 6m to a sandstone stream bed in a gorge at the left abutment (Figure 2). Upgrade works undertaken in 2003 added a 2m wide by 1.4m high rectangular reinforced concrete auxiliary spillway to the left of the main spillway with a weir level of 99.1mOD, also discharging as a cascade immediately downstream of the main spillway. Additional works at this time included a new stone-dressed reinforced concrete pedestrian bridge with increased clearance height over the main spillway invert.

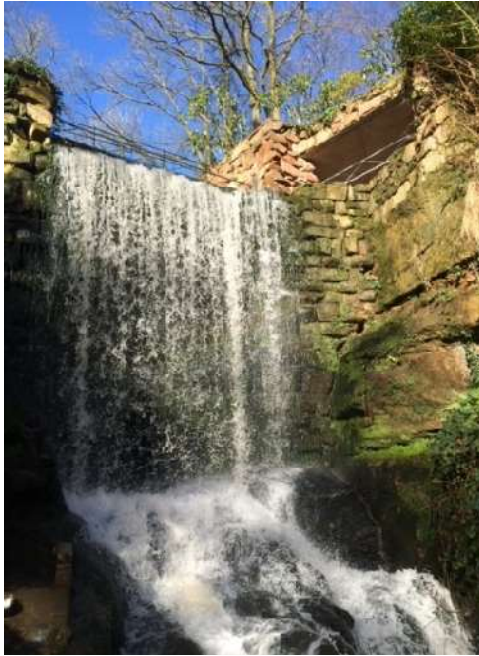
*Figure 2. Overflow channel in operation as a cascade.*

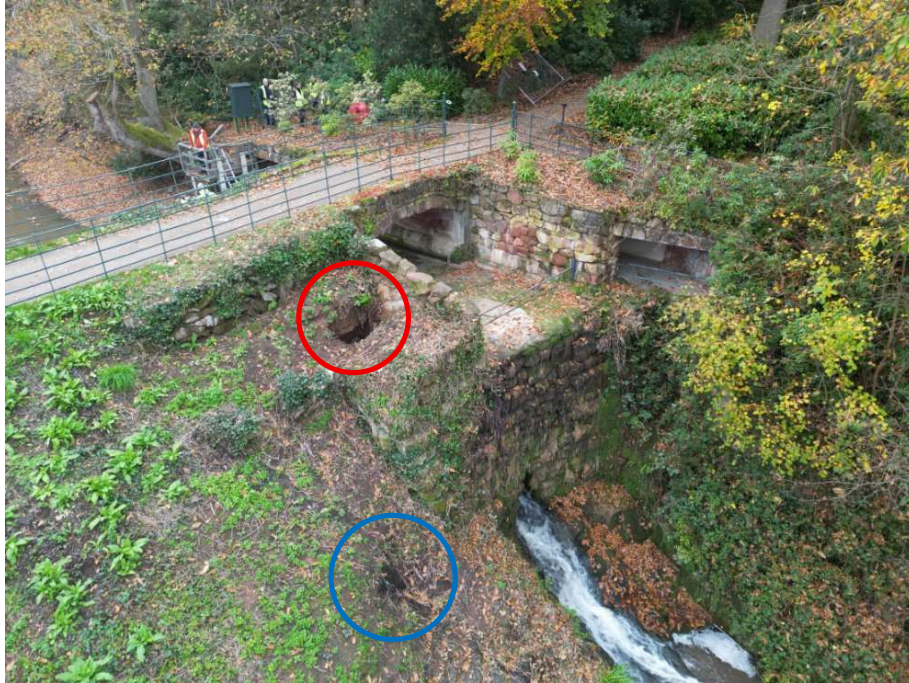
*Figure 4. Daylighting void adjacent to right spillway wall, downstream of crest. Primary voiding circled red, secondary depression circled blue. Flows from the outlet chamber 'grotto' can be seen entering the streambed.*

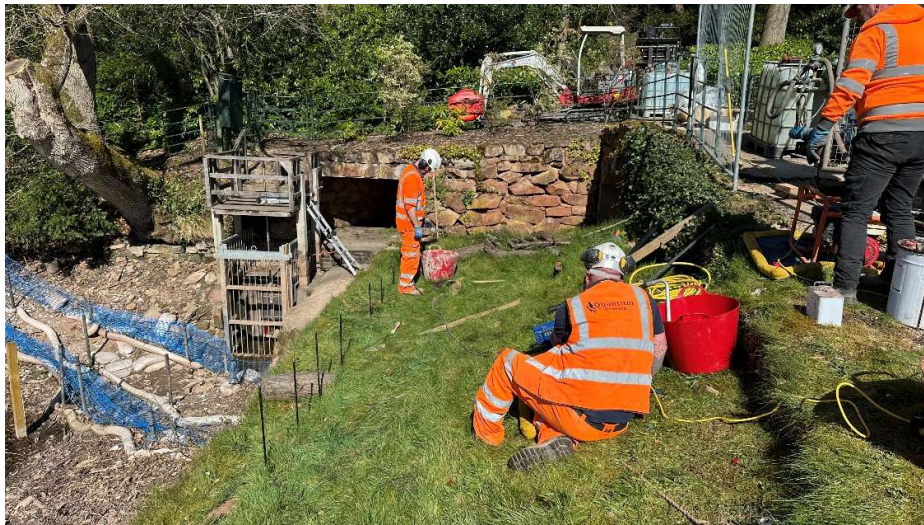
*Figure 5. Polyurethane resin injection at the upstream crest to reduce permeability across the presumed infiltration zone for seepage.*

to the right of the spillway channel. Due to the proximity to the water body, the resin product selected would become chemically inert upon contact with water, to avoid the risk of any pollution in the event of escape from the upstream masonry wall. Resin was injected to each lance by electric pump until refusal, and the lances were withdrawn by 0.5m at a time with injection repeated at each horizontal level.

No volumes of resin higher than expected were injected, suggesting no significant voiding was encountered in this area. The resin product expands on contact with moisture, which has the effect of compressing the soil around each injection point and reducing the permeability of the treated area.

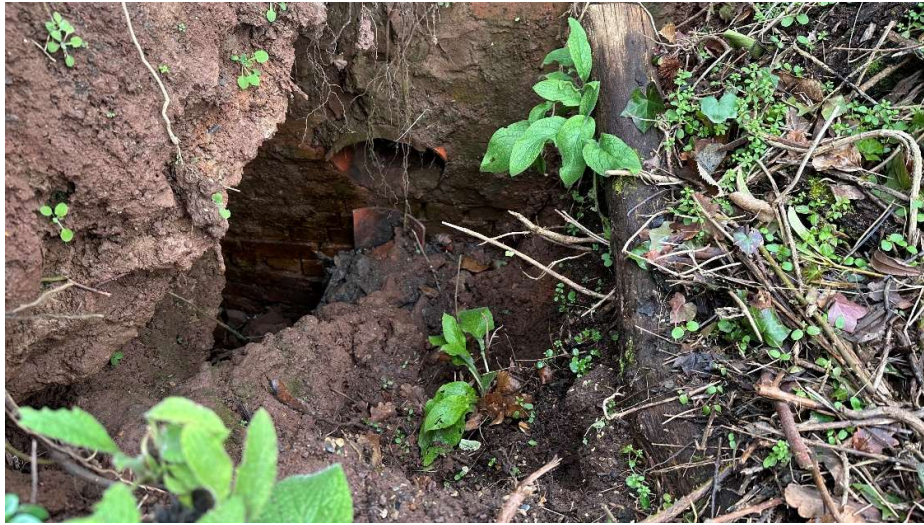
Figure 6. Clay pipe opening below the spillway, within the void. The void extended over 2.5m upstream, to the left of the image. The broken, active PVC pipe was obscured and buried within the sunken fill and not observed until it started running during the repair works.

The broken end of the PVC pipe, now exposed in the void by 'washing' of the outflow, was cut square and bunged with 300mm of mortar. The pipe opening below the spillway invert was also bunged in the same manner. The QCE advised that upon finding a solution to the active sewer, the remnant pipe within the embankment should be grouted or removed as pipes across the embankment would remain a reservoir safety risk.

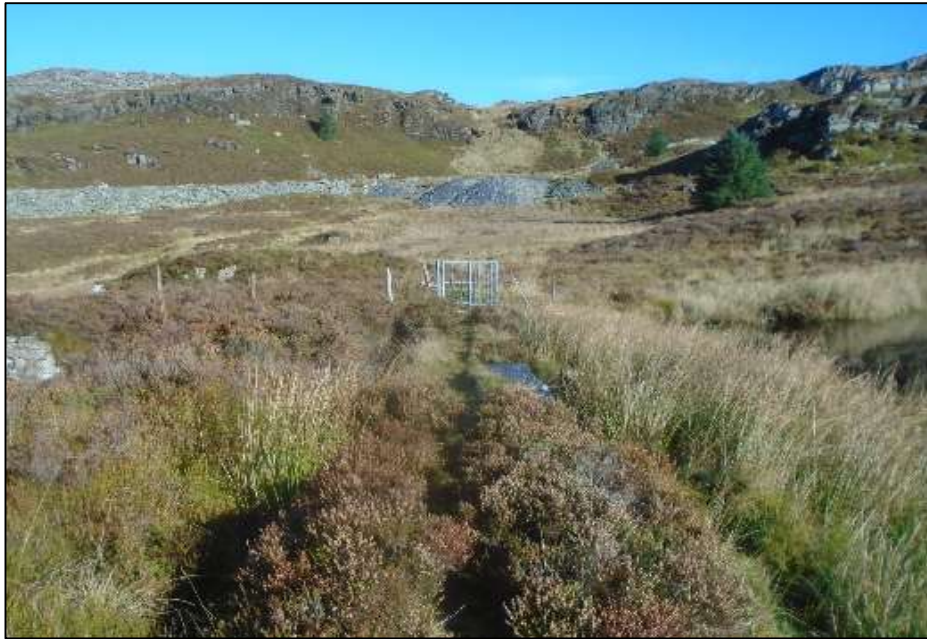
*Figure 2. Dam crest viewed from the left abutment, taken during the 2022 Section 10 Inspection*

The dam construction was found to be typical of those associated with similar reservoirs in North Wales, consisting of two dry stone walls encasing a central peat core, evidently formed using materials found locally to the site. The age and history of the dam of course meant that there was no information available on the internal construction or foundation treatment. At the time of the Section 10 inspection the dam wall, including the peat core, appeared to be largely intact with no signs of significant movement, loose stones or loss of material. There was, however, minor leakage through the lower part of the 3m high dam.

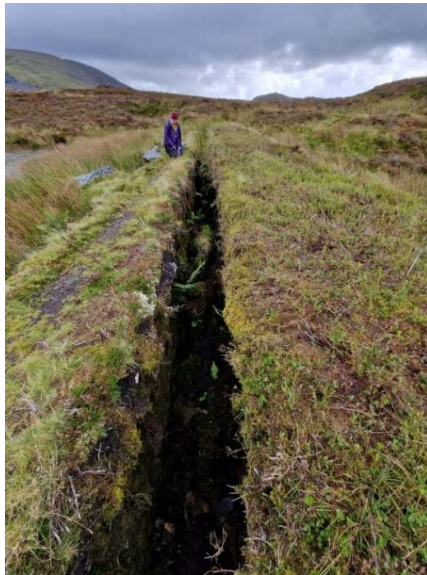
*Figure 5. Dam crest viewed from the right abutment in 2025, with missing peat core*

During the Supervising Engineer's visit in September 2025 it was discovered that the central peat core, intended to form the watertight element for the dam, was almost entirely absent, leaving a large void between the two stone walls. The ARPE was requested to visit the site as soon as possible to advise on the required course of action. Upon investigation it became clear that the central peat core had in fact eroded and been washed out over an extended period of time with the upper area bridging the gap. This upper part was most likely reinforced, protected, and held in place by vegetation until weathering or overspilling of the dam had sufficiently weakened the upper part of the core for it to fall into the void beneath. Leakage through the dam had significantly increased, flowing mainly from the base of the dam.

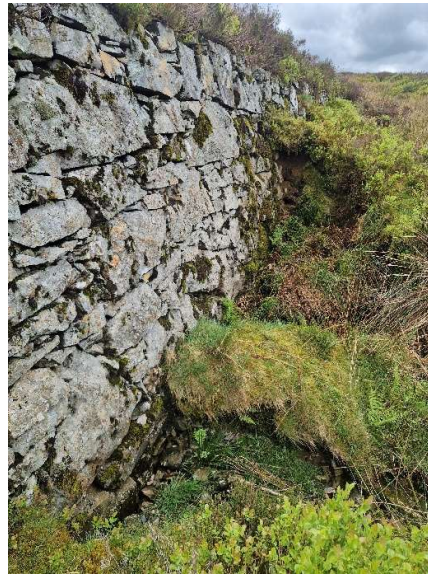
*Figure 6. Dam wall viewed from downstream, showing area of leakage at the dam toe*

With concern that the leakage at or just above foundation level could wash out material supporting the dam walls, it was clear that measures needed to be taken to make the reservoir safe. The usual course of action in these circumstances would be to release water from the reservoir to lower the

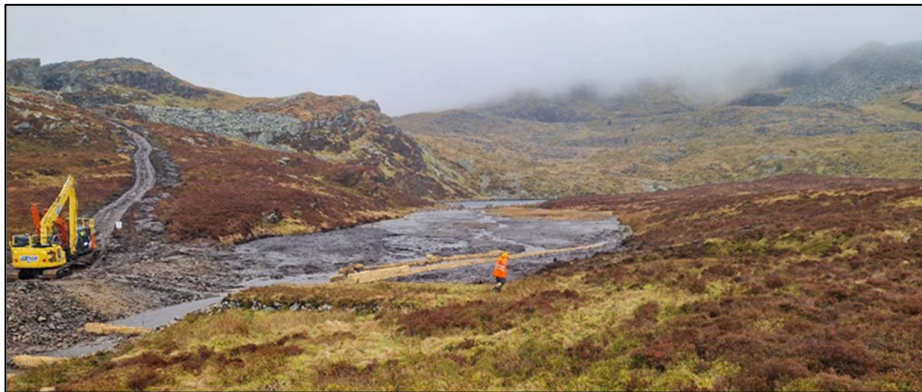
*Figure 7. Completed drawdown and dam removal with silt mitigation and silt retention measures being added*

The controlled dismantling proved to be a successful approach, even with some higher flows through the reservoir during wetter periods. Silt within the reservoir basin was carefully managed, with silt capture arrangements in place at the location of the dam and downstream. Silt retention measures were installed as the reservoir level was drawn down with the reservoir basin becoming accessible.

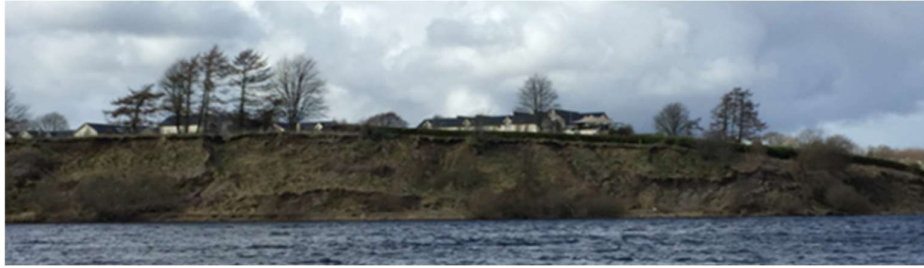
*Figure 2. Erosion identified at Burgage More prior to remediation works*

Burgage More is located south of Blessington, County Wicklow, adjacent to a resort complex (Figure 1). The affected shoreline comprises steep banks with evidence of localised failures, severe erosion, gully development, step features, and slumping of topsoil (Figure 2). These features indicated a deterioration trajectory that posed risk to amenities located upslope, including a public walkway.

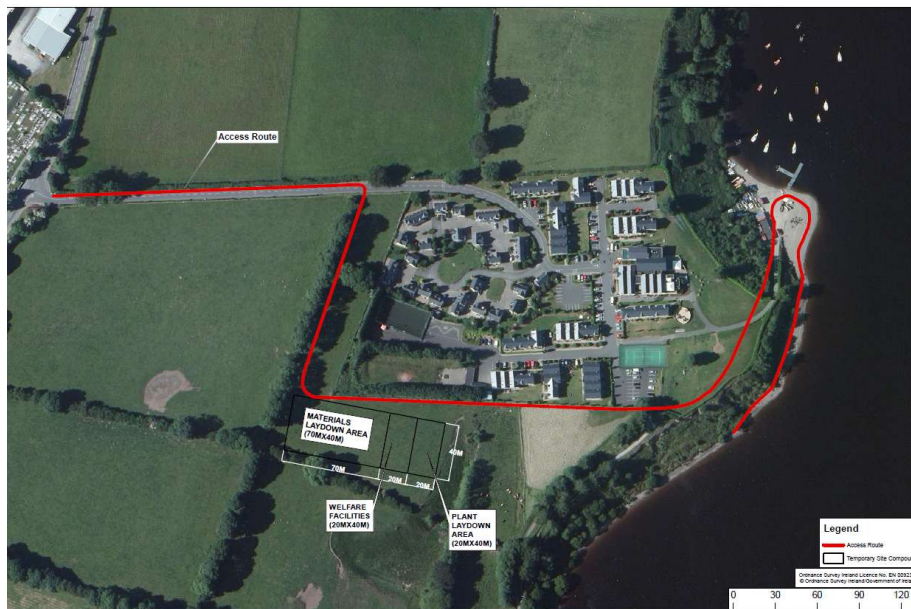
Figure 4. Revised Access Route (QS-000177-01-G451-004)

Early planning assessed alternative site access routes: (i) via private land north of the Avon Ri complex and (ii) via/through the Avon Ri complex. Minimising disruption initially favoured northern access. However, subsequent geotechnical assessment and constructability considerations informed a revised access strategy which meant that a route to the east and south was chosen for access (Figure 4).

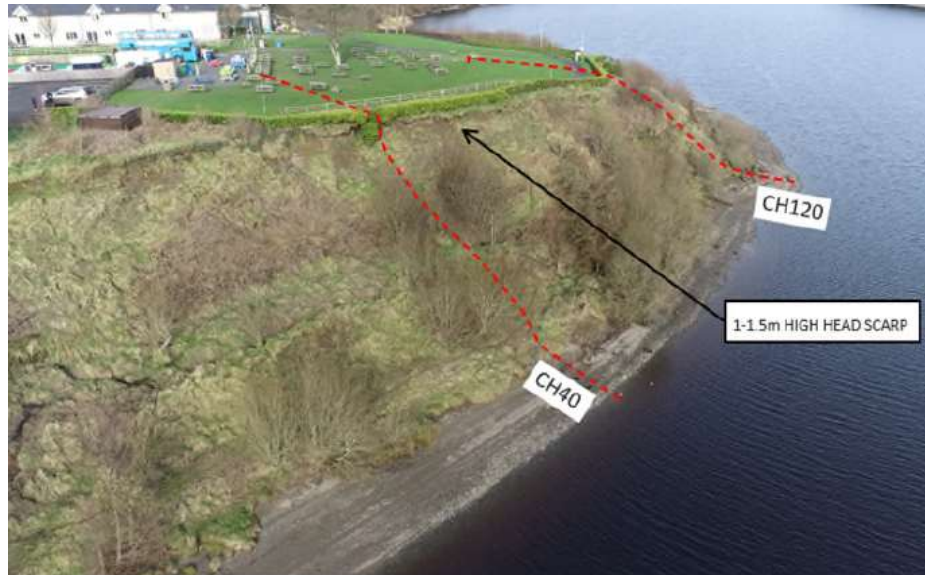
*Figure 6. View of slopes before works*

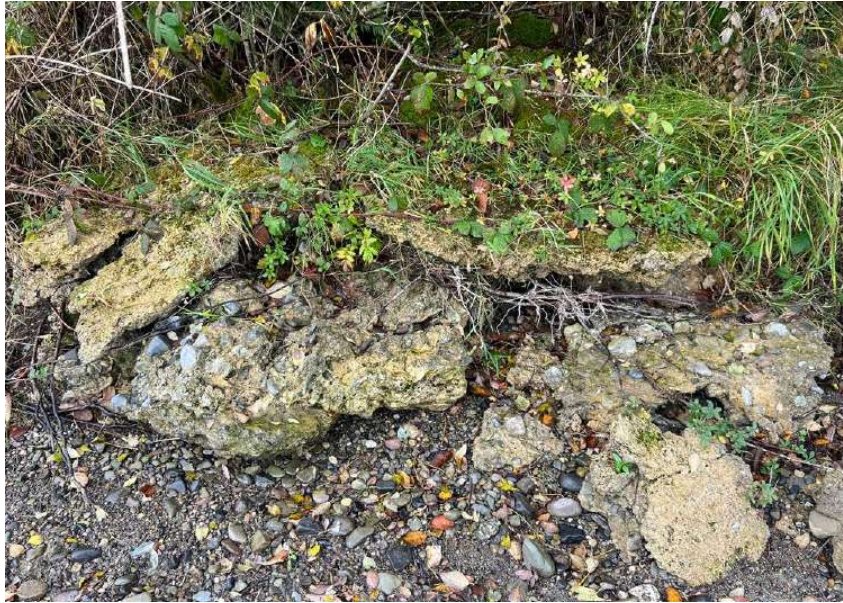
Figure 9. Tufa formation on reservoir shore

During site attendance by the project ecologist, seepages/ springs were identified and subsequently confirmed as tufa (petrifying) springs, described as lime-rich discharges capable of depositing calcium carbonate and forming porous tufa deposits. Tufa springs are designated as a priority habitat in Annex I of the European Union Habitats Directive in recognition of their vulnerability. A specialist was engaged to confirm habitat identification. Given the sensitivity of these features, a hydrogeological review assessed potential impacts of the proposed drainage and revised slope geometry, drawing on the borehole and groundwater dataset. The drainage design was modified, including raising a portion of the cut-off drain, to reduce risk of adverse effects.

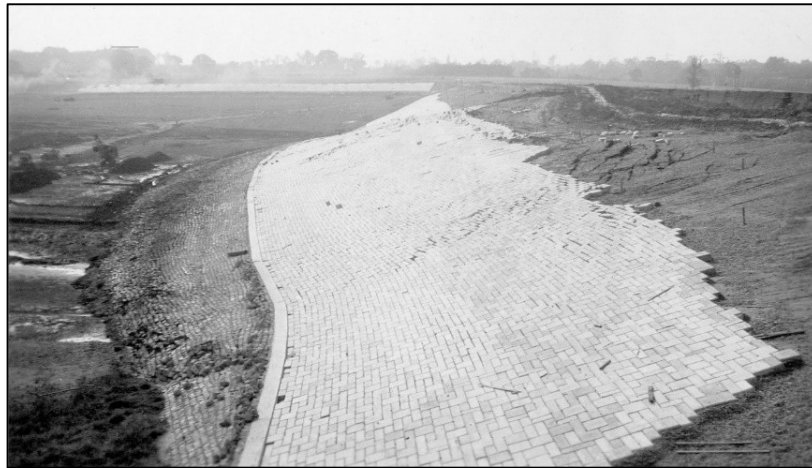
Figure 2. General view of 'original' dam failure

The FE analyses modelled the failure during 'initial' dam construction in 1937 (Figure 2) and its subsequent successful completion and operation (Kovacevic et al, 2013), before it was raised from 2009 to 2013 (Figure 3). The best estimate of the dam history was modelled in the 'coupled' FE analyses. Table 1 shows the increment numbers corresponding to the various stages of the analysis and appropriate time steps. The model parameters were derived on the basis of the available site investigations and laboratory testing (Table 2).
