## The Washburn Valley Reservoirs – spillway improvements

J. R. CLAYDON, Yorkshire Water D. L. KNOTT, TEAM I. C. CARTER, TEAM

SYNOPSIS. The Washburn Valley reservoirs comprise a cascade of four impounding reservoirs situated about 12 km to the west of Harrogate in North Yorkshire. The three lower reservoirs, Lindley Wood, Swinsty and Fewston, were formed between 1875 and 1879, by the construction of earth embankment dams with puddle clay cores. The upper reservoir, Thruscross, is a mass concrete gravity dam constructed in 1966. The upper three reservoirs supply water to Leeds while the lowest, Lindley Wood, provides compensation flows to the River Washburn.

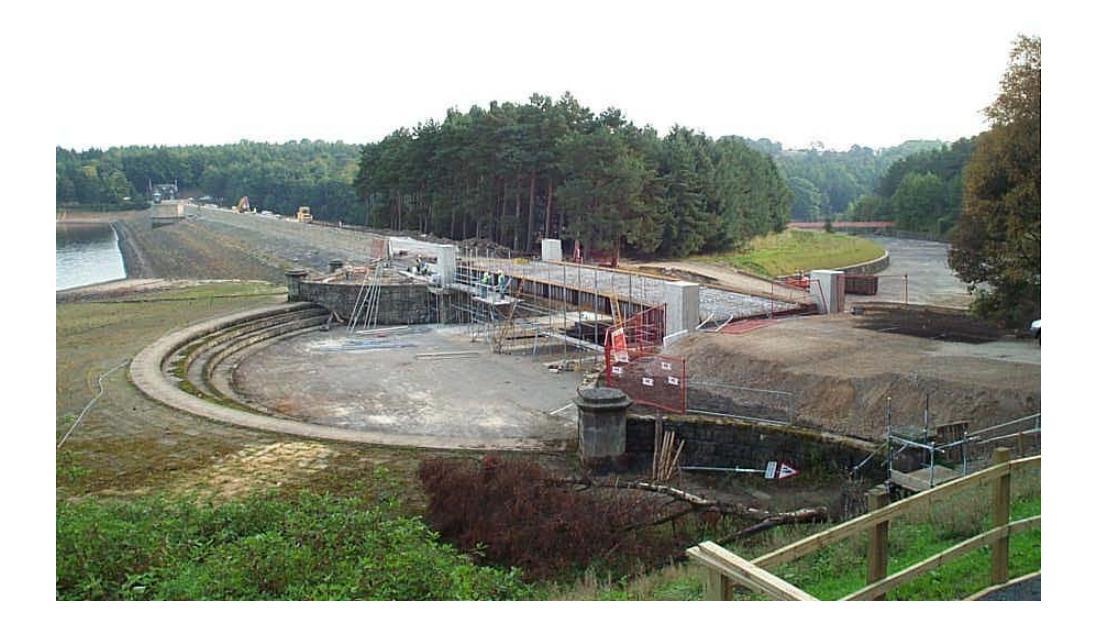
construction of additional bunding and provision of reinforced grass revetments utilising proprietary pre-cast concrete blocks. The replacement of the bridge at Swinsty was undertaken as a 'design & build' element within the contract, and designed to be lifted 0.5 m in the future. The main beams for the bridge were prefabricated and delivered to site as single 30 m long units;

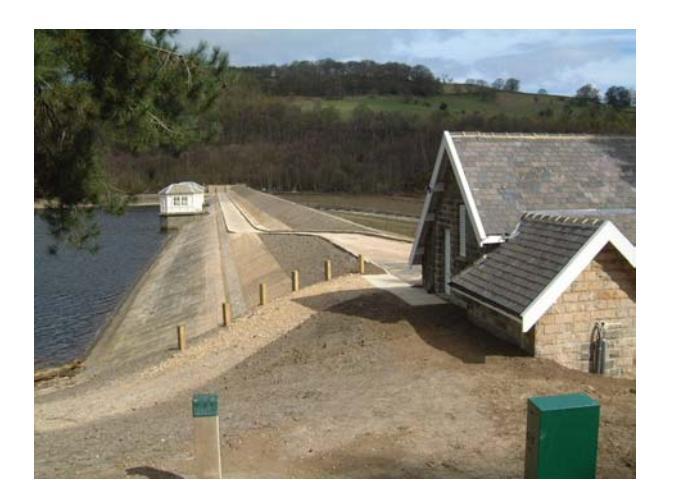
This disused dwelling was originally intended for demolition as it was considered an obstruction to the dam raising works. However plans were altered when two bat colonies were discovered within the roof void. Bats are protected species and a mitigation strategy needed to be agreed with DEFRA in order that permission to remove the habitat could be given.

The most straightforward mitigation was to build another bat roost nearby, carefully replicating the conditions in the hope that the bats would move, however this would have meant delaying the work by at least one year and possibly longer. Alternatively, the raising could have been done by a complicated realignment of the crest around the house, in order that the structure might be left intact. The solution adopted in order to facilitate both the crest raising and the maintenance of the bat habitat was to build the cottage into the raised dam embankment. The ground floor was filled with lightweight concrete and the existing first floor became an electrical plant room. Landscaping around the house was designed to maintain flight paths and bat tiles were built into the roof to maintain access for the bats. The bats returned to breed in 2003, helpfully discharging the planning condition.
