EVENING MEETING

75th Anniversary of the Dam Busters Raid

Jonathan HINKS, HR Wallingford Chris HEITEFUSS, Ruhr River Association

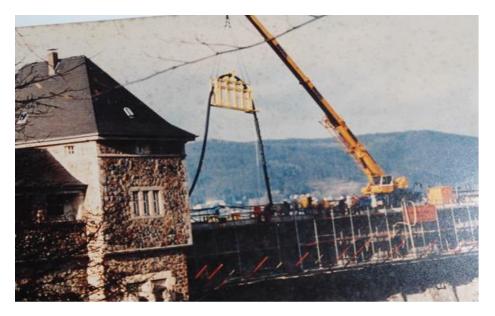
Old photograph: showing installation of anchors at Eder dam.

At the 48m high Eder masonry dam a gallery was excavated by drill and blast and in 1991 - 1994 a total of 104 anchors, 65 to 75m long, were installed each with an ultimate tensile strength of 7.5 MN.
